SKIN: SKINIS SIGNIFICANTLY CRUMPLED, UPPEREDGE

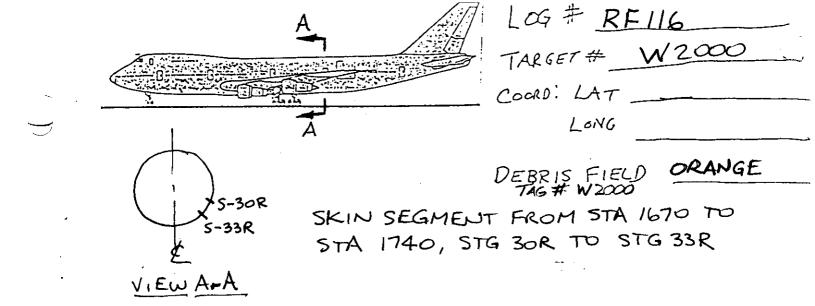
FROM STA 1670 BACK TO STA 1720 IS FOLDED INBOARD ROUGHLY ALONG STG 31R. MOST OF THIS FOLD IS A TIGHT RADIUS, AND CRUSHES STG 31R FROM STA 1670 TO ABOUT STA 1700. ALL EDGES ARE JAGGED. THERE ARE A NUMBER OF AREAS ON THE INSIDE SURFACE WHERE THE ALUMINUM IS BARE, PAINT & PRIMER HAVING BEEN ABRADED AWAY. AT THE AFT END OF THE SEGMENT IS PART OF THE CUTOUT FOR THE CARGO EXTERNAL LIGHTING INSTALLATION (DWG 65840341-2). THE CUTOUT PORTION INCLUDES THE AFT, UPPER CORNER GOING FORWARD THEN DOWN TO THE FWD LOWER CORNER. THE CUTOUT IS CENTERED AT STA 1729.50, W.L. 157 (BETWEEN STG 31R AND STG 33R., STG 32 R IS DISCONTINUOUS BETWEEN 1720 \$ 1741.1), THERE IS A PENETRATION AT

STA~1698, STG 31/2. ABOUT 11/2"LONG 0.5" WIDE, FLANGED OUTBOARD

REMAINING ATTACHED TO THE SKIN IS STG 31R BETWEEN STAN1720 TO STATIN 1672, STG 32R REMAINS ATTACHED FROM STA~1690 TO STA 1720. A REMNANT OF STG 33R REMAINS ATTACHED BETWEEN STAN1702 AND STA 1720.

FRAME SHEAR TIE REMNANTS (FLANGES ATTACHED TO SKIN) REMAIN ATTACHED BETWEEN STG JOR TO 31R, 31R TO 32R, & 32R TO 33R, ALLAT STA 1720. REMNANT OF A STRINGERCLIP STILL ATTACHED AT STG 32R, STA 1720.

NO APPARENT SOUTING PRESENT,
