LOG # RF136

TARGET # D2114

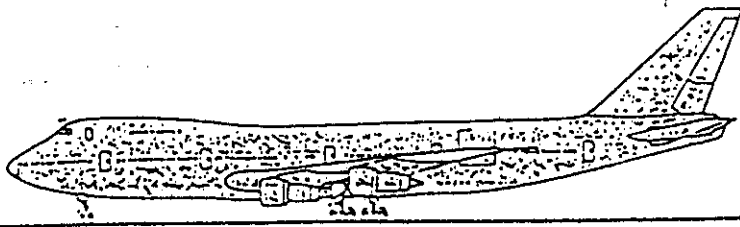
RF136 CONSISTS OF PRESSURE DECK FLOOR BEAM AT ATRBL 33.99 FROM BS 1320 TO DEBRIS FIELD WHITE

1395. FAILURE IS VERY SIMILAR TO RF135 UPPER CHORD SEAT TRACK FLANGES AND CROWN ARE LARGELY INTACT. LOWER CHORD IS FAILED

AT RADIUS. A FORE-AFT <sup>FLOOR</sup> STIFFENER IS ATTACHED WITH A LENGTH OF FLOOR PANELING TO UPPER CHORD FLANGE. THE CENTER LINE OF THE

PARALLEL STIFFENER IS APPROX. 6 INCHES INBOARD OF THE SEAT TRACK CROWN CENTER LINE. THIS FORE-AFT STIFFENER RUNS AT FLOOR LEVEL FROM BS 1327 TO 1367.

FLOOR BEAM FASTENERS AND STIFFENERS ARE LARGELY IN-TACT. STRUCTURE APPEARS TO HAVE HAD CORROSION INHIBITOR (DINOL) APPLIED WITH THE ASSOCIATED "DIRTY" FINISH.
