LOG # RF 141
 TARGET # Z 2739
 COORD: LAT _____
 LONG _____

RBL 75.92
FLR BM

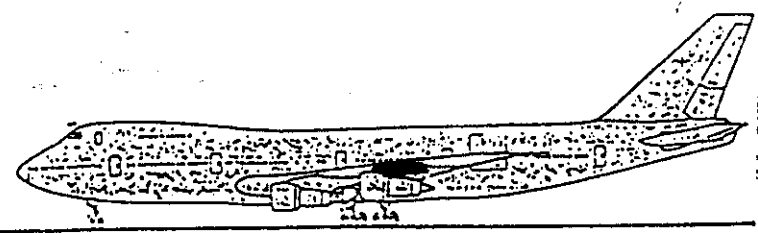
RF 141 CONSISTS OF PRESSURE DEBRIS FIELD GABBN
 DECK FLOOR BEAM AND PART OF A CABIN SEAT LEG. THE LOWER CHORD HAS FAILED IN THE RADIUS AND THE UPPER CHORD HAS FAILED ALONG MOST OF THE LENGTH OF THE SECTION. THIS SECTION IS AT RBL 75.92 FROM BS1447 TO 1480.

LOWER CHORD FRACTURED AT RADIUS
 R. Hanover 3/28/97
 Boeing
