LOG # RF-15

Green Tag #
C117

SKIN PANEL STA 2280 TO STA 2340

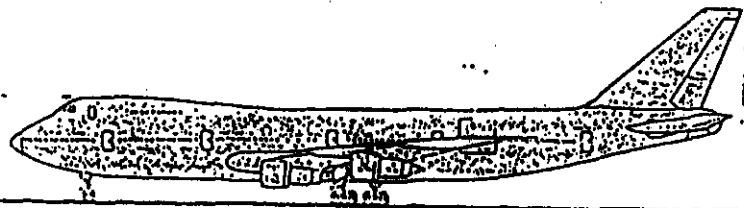
RF-15

S-11R TO SAW CUT @ S-1.5 RIGHT

STRINGERS ATTACHED @ 9R STA 2306-2340,

8R, 7R, 4R STA 2280-2340, 5&6R 2270-2340

S 2R & S3R 2260-2340.

ALMOST ALL STRINGERS HAVE SQUARE TENSION BREAKS

FRAME SEGMENT 2300, S3R TO S6R ONLY

PIECE STILL ATTACHED, NO STRINGER/FRAME

CLIPS REMAIN ELSEWHERE.

SAWCUT FROM RF-9A

NET TENSION FAILURE ALONG 'RIVET' LINES
