LOG # RF162

PRESSURE DECK WEB DEBRIS FIELD UNKNOWN

STA 1324 - 1346

RBL 75.92 - 98.58

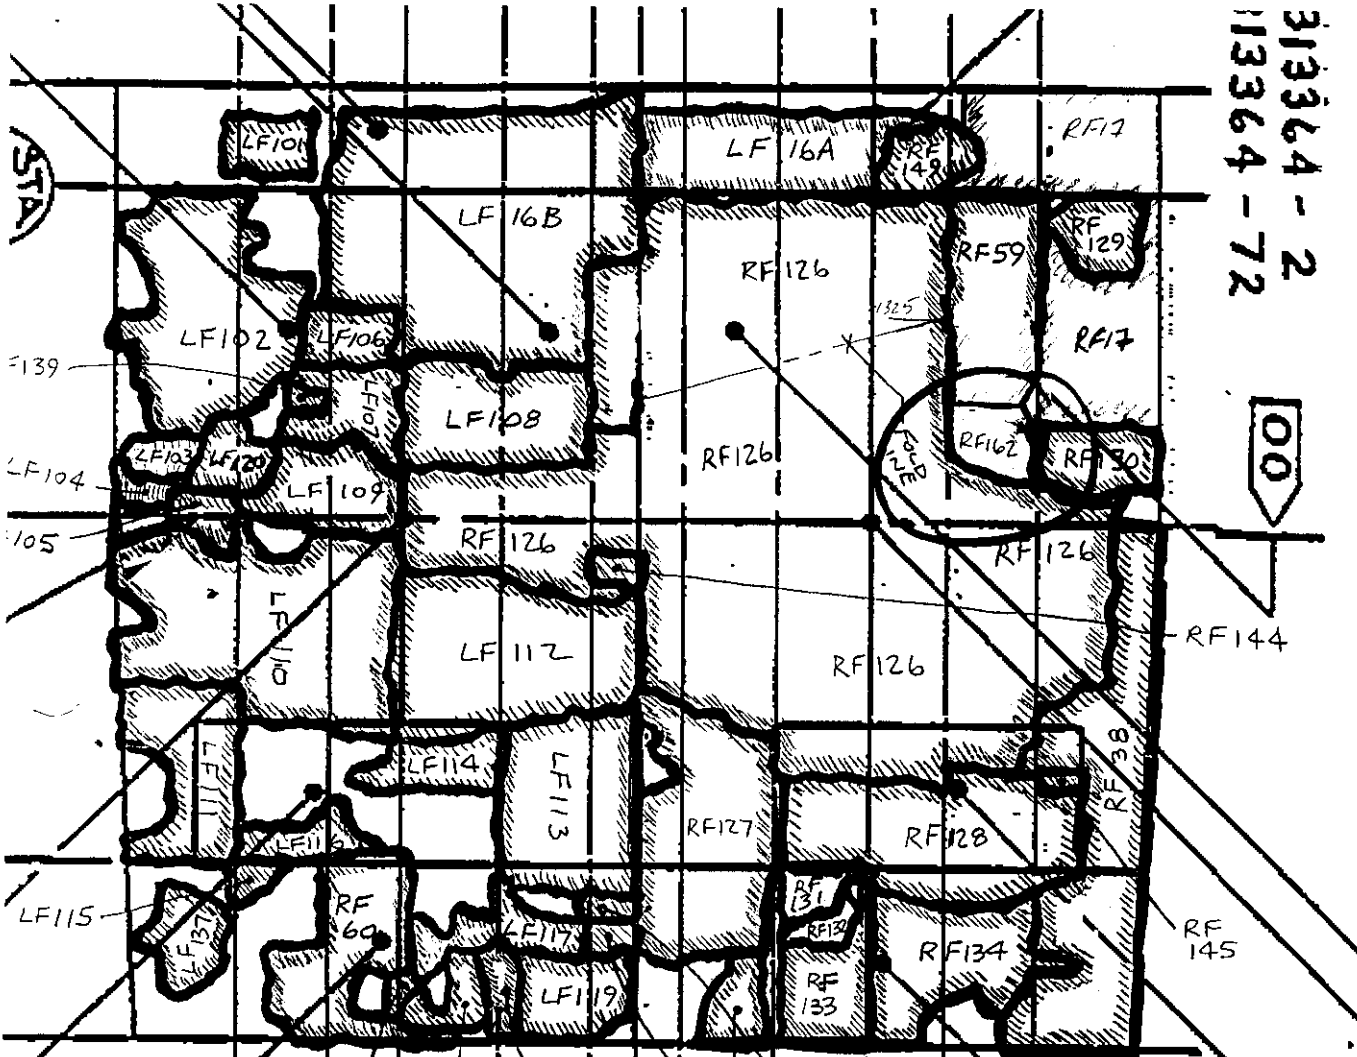
RF162

- UPPER SURFACE OF PART IS CLEAN
- ALL FRACTURE SURFACES AND DISBONDED SURFACES ARE FREE OF SOOT
- LOWER SURFACE OF PART IS DIRTY WITH THE AFT SURFACES OF THE STA 1329 & 1334 STIFFENERS BLACKENED

UPPER SURFACE OF STIFFENER IS FREE OF SOOT; NOTE, THIS PART MATES WITH RF17 WHICH IS BURNED

STA 1334 TRANSVERSE STIFFENER EXTENDS OUTBD FOR 15"

PRESSURE DECK WEB CURLED DOWN & FWD

FAILURE THRU FASTENER LINE

PUNCTURE - NO CORRESPONDING MARK ON OTHER HALF OF PART

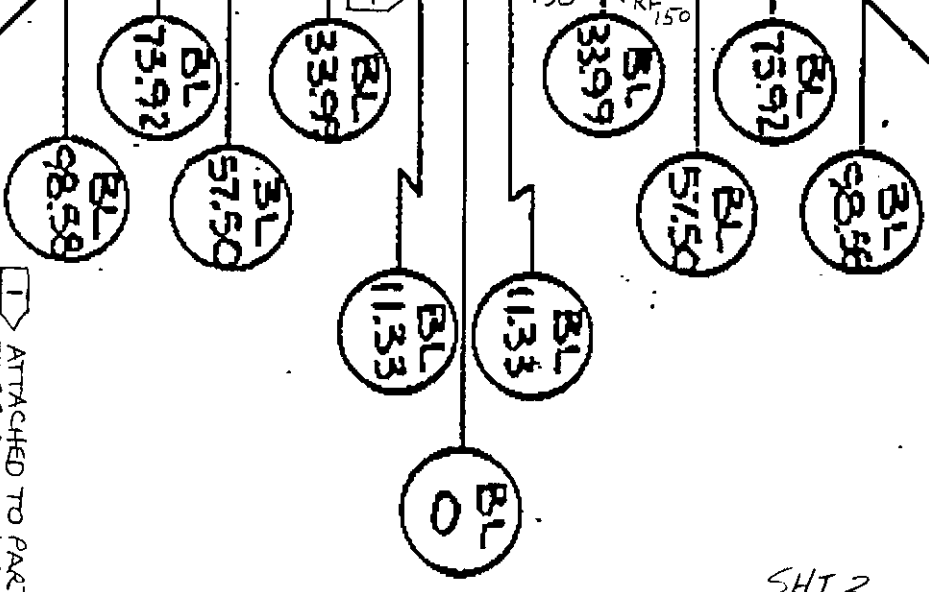
ATTACHED TO PART
TAGGED WITH C-
(STX 1480 BLKHD)
