LOG # RF-22

RF-22

4½ WINDOW SEGMENT AFT OF STA 1480
STA 1480 - 1580, STR 19R - 26R

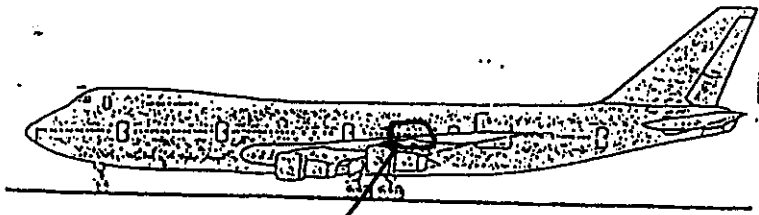
STA 1480-1580

STR 19R-26R

ON RIGHT HAND SIDE

REFER FIRE AND EXPLOSION GROUP NOTES FOR FIRE DAMAGE

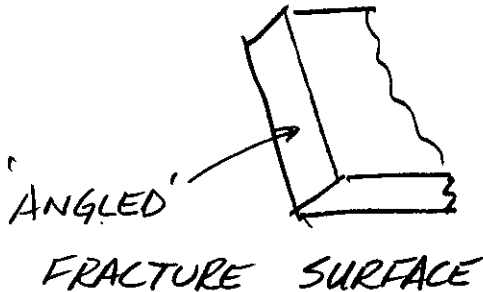
- MOST FRACTURE SURFACES ARE 'ANGLED' (BUT LIGHT SOOT ON THE OUTSIDE)
- NO SIGN OF HEAT DAMAGE, WHITE PAINT ON EXTERIOR IS NOW LIGHT GREY. ½ OF RED PAINT BELOW WINDOWS HAS PEELED OFF
