LOG # RF 23

145A-309

STA 1020 TO STA 1240, S11 TO S19; SKIN STRINGER AND FRAMES.

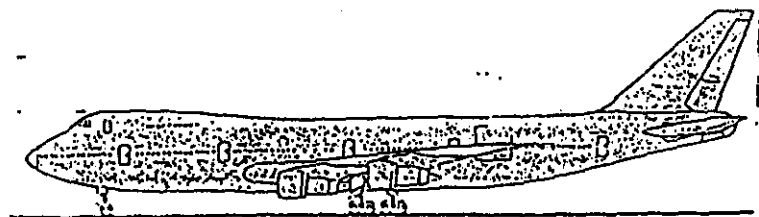
EXTERIOR HAS SIGNS OF SMOKE, NOT HEAVY OR BURNT

- 1140 BULKHEAD ATTACHED S-9 TO S-17.5 (SPICE) FRACTURE @ LOWER WEB SEGMENT UPPER ROW
- 1120 FRAME ATTACHED S-11 TO S 17
- 1100 FRAME ATTACHED S 11 TO S 18
- ALL STRINGERS ATTACHED TO FWD & AFT EDGES OF PANEL

ALL STRINGERS BROKE AT STA 1145 - 1150 RANGE

S-15	PEELED OFF SKIN	STA 1145 TO 1200	} FOLLOWED BEND TANGENT
S 14	" " OFF " "	STA 1145 TO 1190	
S 13	" " " "	STA 1147 TO 1175

- STA 1241 SKIN SPICE IS FAILED THROUGH FWD ROW OF FASTENERS OF SKIN
- FWD END DIDN'T FOLLOW ANY FASTENER LINES
- S 11 FAILED THROUGH FASTENER OF 100% OF PANEL
- S 19 & S 16 FAILED THROUGH FASTENERS LESS THAN 50%
