LOG # RF26 U.S. 1 RS 9-30-96 AEB
 TARGET # _____
 COORD: LAT _____
 LONG _____

DEBRIS FIELD #1 Green
 (Far)

RHS aft Body skin between Door 5 and STA 2360, S-11R → 24R, and area below the Door.

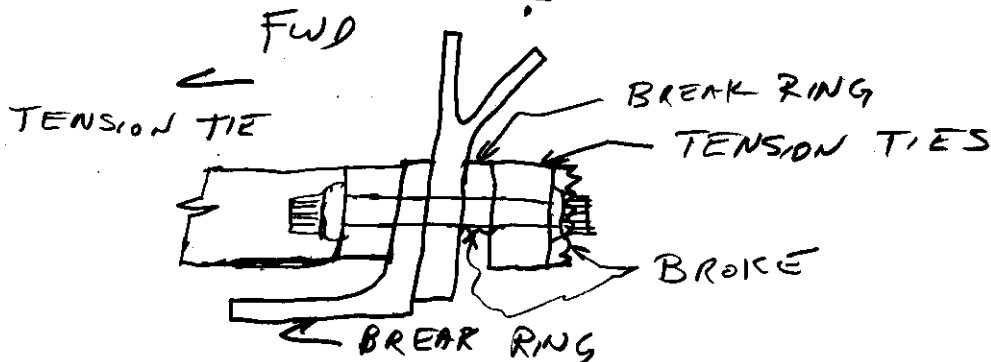
RF 26A

DOOR 5 UPPER AFT CORNER CUTOUT

STA 2360 TO STA 2280, S 11R TO S 23R

- NO SMOKE INSIDE
- LIGHT GREY SMOKE OUTSIDE
- TEAR ALONG S-11 @ FASTENER &
- S 12 LAP PERL BETWEEN 2315 - 2340 OUTWARD
- LOWER END OF PANEL CRUMPLED AND TORN
- DOOR FRAME SEVERED @ S-21
- SILL BROKE AT 2280 (NEAR TANGENT OF RADIUS
- 2280 FRAME, S 13 TO SILL
- 2285 S-21 TO AUX SILL (S-13)
- 2300 S 18 TO AUX SILL (S-13)
- 2320 S 18 TO S-12
- 2360 BLKH FWD BREAK RING, 48 SEC BREAK RING, EXTRUSION @ FROM PRESSURE DOME S 13 TO S-22 EXCLUSIVE OF BOTH ENDS TENSION TIES
- AFT TENSION TIES FAILED (48 SEC) @ EXTRUSION ROOT AND 48 SECTION BREAK RING FRACTURED ALMOST EXCESSIVELY @ TENSION BOLTS &

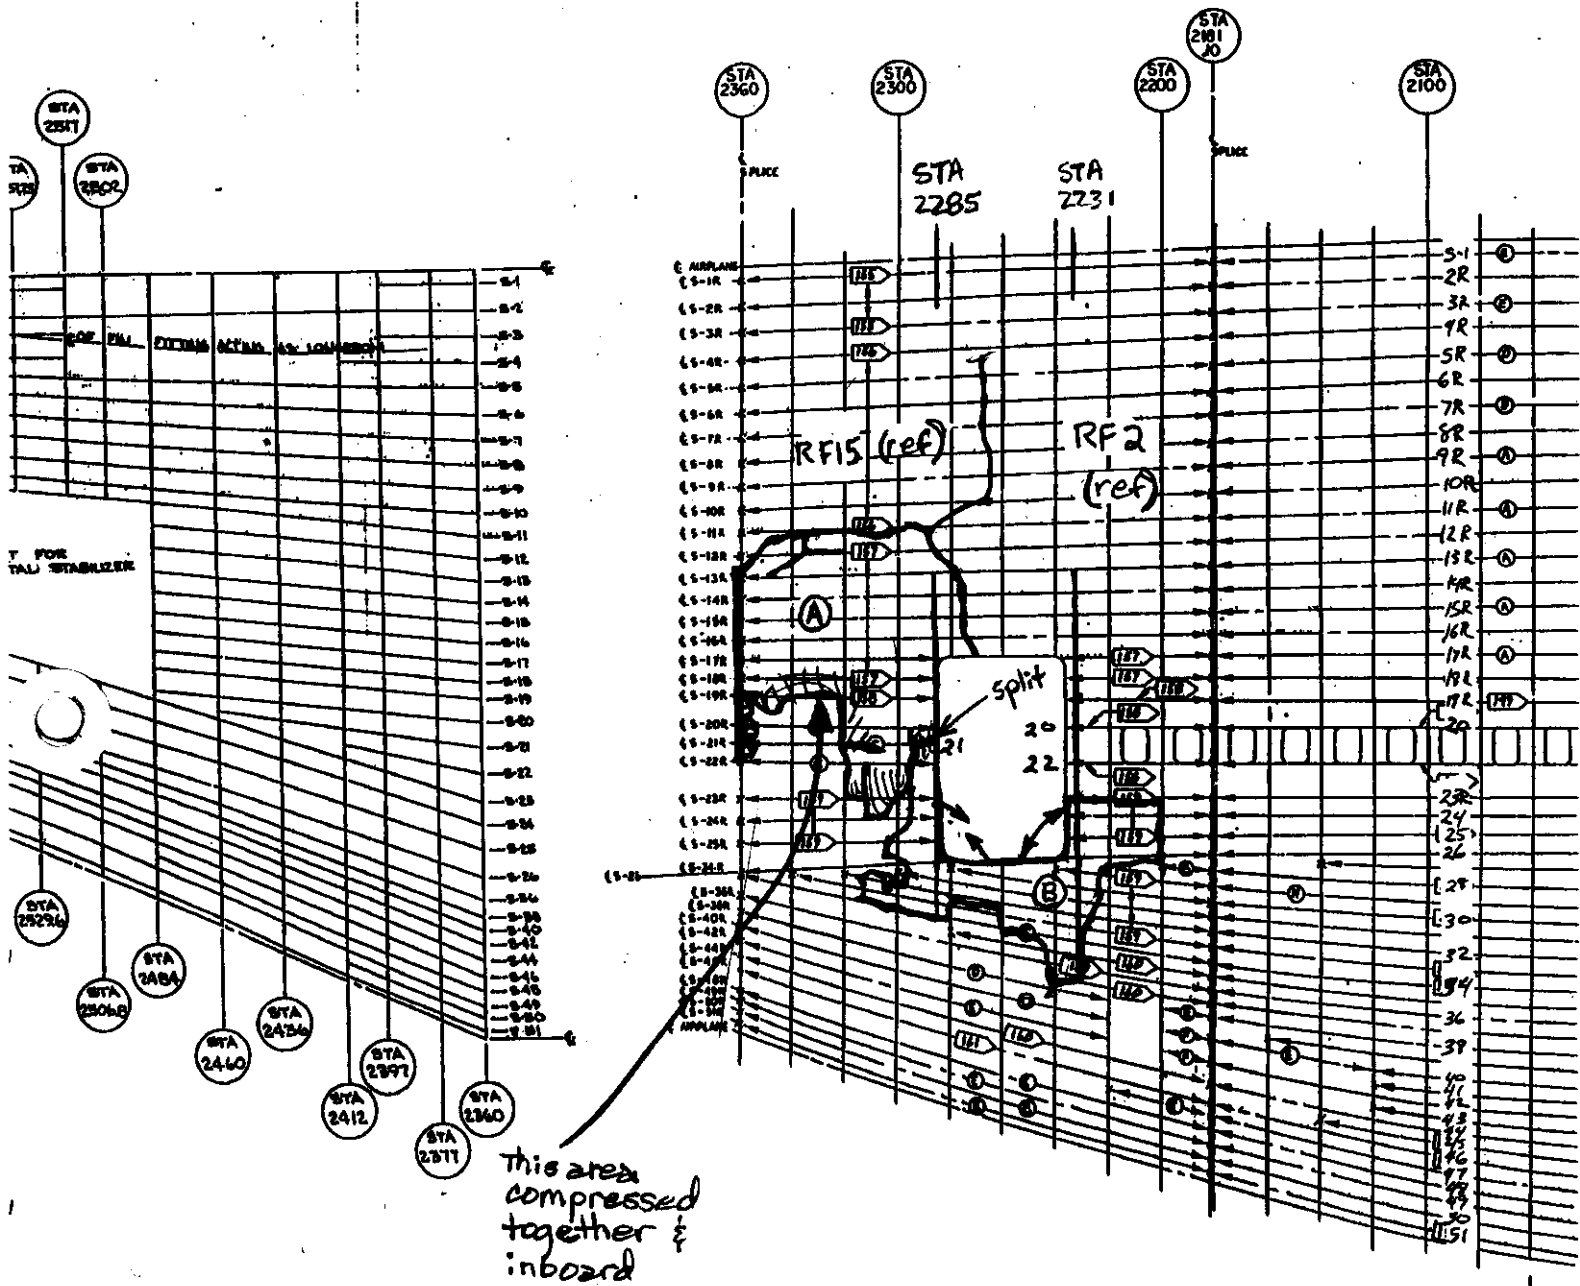
RF26

Lwr portion of skin is crumpled upward and inboard. Panel is torn in several places. Y ring is attached from S-13R to S-22R and portion of Blkhd web attached to Y ring as shown in detail on LF26.

This panel aligns with Panel A at S-21 (failure through skin, straps and edge frame). Lwr portion of door cutout is distorted with fwd cnr obtuse and aft cnr acute.

There is light scuffing on exterior surface only (both segments).
