LOG # RF3 ^{SDG} ^{D. J.} ^{AS} ^{-A-F-96} ⁴⁻³⁰⁻⁹⁶

TARGET RF3 CONTAINS APPROX 20% OF THE MAIN CARGO DOOR STRUCTURE AND SKIN. ALL DOOR FRAMES ARE FRACTURED AND BENT APT. DOOR IS CUT THRU BETWEEN REMAINING PORTIONS AT STA 64.5 AND 652.9 SKIN MATERIAL JAGGERED AND CRUSHED. NO EVIDENCE OF FIRE OR SMOKE DAMAGE.

RF3 FORWARD CARGO DOOR

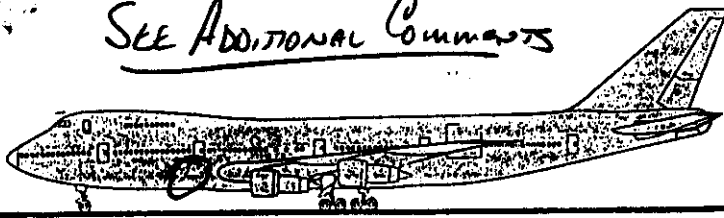
TARGET RF3A REMAINS ATTACHED TO DOOR STRUCTURE ^(RF3) BY MEANS OF THE LOWER DOOR LOCKS STILL ENGAGED TO DOOR SILL. THIS STRUCTURE IS SEVERELY CRUSHED, AND MANY FRAMES MISSING, AND STRINGERS MISSING AND FRACTURED. THIS TARGET COVERS STA 600 THRU 780 AND STRINGERS S23R THRU S44R NO FIRE DAMAGE

TARGET RF3B CONTAINS THE UPPER TOP DOOR OPENING STRUCTURE FROM STA 600 THRU 640 AND STRINGERS S26R, S25R ALSO ATTACHED IS PORTION OF FLOOR BEAM TO FUSELAGE. STRINGERS FRACTURED AND SKIN CRUSHED AND JAGGERED NO EVIDENCE OF FIRE/SMOKE DAMAGE
