LOG # RF-32

TAG A 605

SKIN PANEL, STRINGERS AND FRAME ASSY STA 800 TO STA 940, S-37R TO S44R

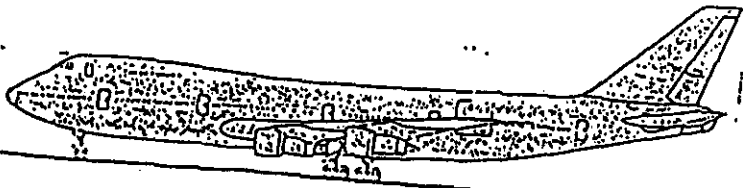
- STA 800 FRACTURE THRU SHEAR TIE FASTENER & EXCEPT S41-S42 WHERE FAIRING BRACKET REMAINED FIXED.

- LOWER END FRACTURE ON STRINGER & FASTENERS

TYPICAL BREAK

- AFT END TYPICALLY FRACTURED BETWEEN FRAMES
- UPPER END FRACTURE BASICALLY ALONG STRINGER &

FRACTURE FACE $\approx 45^\circ$ RANDOM INWARD AND OUTWARD SLOPE

- STA 840, 860 & 880 FRAMES SQUARE FRACTURE @ S37.5. LINING SUPPORT, CARGO SIDE RAIL, ROLLER TRAY & CARGO TRACK STILL INTACT.

- STA 840 FRAME FRACTURE @ S47 @ SKIN & \approx S45 @ CARGO FLOOR

- STA 860 FRAME FRACTURE @ S44 @ SKIN & \approx S47 @ CARGO FLOOR

- STA 880 FRAME FRACTURE @ S44 @ SKIN & \approx S45 @ CARGO FLOOR

SKIN ROLLED FWD ^{UP} @ STA 880 WITH SKIN ^{OUTWARD} PUNCTURE AT S39 & STA 895

- STRINGERS @ 800 SQUARE FRACTURE, S39-S43
