bluanduhida TWA 500 Due of you

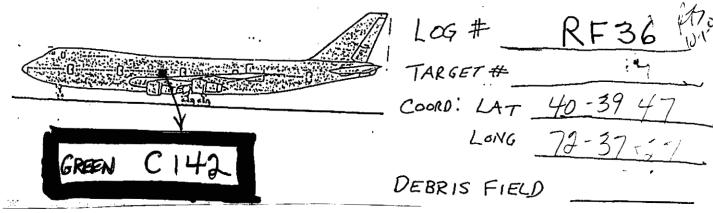
This SECTION OF RIGHT FUSE LAGE SKIN MEASURES APPROX 2'x 31/2' AND ENCOMPASSES FRAME STATIONS 1080 THRU 1120, AND STRINGERS S24R THRU 527R. The piece is irregular in shape and is Torn and sheaped on All addes, Many places where river Heats Had bean, And BNIY holes exist NOW, STRINGERS FOR The most part are missing, only SMALL SECTION OF STRINGERS FOR THE MOST PART ARE MISSING, ONLY hetween STA 1080 +1100, AND STRINGERS 527 HETWEEN STA 1080 +1100, AND STRINGERS 527

EXTERIOR SURFACE OF FUSEIAGE SKIN (PAINTED RED) COVERED WITH Black SOOT, AND PAINT PEELED IN SOME SPOTS. .... Quill
