LOG # RF38

Green Tag # CB11

STA 1350 Bulkhead and Landing Gear Beam

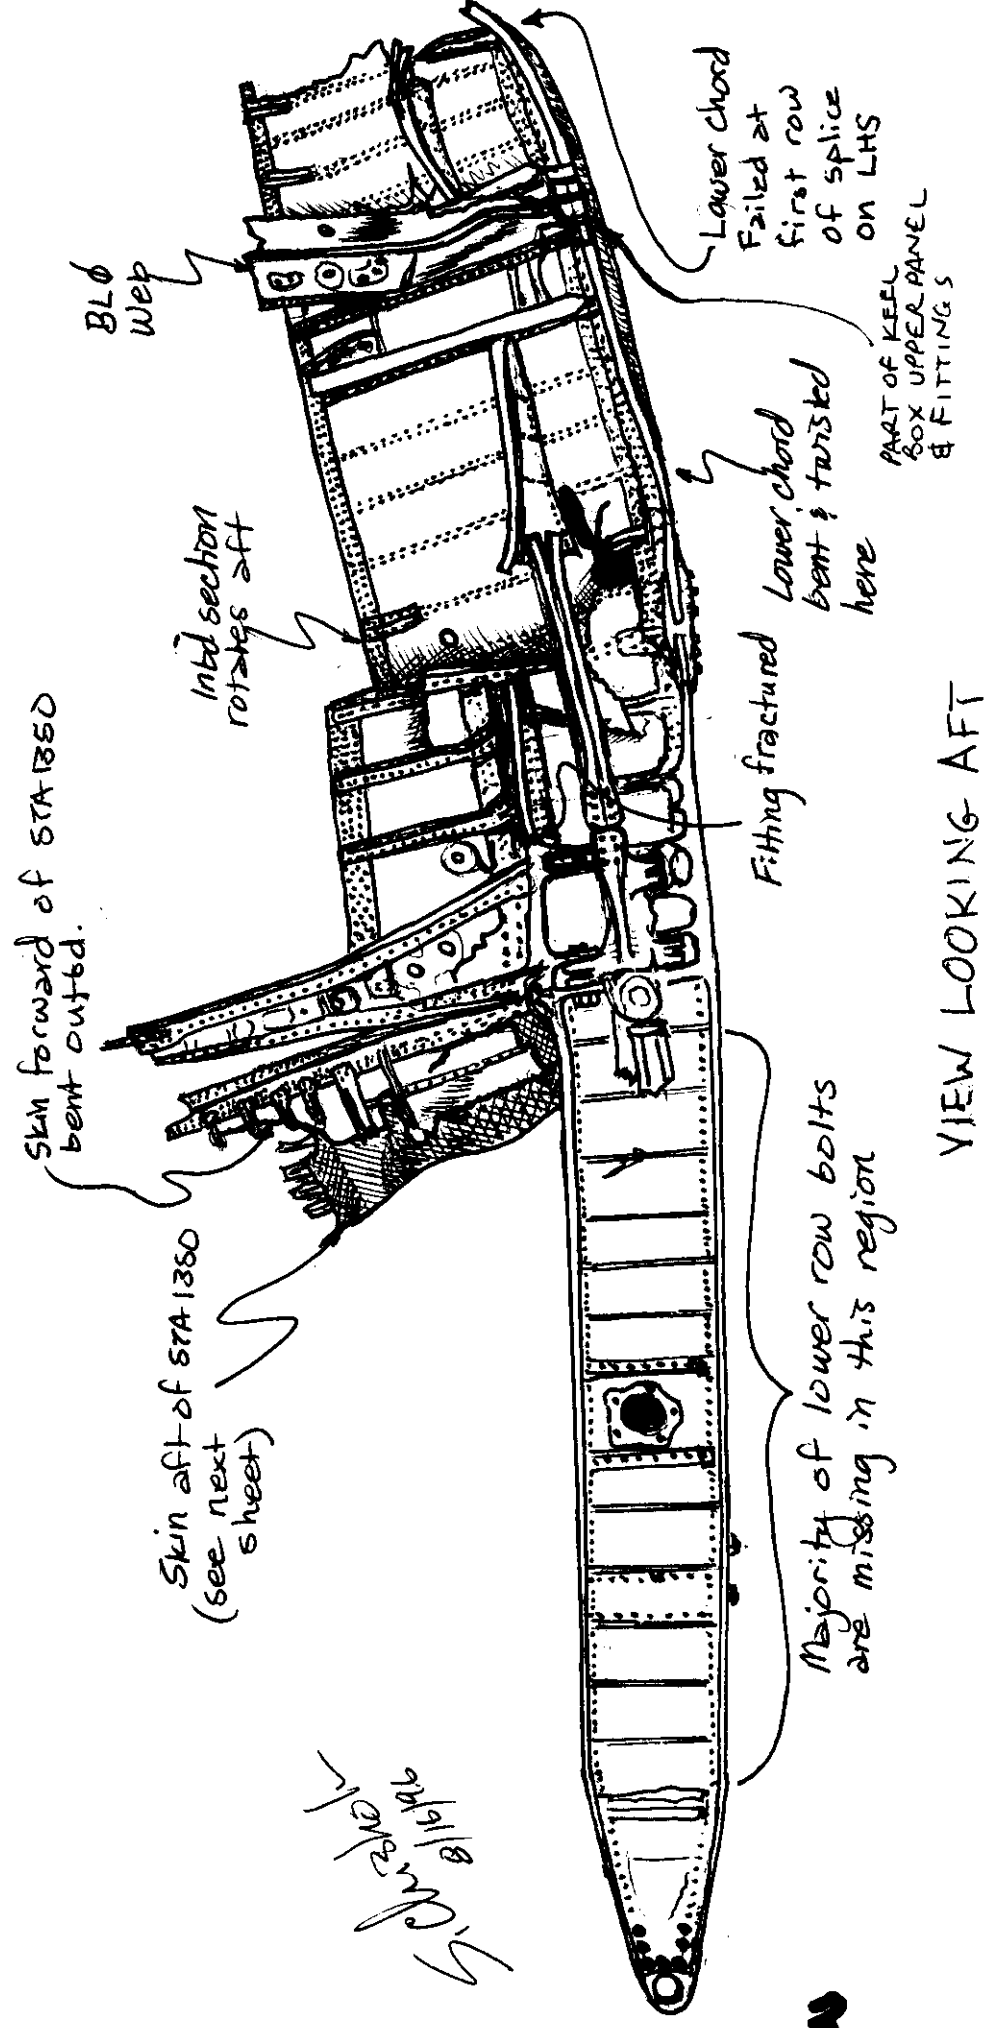
RF38

STA 1350 Bulkhead, RHS Landing gear Beam,  
and attached RHS fuselage skin aft to  
STA 1480.

The landing gear beam appears to be  
straight and intact. Many of the lower fasteners  
attaching the two halves of the beam  
together are missing.

The RHS of the Bulkhead failed at approximately  
S-20. At RBL 75, the Bulkhead is fractured  
through the upper chord and web to  
just above the lower chord. The inbd  
section is bent aft approximately 20  
inches at the upper chord fracture  
location (see sketch next sheet). Approximately  
20 inches of BLΦ web remain attached both  
Fwd and Aft of the Bulkhead. The LHS failure  
is at LBL 60. The lower chord is fractured at  
the inbd row of fasteners common to the  
splice.

Frames remain attached to skin except at  
upper end (≈ S-23 to S-26) where skin bends  
outbd.

There is no obvious fire damage or  
sooting.
