LOG # RF 45E

TARGET # C1080

DEBRIS FIELD Grass #1

Section of FUSELAGE MEASURES 5'7" x 4'3"

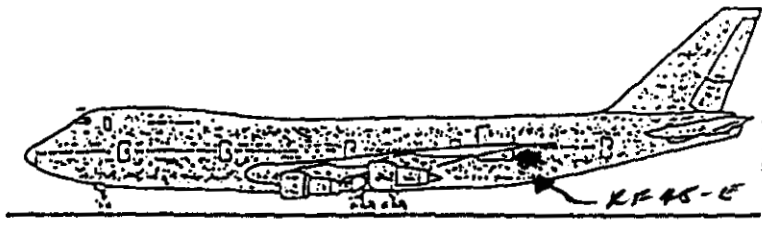
ENCOMPASSES STATION 1920-1940 & 1961 ALL THREE FRAMES MISSING FROM SKIN (Puncture outward @ STA 1940 4" in length 1/2" wide Between S41R & S42R)

S-39R 17 1/2" in length Severed at fwd edge & cracked, Pulled away from SKIN & curled outward & upward.

S-40R Lower section of stringer 1/2" attached to SKIN, 8" long Rest of stringer MISSING FROM SKIN

S-41R ATTACHED TO SKIN (Deformation of SKIN sections of stringer ARE CRACKED & MISSING AND Aft portion Pulled away From SKIN)

S-42R ATTACHED TO SKIN cracked & Bent FLAP Against SKIN Between S42R & S43R Puncture in SKIN 2" aft of STA 1940 2" x 1"

S-43R crack aft of STA 1920 ATTACHED TO SKIN

S-44R CRACKED CRUSHED & Flattened Against SKIN

S-45S small section ATTACHED TO SKIN at STA 1920 Fwd 11 1/2"

OVERALL There is Deformation of SKIN STATION FRAMES MISSING.

STRINGERS ARE CRACKED CRUSHED, Pulled away From SKIN & ALSO ATTACHED.

2 PUNCTURES 1- Between S-41R & S42R stat 1940 & another

Between S-42 & 43 sta 1940

Piece is curled inward & outward with jagged edges no sign of Burning or soot.
