LOG # RF 53

B. HOCKING  
BOEING  
9/4/96

SEGMENT A - STA 1560 TO 1520,  
STG 34R TO 40R

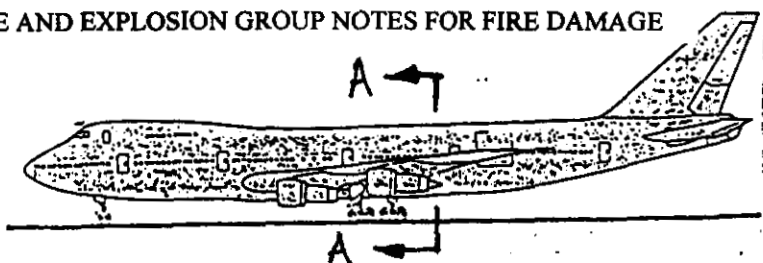
- 1) SKIN PANEL IS SIGNIFICANTLY WARPED DEFORMED. IT HAS AN OVERALL CURVATURE ABOUT AN OUTBOARD RADIUS OF APPROXIMATELY 9 INCHES (ie, CENTER OF RADIUS OUTSIDE OF SKIN).
- 2) THERE ARE LOCALIZED DEFORMITIES AS WELL, THE MOST SIGNIFICANT BEING INWARD BULGING OF THE SKIN BETWEEN STRINGERS WHICH WOULD RESULT FROM AN INWARD ACTING PRESSURE APPLIED TO THE OUTSIDE SURFACE.
- 3) THERE ARE THREE NOTABLE SKIN TEARS: ONE IS LOCATED AT APPROXIMATELY STA 1547, BETWEEN STG'S 37R & 39R, ABOUT 7 INCH LONG. THE OTHER TWO ARE AT THE TWO FORWARD CORNERS OF THE PANEL, ONE ABOUT 12 INCHES LONG, AND THE OTHER ABOUT 9 INCHES LONG.

- 1) STRINGER 36R REMAINS ATTACHED TO THE SKIN FROM ABOUT STA 1540 TO STA 1560
- 2) STRINGER 37R REMAINS ATTACHED FROM STA 1521 TO STA 1560.
- 3) STRINGER 39R REMAINS ATTACHED FROM STA 1520 TO STA 1541.
- 4) STRS 34, 35, ~~36~~ 38, AND 40 ARE MISSING.
- 5) THE STRINGERS WHICH REMAIN ATTACHED ARE NOT SIGNIFICANTLY DEFORMED. FOR THE MOST PART, THEY HAVE RETAINED THEIR ORIGINAL SHAPE EXCEPT FOR SOME LOCALIZED DEFORMATION AT THE END FAILURE POINTS.

- 1) FRAME-TO-SKIN SHEARTIES WERE NOT RETAINED BY THE PANEL EXCEPT AT STA 1540 BETWEEN STG 39R & 40R - IT IS CONSIDERABLY DEFORMED.
