LOG # RF6 R3A-C
9-30-96

TARGET # 2 (P/L
of 5)

RF6A

This section of ~~of~~ RIGHT FUSELAGE SKIN AND FRAMES (which includes 5 1/2 MAIN DECK PAX WINDOWS AND ENCOMPASSES STATION 620 TO STA 641, AND STRINGERS S20R TO S26R. WITHIN AN AREA 10'x4'

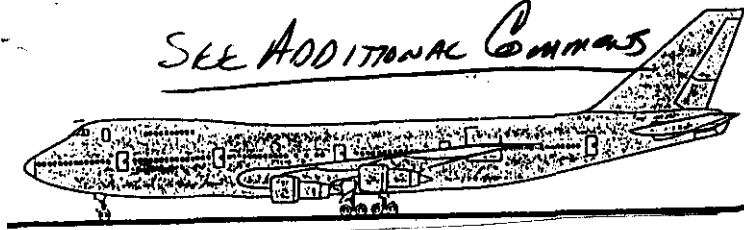
FUSELAGE SKIN SHEARED AND JAGGERED ALONG TOP STRINGER R20R RIVET HOLES FROM STA 620 TO STA 720.

VERTICALLY AT STA 741 (SHEAR TIE) METAL TIE IS SHEARED + JAGGERED

FUSELAGE SKIN BELOW S22R (WINDOW STRINGER) JAGGERED, BENT, AND FOLLOWS OUTLINE OF EACH INDIVIDUAL WINDOW REINFORCEMENT PANEL FROM STA. 640 TO STA 720, AT WHICH POINT FUSELAGE SKIN APPEARS AND CONTINUES AFT TO STA 741 (LENGTH OF SKIN IS APPROX 30", BUT IS WRINKLED AND ROLLED OVER - THIS SKIN ALSO INCLUDES SECTION OF FLOOR TO SIDEWALL ATTACH ANGLE BETWEEN STRINGERS S25R + S26R)

1) FUSELAGE FRAMES 620, 640, 680, AND 720

FRACTURED AND BENT FORWARD AT MIDPOINT AND REMAINING PORTIONS BENT AFT.

2) NO EVIDENCE OF FIRE OR SMOKE DAMAGE
