LOG # RF62

TAG # C2337

SKIN SEGMENT, STA 1920 TO
STA 1940, STG 34R TO 40R

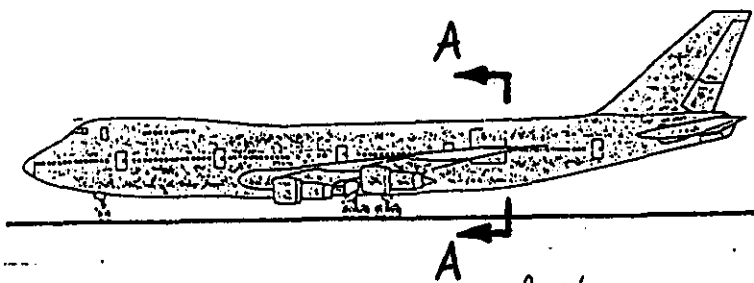
SKIN SEGMENT IS CRUMPLED CIRCUMFERENTIALLY AND IS BENT AS DESCRIBED IN SKETCH BELOW:

1) STR 34R IS BADLY CRUSHED BUT REMAINS ATTACHED. A CARGO DOOR STOP INTERCOSTAL WEB REMAINS ATTACHED TO THE I/C BUT IS BADLY TORN.

2) STG 35R IS MISSING. ATTACHMENT HOLES ARE ENLARGED BY PULL-THRU.

3) STG 36R NOT TOO BADLY CRUSHED AND REMAINS ATTACHED.

4) STG 37R REMAINS ATTACHED BUT IS BADLY CRUSHED SINCE IT IS LOCATED IN THE MIDDLE OF A SKIN BEND (SEE SKETCH). A CARGO DOOR STOP INTERCOSTAL WEB REMAINS ATTACHED TO THE I/C.

5) STG 38R IS MISSING BUT A PIECE OF THE STRINGER "HAT" TOP IS STILL ATTACHED. A FEW PULLED-THRU FASTENERS EXIST WITH THE CHARACTERISTIC ENLARGED HOLES.

6) STG 39R IS MISSING.

7) THE WEB IS TORN OFF AT THE FIRST ROW OF FASTENERS AT THE WEB SPLICE AT STRINGER 40R. NO STRINGER IS ATTACHED.

AS NOTED ABOVE IN #1) & 4), DOOR STOP INTERCOSTAL WEBS REMAIN ATTACHED AT STRINGERS 34R & 37R. ALSO, AN APPARENT PIECE OF INTERCOSTAL WEB AND ITS ATTACHMENT LEG ARE STILL ATTACHED TO THE SKIN BETWEEN STRINGERS 39R & 40R.

OTHER OBSERVATIONS: NO APPARENT CHARRING OF ITEM. FRACTURE SURFACES APPEAR TO BE DUCTILE FAILURES - NOT FATIGUE.
