RF 2146

LOG # RF 65
 TARGET # C1661 GREEN
 COORD: LAT _____
 LONG _____

REFER FIRE AND EXPLOSION GROUP NOTES FOR FIRE DAMAGE

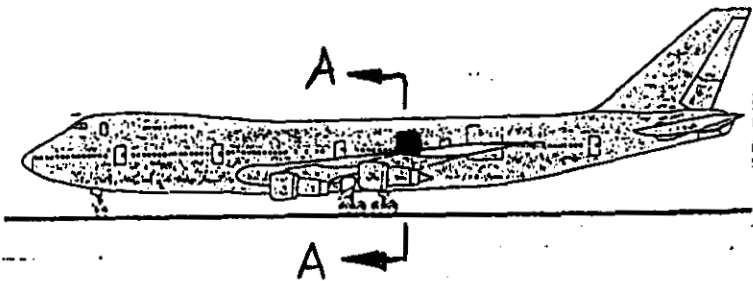
SEGMENT OF SKIN RUNS FROM STA 1500 TO STA 1600, STG 12R TO "STG 21R" (WINDOW BELT)

SEGMENT HAS ONLY TWO SHORT PIECES OF STRINGER STILL ATTACHED. ONE IS A PIECE OF STG 14R FROM STA ~ 1550 TO 1560. THE OTHER IS

A PIECE OF S-19R FROM STA ~ 1572 TO STA ~ 1592. THE LACK OF STRINGERS AND FRAME SHEAR TIE ATTACHMENT TO SKIN APPEAR TO INDICATE OVERPRESSURIZATION CONDITION.

A PIECE OF WINDOW FORGING IS PRESENT BETWEEN STA 1580 AND 1600 RUNNING FROM ABOUT 11 O'CLOCK TO 3 O'CLOCK (VIEWING WINDOW FROM OUTSIDE).

AFT END OF PANEL IS BENT SLIGHTLY OUTBOARD WITH BEND LINE AT ABOUT STA 1570 TO 1575 (BENDLINE RUNNING CIRCUMFERENTIALLY). THE FWD LOWER CORNER IS BENT SLIGHTLY INBOARD WITH A BENDLINE RUNNING ABOUT FROM STA 1500, STG 17R TO STA 1530, STG 19R. THE FWD EDGE, UPPER, IS BENT OUTBOARD WITH BENDLINE RUNNING FROM STA 1520, STG 13R TO STA 1535, STG 12R.

AN ELLIPTICAL CUTOUT LOCATED AT STA ~~1554~~ ¹⁵⁵⁴ TO STA ~~1554~~ ¹⁵⁵⁴, STG 13 1/2 R IS MISSING THE EQUIPMENT WHICH NORMALLY IS INSTALLED THERE. THE INBOARD SURFACE HAS NO APPARENT SOOTING. THE OUTBOARD SURFACE, HOWEVER, DOES EXHIBIT LIGHT SOOTING OVER THE ENTIRE AREA. FRACTURE SURFACES APPEAR TO BE DUCTILE FAILURE.
