LOG # RF 66

TARGET # C2156 GREEN

SKIN SEGMENT IS LOCATED FROM STA ~1536 TO STA ~1620, FROM STG. 42R DOWN TO 49 1/2R.

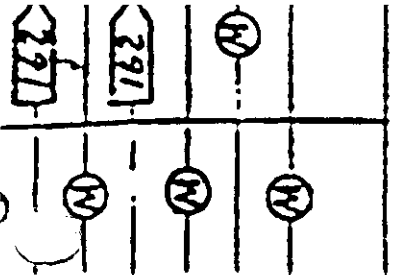
LOG# R F 66
TAG# C 2156
GREEN

- 1) AN EXTERNAL SKIN REPAIR EXISTS BETWEEN STA~1570 TO STA~1588, STG 46 1/2 R TO 45 1/4 R.

- 2) THERE APPEARS TO BE SOME SLIGHT SOOTING OF THE OUTER SURFACE. THE FWD CORNER OF THE LARGE DOUBLER PICTURED ABOVE AT STG 46R HAS DARK SOOTING ABOUT 1 1/2 INCH BY 3 INCH.
- 3) THE INBOARD SURFACE APPEARS TO BE SOOTED MORE EXTENSIVELY. GRIME IN THE LOWER BILGE REGION SEEMS TO BE DARKER THAN THE STRINGER FLANGES. ALSO, THE AFT REGION OF THE PANEL WHICH IS BENT INBOARD AND FWD IS MORE SIGNIFICANTLY SOOTED ON THE INBOARD SURFACE.
- 4) SOME OF THE FRACTURE SURFACES SHOW SOOTING, AS WELL, PARTICULARLY IN THE AFT REGION BENT I/B & FWD.
