LOG # RF 67 *RF 20219*

TAG # C 1696

RF 67  
PAGE 1

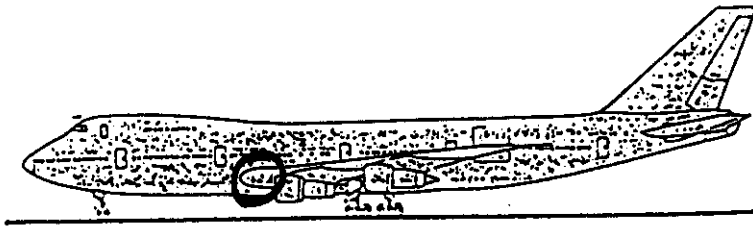
BACK OF PANEL  
VERY CLEAN

BRACKET  
HEAVILY BURNED  
STA 940

PANEL UNZIPPED  
AT FASTENERS

HEAVY  
SOOT

VERY LIGHT  
BOILING  
SLANT FACE FRACTURES

HEAVY SOOT  
PATTERN

TIP COILED IN

WIRES  
HEAVILY  
BURNED

NO BURNING  
NO SCOTING

DUCTILE FAILURE  
NO BENDING EVIDENT

PICKLE FORK PULLED  
INBD + BROKEN OFF
