LOG # RFB 506  
TARGET # \_\_\_\_\_  
COORD: LAT \_\_\_\_\_  
LONG \_\_\_\_\_

DEBRIS FIELD #2  
yellow (middle)

RHS Fwd upper section 41 skin Assy's.

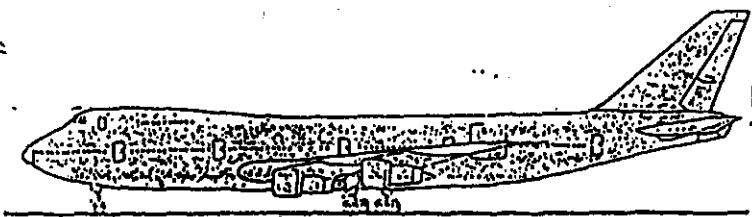
This panel is very curved. No frames remain attached and there are no stringers above 5-17. Fastener holes are mainly open and appear to have failed with rivet tension (skin puckers inbd).

Stringers that do remain are bent but not flattened.

Bent similar to ①. Again, no frames remain on panel. The ~~att~~ upper end of the panel curled outbd 360°. All holes aft of STA 260 are open, all holes fwd of STA 260 are filled. Most stringer segments fwd of 260 remain.

forward. The fwd window belt area is also bent inbd. The STA 134 ring and STA 140 B/khd are detached. Almost all stringers remain. The STA 160 frame is attached for 3 bays above the window belt, STA 180 frame is attached for 6 bays, and STA 200 attached for 12 bays. The STA 220 frame is gone.

✓ (D) Yellow Tag # B068  
This small piece is very twisted and deformed. The stringers are flattened and there are no frames.

✓ (E) Yellow Tag # B268  
Panel is twisted and ripped. All internal structure is flattened.

✓ (F) Yellow Tag # B248  
Panel is curled similar to adjacent panel (A)

No panels show any obvious signs of smoke or fire damage.
