LOG # RF9 ^{RTS A-C} ₉₋₂₀₋₉₆

DEBRIS FIELD _____ Pg 14B

This Report contains:

RF9A
RF9B
RF9C

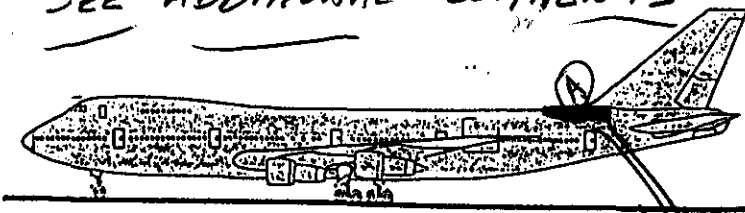
Part (A)

- ① LOG # RF9 (A) CONTAINS FUSELAGE SKIN AND STRUCTURE APPROX 35' X 11.5'.
- ② ENCOMPASSES STATION 1900 THROUGH 2320, STRINGERS LEFT SIDE S10L THROUGH S1L, CONTINUING OVER THE TOP OF THE FUSELAGE RIGHT SIDE, S1R THROUGH S6R.
- ③ FRAMES FRACTURED, MISSING, NO EVIDENCE OF TWISTING FORE AND AFT. NO EVIDENCE OF FIRE.

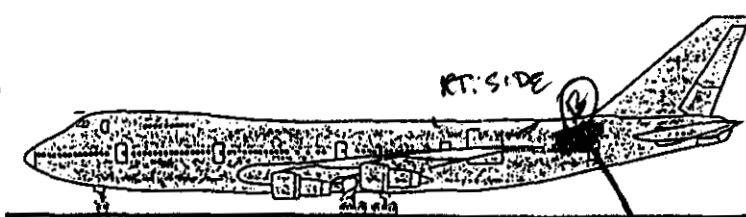
PART (B) C117 C2332

RIGHT
 THIS SECTION OF FUSELAGE MEASURES APPROXIMATELY 20' X 15', AND ENCOMPASSES STA. 1900 THRU STA. 2140, AND FUSELAGE SKIN FROM MAIN DECK PAX WINDOWS UPWARDS TO NTSB CUT LINE, (STRINGERS S22R TO S6R.)

WITH THE EXCEPTION OF THE NTSB CUT LINE (WHICH SEPARATED LOG # RF9; INTO RF9A + RF9B, WHICH WAS NECESSARY DUE TO ITS ORIGINAL HIGH SIZE), THE REMAINING FUSELAGE SKIN IS FRACTURED SHEARED AND JAGGERED AND CONTAINS PORTIONS OF MAIN CABIN PAX WINDOWS.

MANY OF THE ^{omit. str. b/w 10/9/96} STRINGERS AND FRAMES ARE MISSING, AND THE FEW REMAINING MEMBERS ARE FRACTURED AND BENT APT. AND TOM TODDING FAA-10-10-96

THE FUSELAGE SKIN AND STRUCTURE SHOWS NO EVIDENCE OF SMOKE OR FIRE DAMAGE

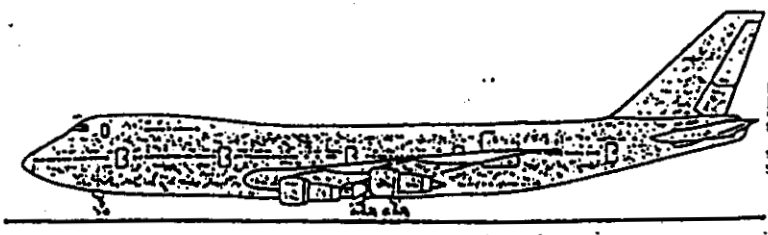
LOG# RF9D

FRAGMENT OF SKIN, LWR. WINDOW BELT.
FS 2018-2040. 10" X 24" LOWER 1/3 OF
WINDOW FRAME. RF9D PART MATCHES
RF9B & RF9C. WINDOW FRAME AND SKIN
FRACTURES, SOME DIS BONDING BETWEEN
FUS. SKIN AND WINDOW DOUBLER AT FWD
LOWER CORNER.
