RW-25

TAG# Z3129

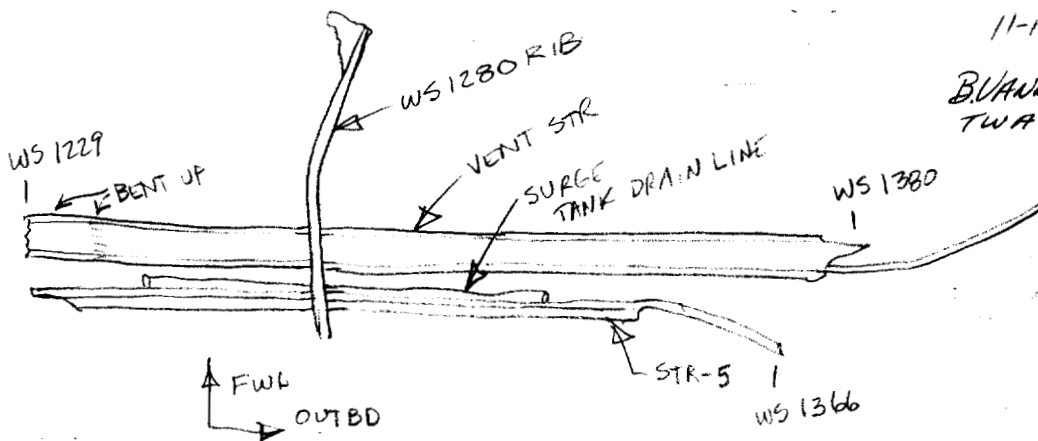
RH OUTBD WING WS 1280 RIB SEGMENT WITH INBOARD MAIN TANK VENT STRINGER AND STR-5 SEGMENTS ATTACHED. ALSO ATTACHED IS A 5 FT SECTION OF THE SURGE TANK DRAIN LINE. ALL PIECES ARE BURNED OR SOOTED BUT NOT AS SEVERELY AS THE WS 1252 RIB (RW-24). THE VENT STRINGER IS BENT UPWARD AND FRACTURED AT WS 1229, AS IS THE STR-5 SEGMENT. THE VENT STR FRACTURES AT ABOUT WS 1380 AT OUTBD END, STR-5 AT ABOUT WS 1366.

REFER FIRE AND EXPLOSION GROUP NOTES FOR FIRE DAMAGE
