11-8-96-1

# RIGHT WING RW37

ORANGE W2003  
 LOG # C 6592-134  
 TARGET # -

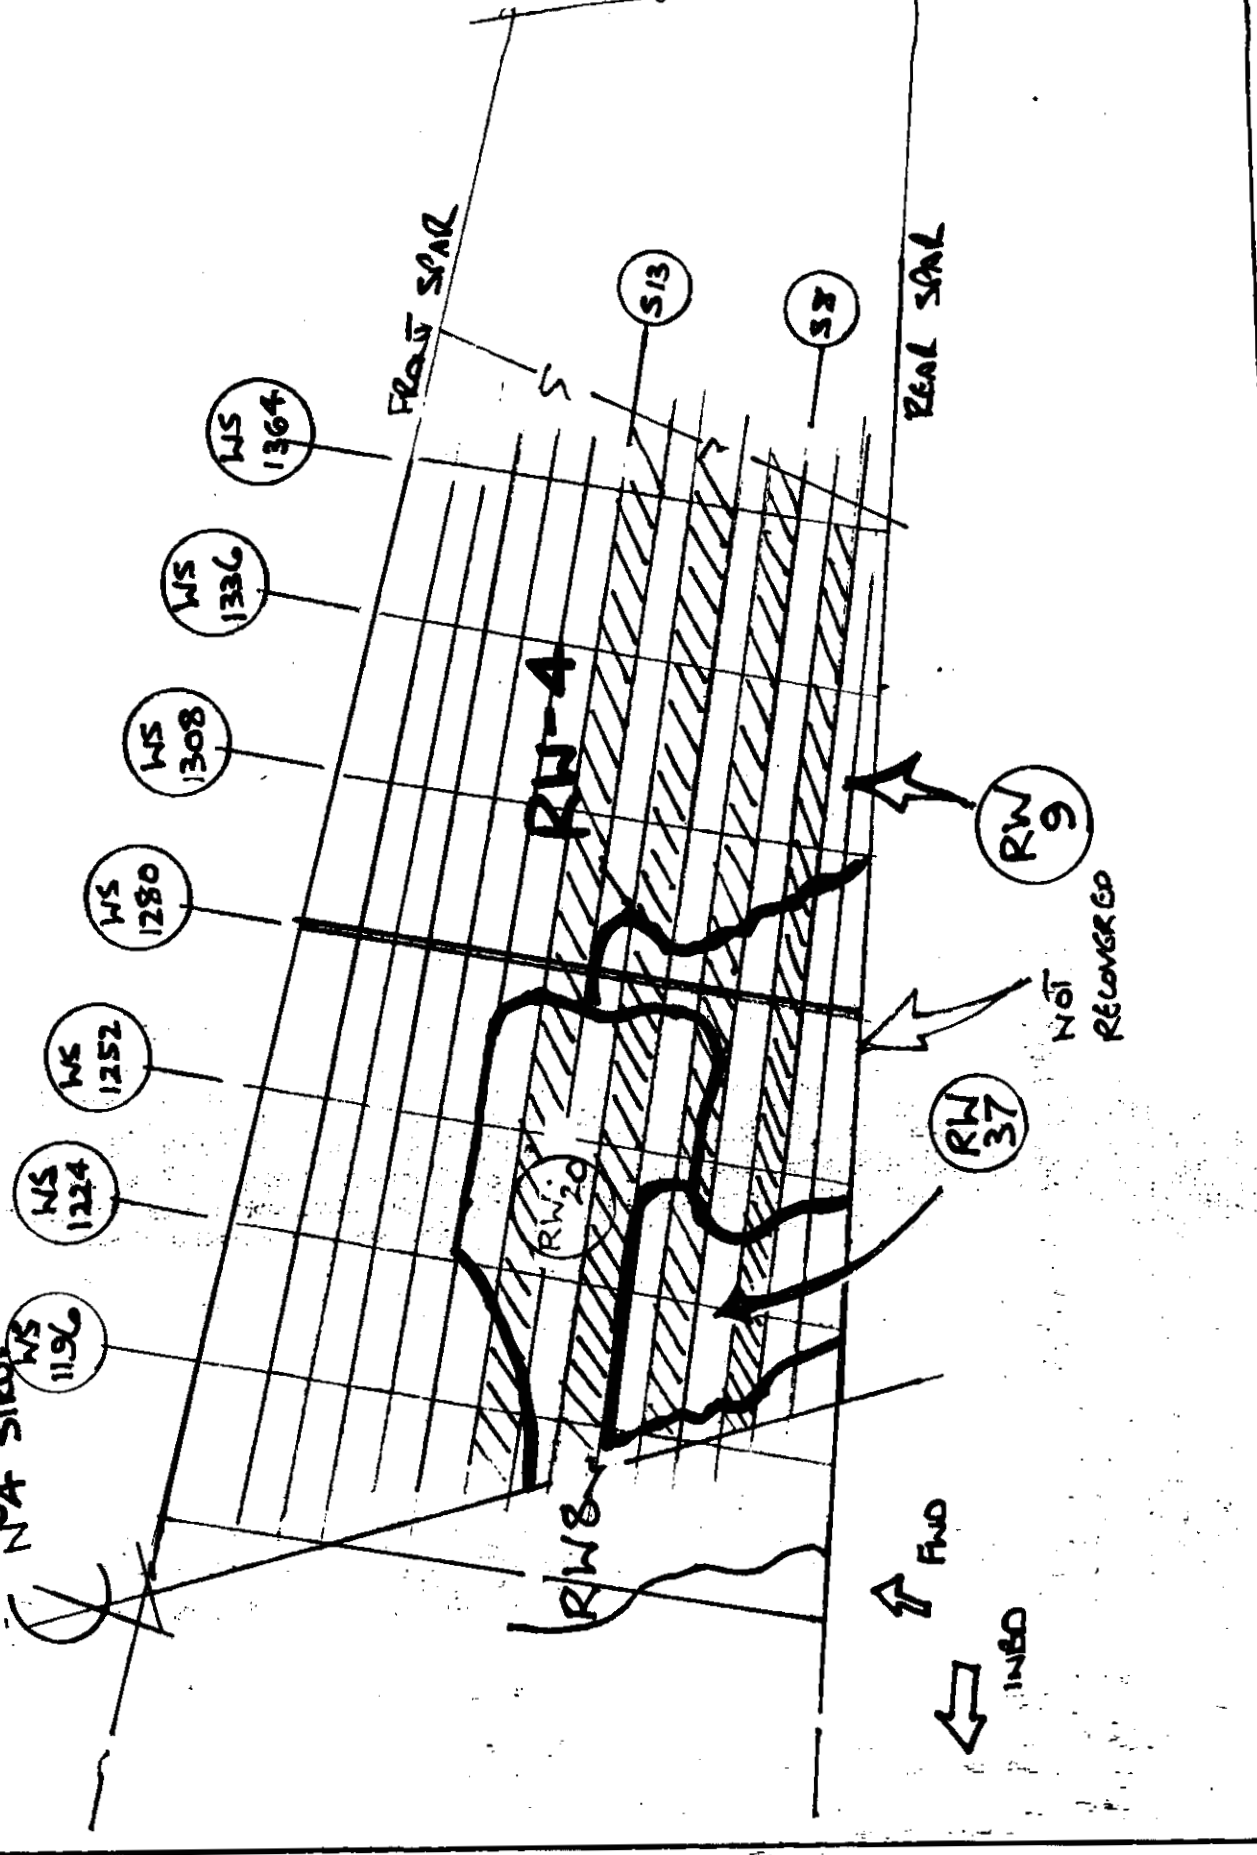
RW 37

RIGHT WING UPPER SKIN PANEL LOCATED JUST OUTBOARD OF THE NO 4 NAAGLE RIB. THE 3' X 4' SECTION EXTENDS FROM WS 1196 TO WS 1252 AND ENCOMPASSES STRINGER REMAINT'S 5 THRU 9, INCLUDING A SECTION OF REAR SPAR CHORD FLANGE. A SECTION OF FIXED TRAINING GOUGE UPPER FIBER GLASS PANEL EDGE REMAINS ATTACHED AND EXTENDS ALONG THE AFT SKIN EDGE. THE PANEL SKIN SECTION SEPARATED IN A DUCTILE MANNER WITH STRINGER NO'S 5 THRU 9 AND THE REAR SPAR CHORD FLANGE, SEPARATING ALONG THE JUNCTION RADIUS OF EACH STRINGER ELEMENT STEM AT THE FLANGE TO SKIN AS INDICATED IN SECTION A-A.

THE PANEL FINISH IS PRIMARILY INTACT WITH NO DEGRADATION OR OBVIOUS ANOMALY, EXCEPT FOR SOME SALT WATER CORROSION ALONG THE EXTERNAL SURFACE BETWEEN STRINGERS 5 AND 7 COVERING APPROX 5" X 10". THE PANEL SHOWED NO SIGNS OF SCOTCH, FIRE OR IMPACT DAMAGE, AND THE SKIN IS RELATIVELY FLAT EXCEPT FOR SOME SLIGHT OUT OF PLANE DEFORMATION ALONG THE INBOARD EDGE INDICATIVE OF PANEL BENDING.
