**WATER IMPACT DAMAGE  
STUDY**

# Metallurgy Group Notes - Fuselage Water Impact Damage Survey

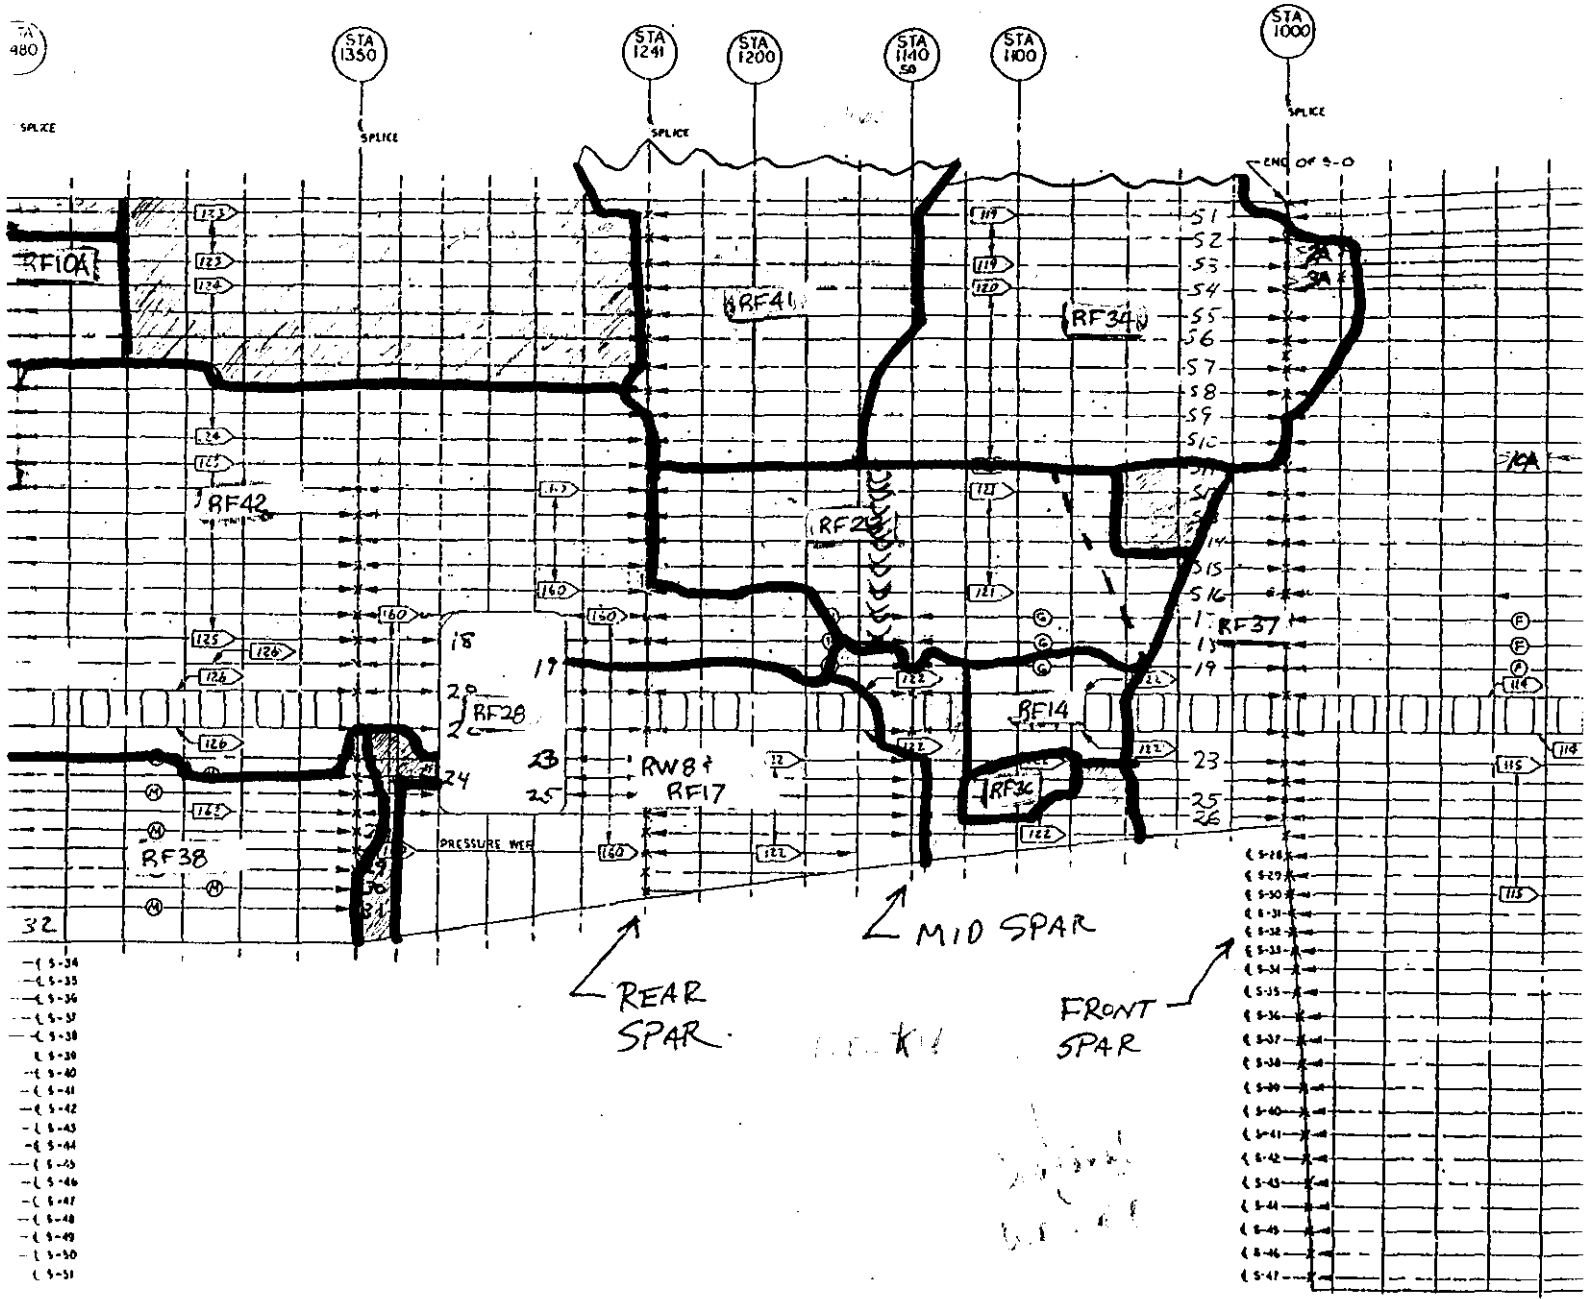
# SECTION 44 - STA. 1000-1480 (R/H Side)

Sta. 1000 - 1480 - Wings - Not included in survey

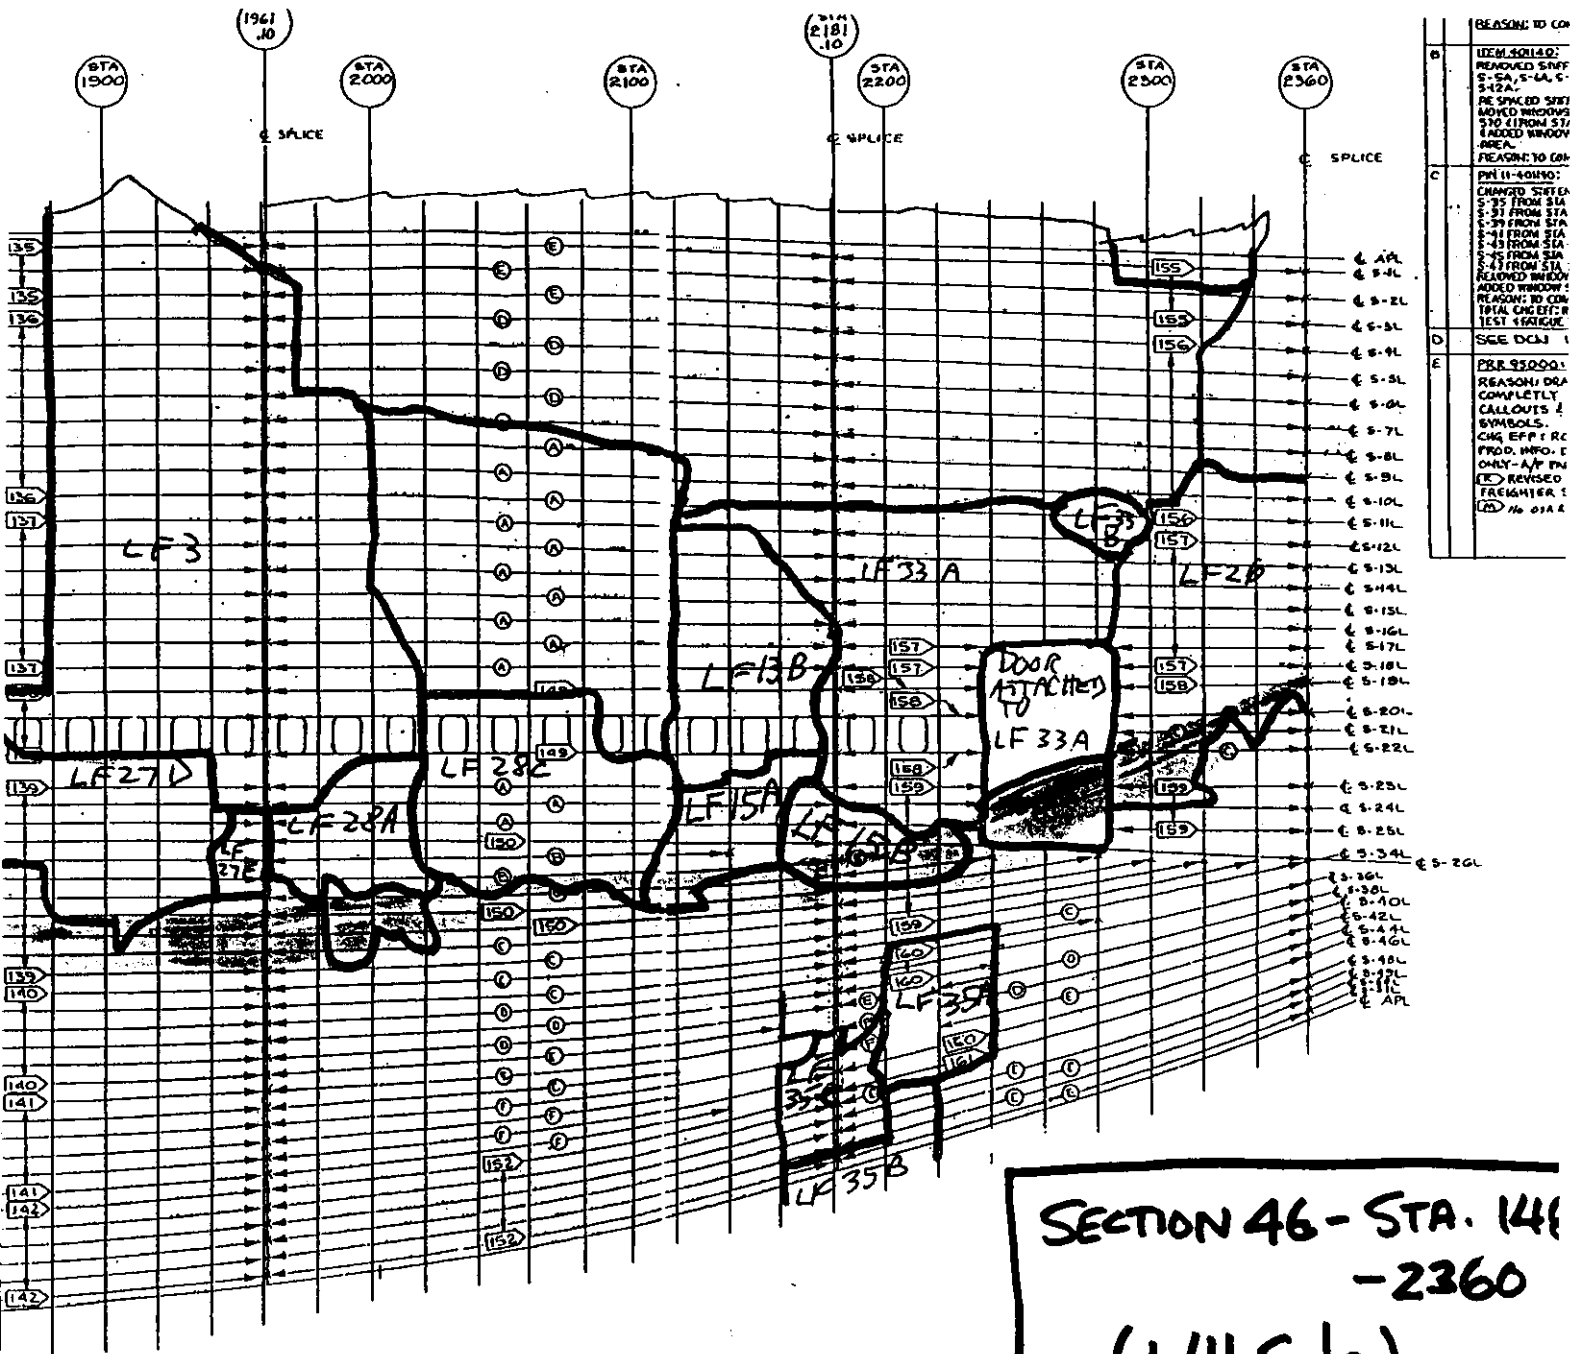
**SECTION 46 - STA. 141  
- 2360  
(L/H Side)**

- Right side of fuselage exhibited water impact damage below the window belt (S-22R) up to Sta. 2240. From Sta. 2240 to Sta. 2360 the damage progressed upward to S-16R.
- The left side of the fuselage exhibited water impact damage primarily below stringer 28L up to Sta. 2240. From Sta. 2240 to Sta. 2360 the damage progressed upward to S-19L.
