**NATIONAL TRANSPORTATION SAFETY BOARD
Office of Aviation Safety
Washington, DC 20594**

STRUCTURES GROUP - WING FACTUAL SUMMARY

ACCIDENT : DCA96MA070
Location : East Moriches, New York
Date : July 17, 1996
Time : 2031 Eastern Daylight Time
Airplane : Boeing 747-131, N93119
Operated as Trans World Airlines (TWA) Flight 800

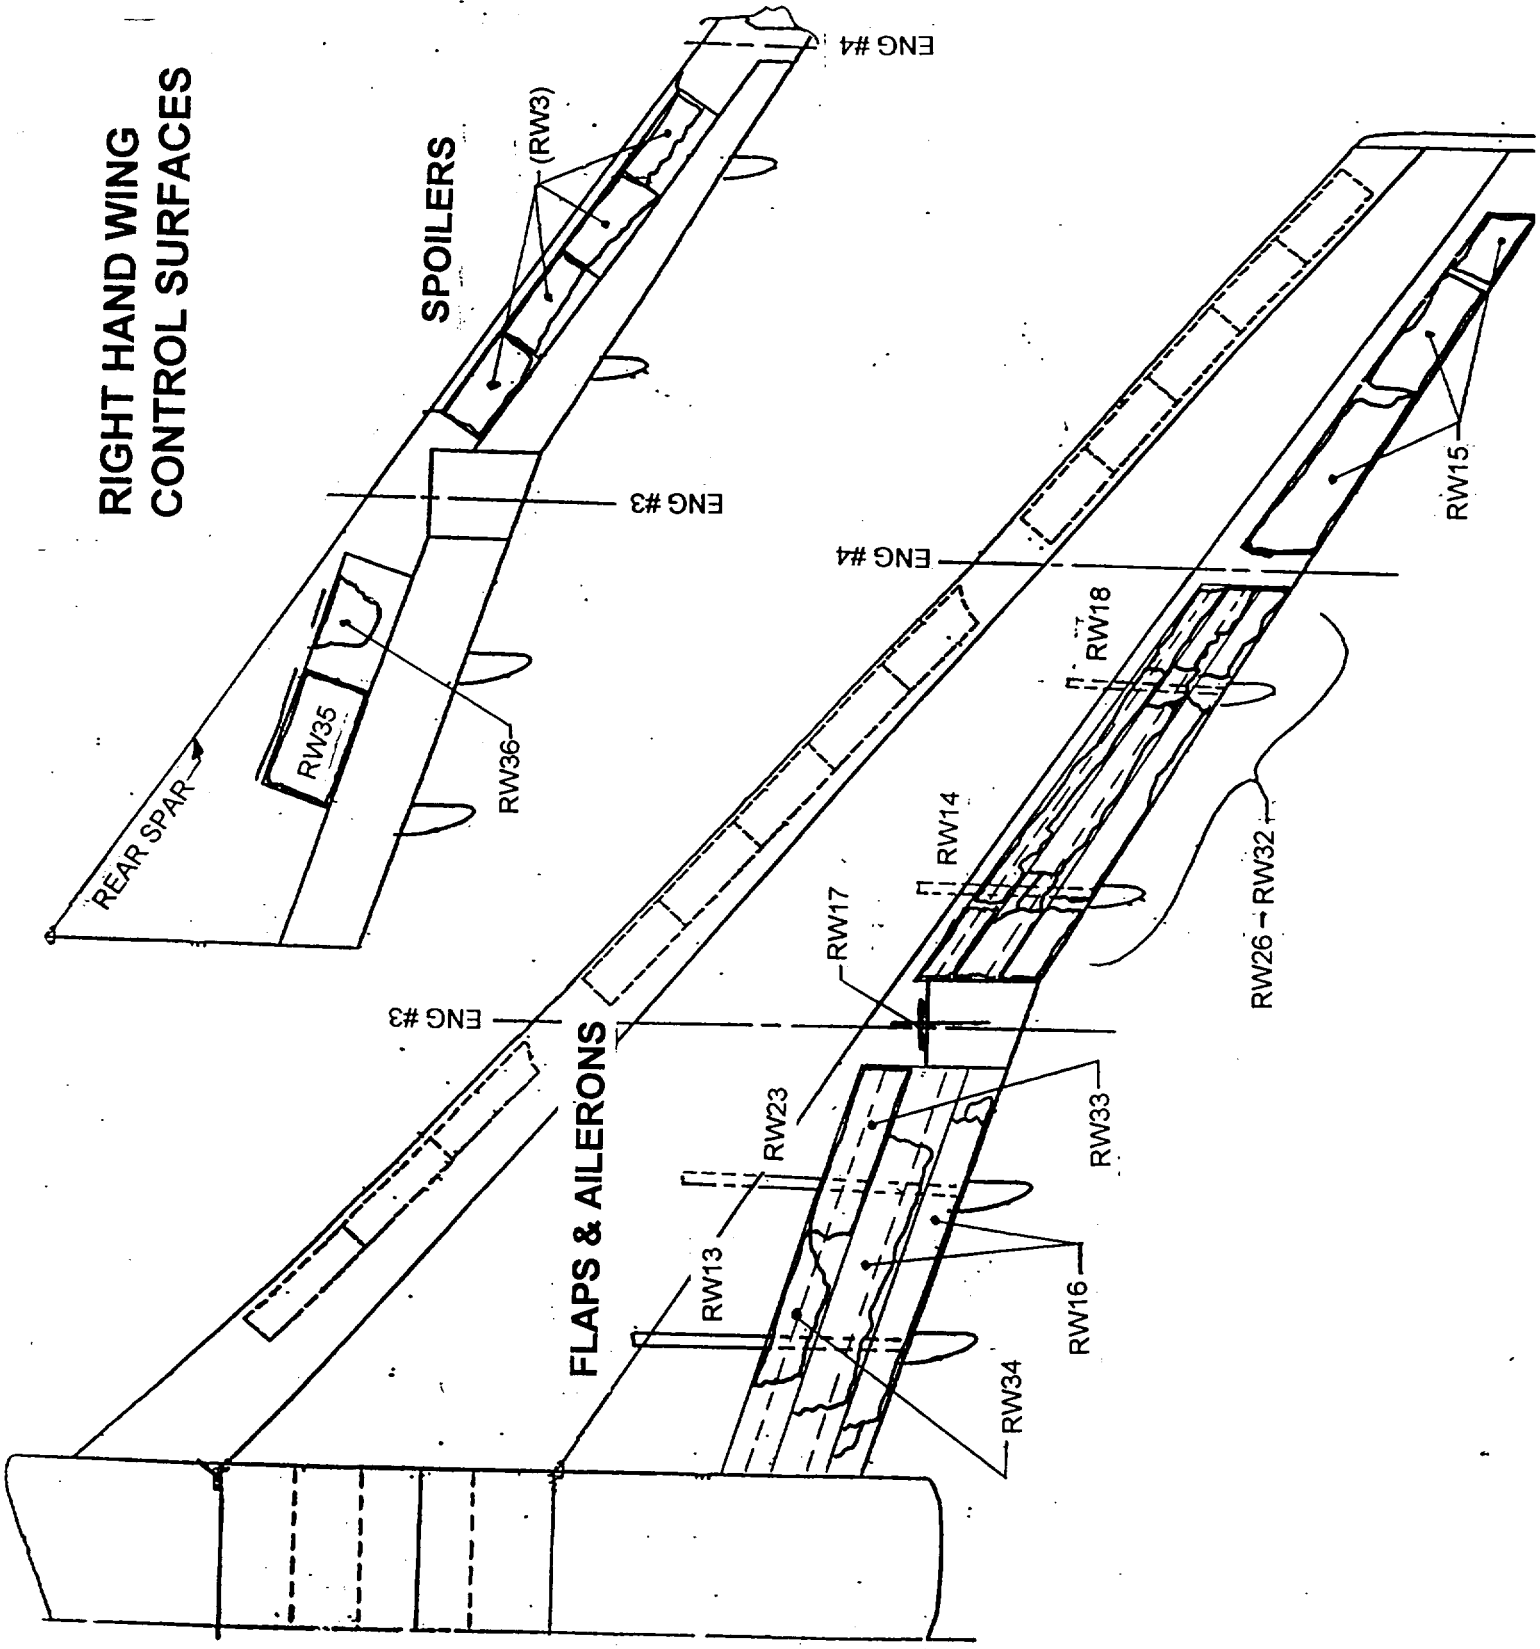
**RIGHT HAND WING
CONTROL SURFACES**

Most of the right-hand wing trailing edge flaps were identified/recovered. The inboard flaps separated into large pieces and show little or no fire or soot damage. There is evidence of severe impact damage, including damage to the honeycomb and associated skin (RW16, RW34, RW33). The outboard flaps separated into numerous smaller pieces and show heavy fire damage. The entire outboard flap sections were recovered and identified, except for a very small area (RW26 to RW32).

All four inboard spoilers and their actuators were recovered. The inboard-most on each wing (LW24 and RW35) show fire and soot damage, and the outboard-most on each wing show impact tearing and fracture damage.

The outboard spoilers on the right wing were still attached to the rear spar (RW3) but were badly burned. The outboard spoilers on the left wing were not identified.
