# NATIONAL TRANSPORTATION SAFETY BOARD

## Structures Group Factual Report of Group Chairman

**A. ACCIDENT:** DCA15MA029  
Location: Gaithersburg, MD  
Date: December 8, 2014, 10:41 am EST  
Aircraft: Embraer EMB-500, Phenom Model 100, N100EQ

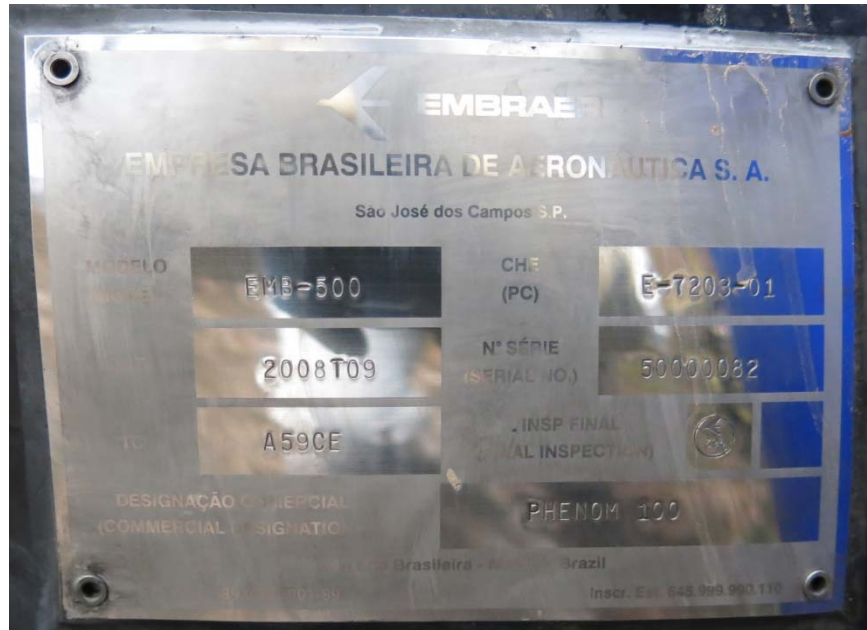
The aircraft data plate contained similar information. (See Figure 1)

Figure 1. Aircraft data plate on aft fuselage.

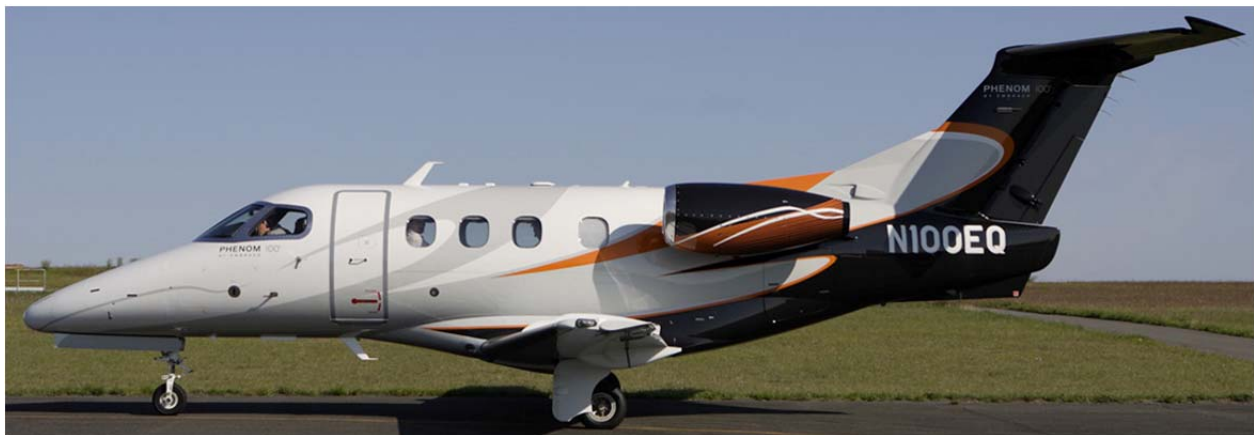
The airplane had a brown, white and orange paint scheme. (See Figure 2) and Embraer reported that on October 7, 2014, the owner provided the following aircraft usage data:

Figure 2. Internet photograph of the airplane prior to the accident in the paint scheme found on-site.

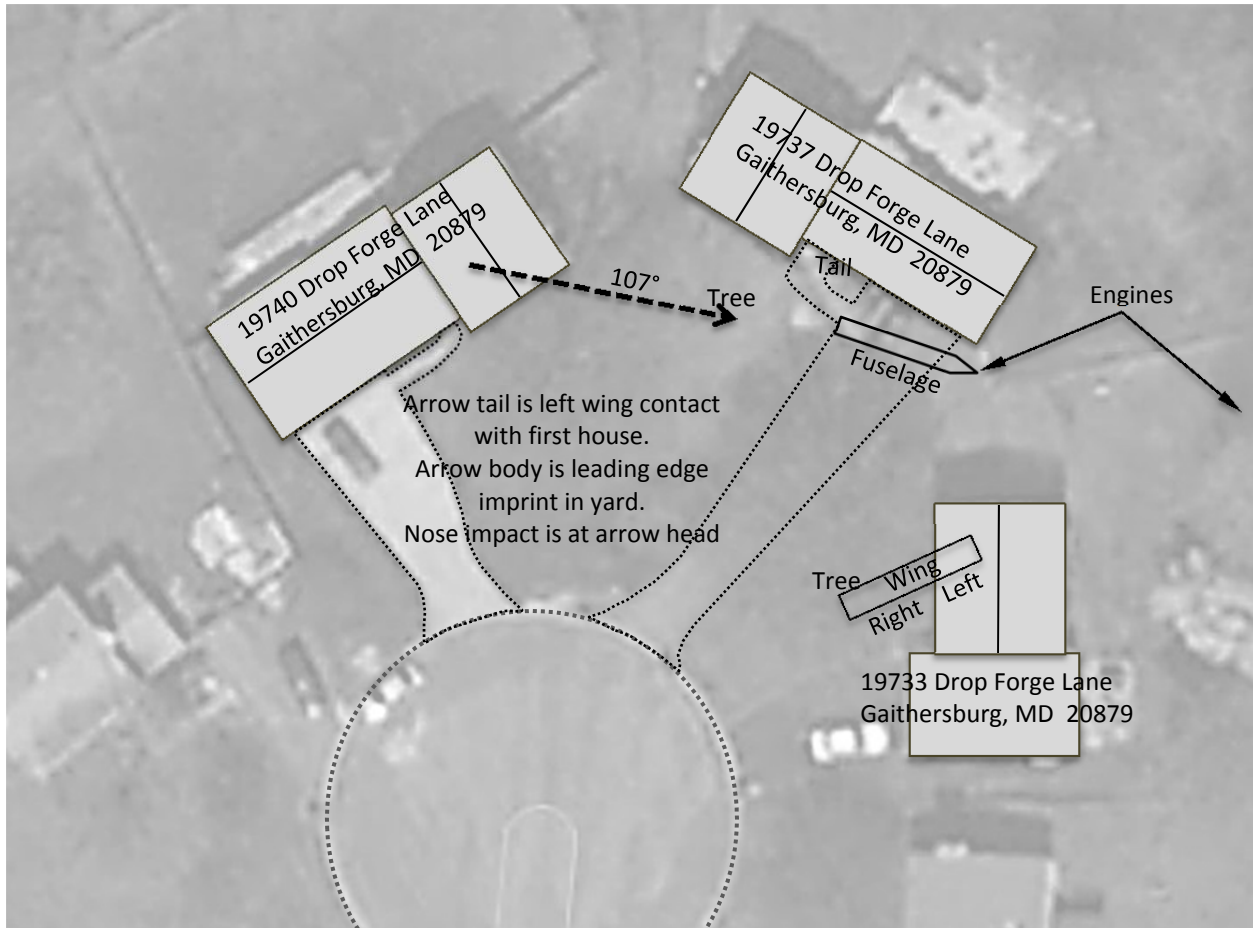
The left wing tip entered this house a major fire occurred at this house.

Figure 4. Diagram of houses and major features traced on to image from Google Maps. The nose of the fuselage was oriented toward the first house struck and the remnants of the wing rested with the top surface up..

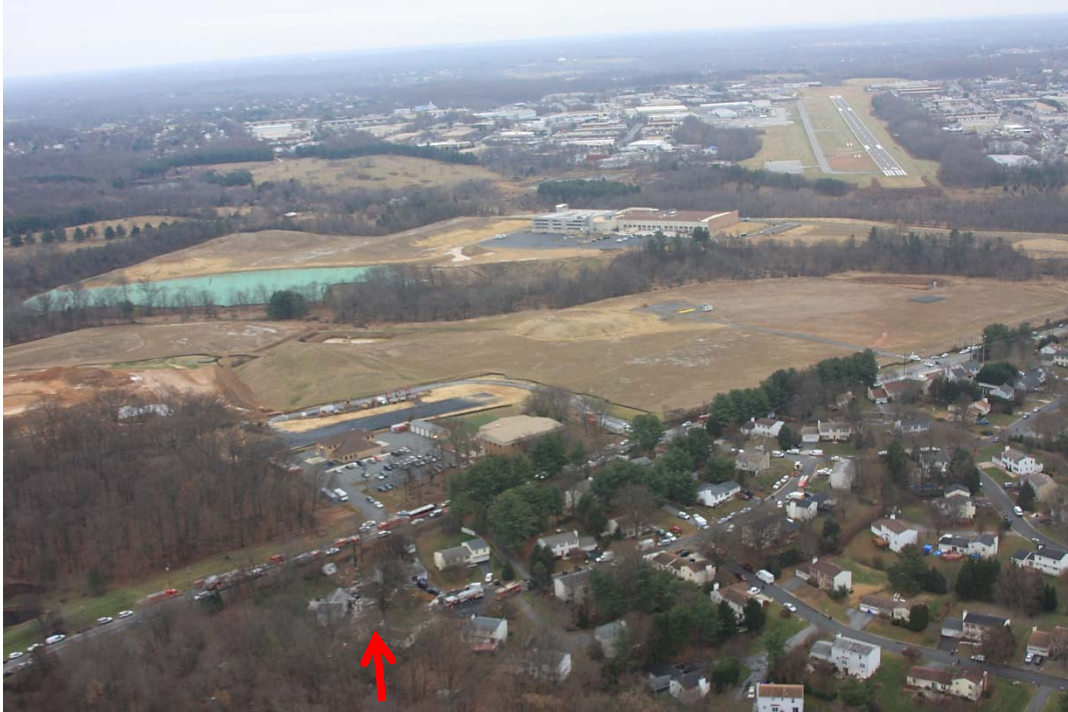
Figure 5. Aerial photo of scene with relation to runway 14. The arrow points to the first house struck and is rotate to the approximate direction of the debris path.

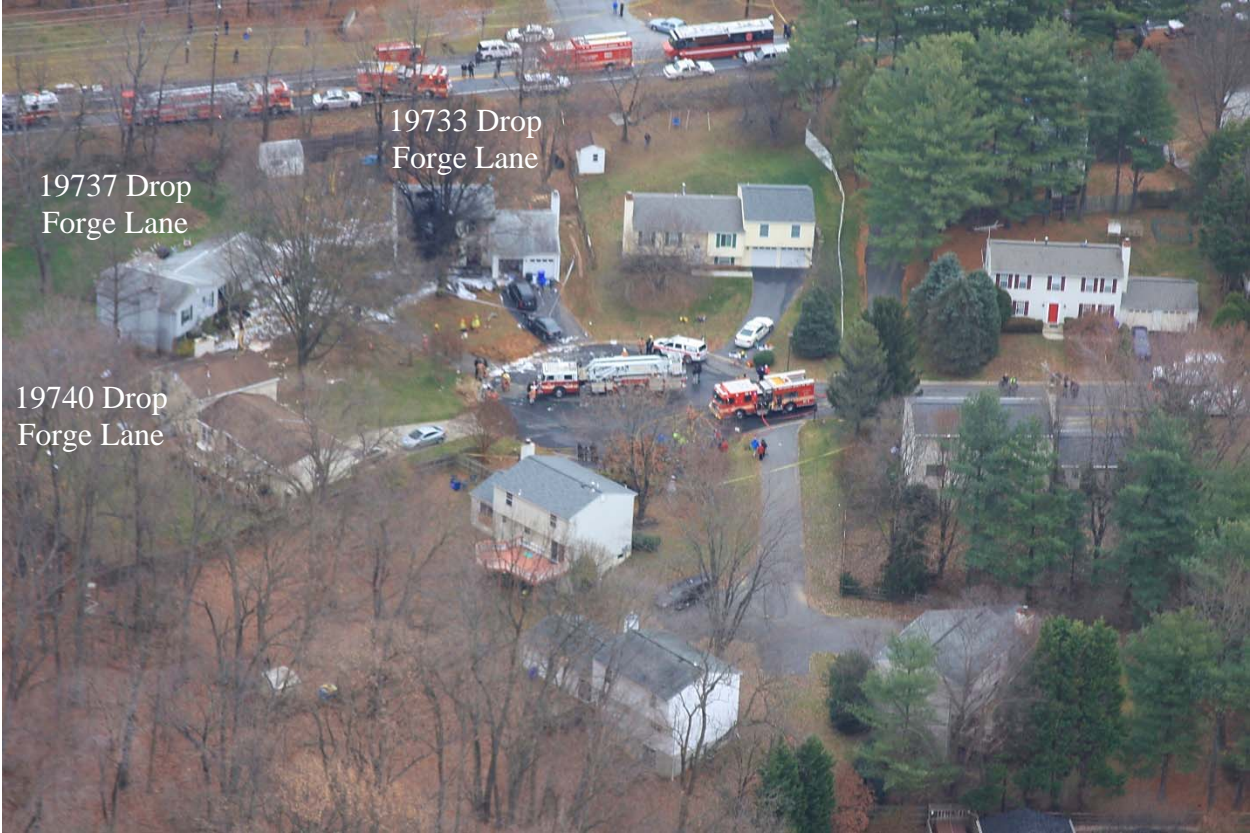
Figure 6. Aerial view of houses on approximate orientation of airplane path.

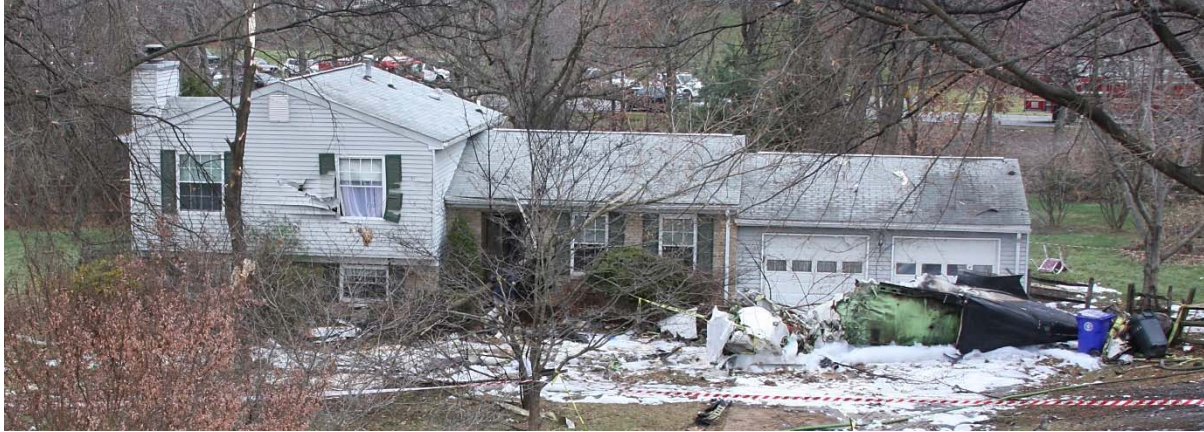
A cut and broad impact mark was found in the front wall and bedroom window of the 19737 house. (See Figures 14 and 15) A carbon composite fragment approximately one foot long from the outboard end of the left elevator was found caught inside the wall to the uptrack side of the damaged window in the front of the house. The torn edge of the fragment matched the left elevator. (See Figure 16) The top outboard portion of the left elevator had smears of color which matched the color of the house aluminum siding.

Figure 14. Overall view of 19737 Drop Forge Lane.

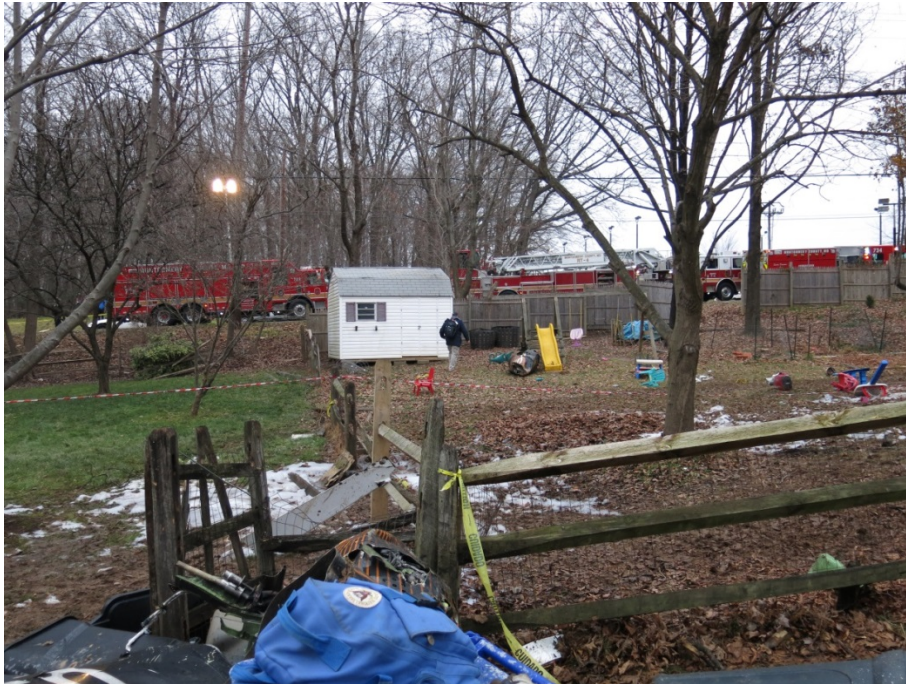
The right engine was found in the back yard of the 19733 house and a fuel burn was in the wet grass at the engine. (See Figures 26 and 27)

Figure 26. Right engine is next to the yellow children's slide, to the right of the person.

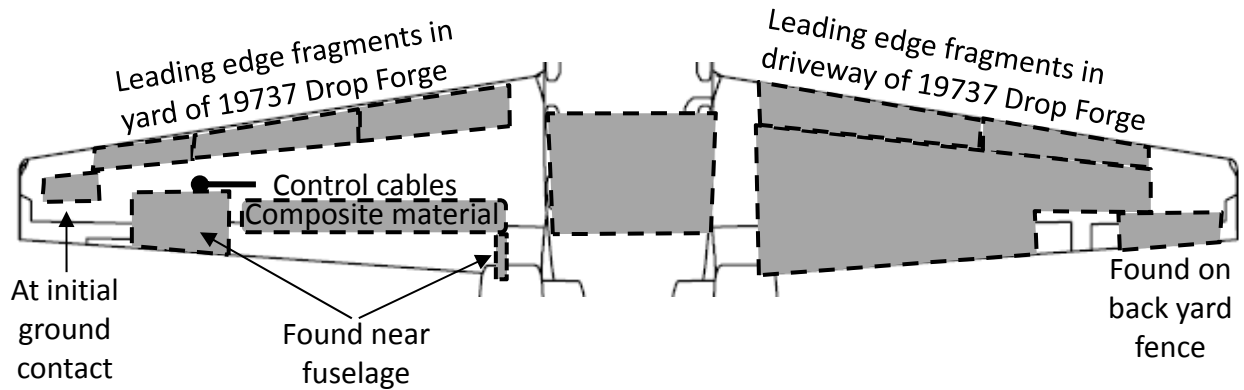
Portions of all major wing sections were identified in 19733 house and on the the three lawns. (See Figure 28)

Figure 28. Identified wing components. For reference, the original wingspan was 40' 5".

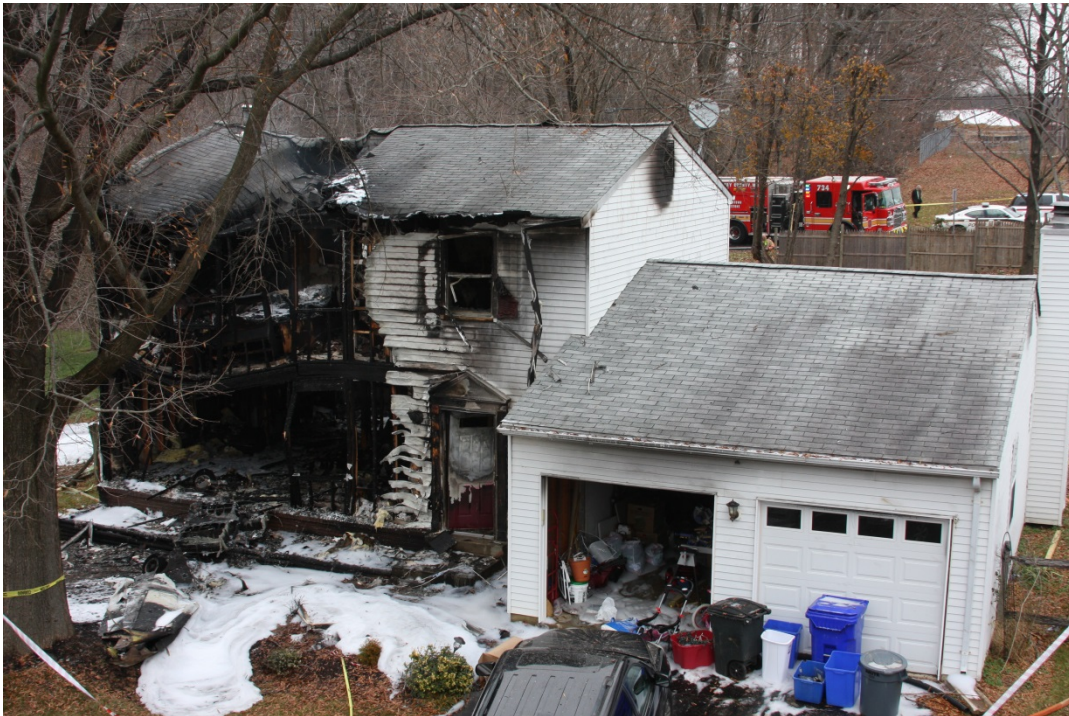
Most of the wing was found at and within the front of the 19733 house, with both main landing gear extended. (See Figures 29-33) The left wing tip in Google Earth was at 39.179984°, -77.180292°. The right wing tip in front yard of the 19733 house in Google Earth was at 39.179955°, -77.180359°

Figure 29. Overall view of 19733 Drop Forge Lane.
