NATIONAL TRANSPORTATION SAFETY BOARD
Office of Aviation Safety
Washington, D.C. 20594
January 30, 2015

Group Chairman's Factual Report

STRUCTURES

DCA13MA081

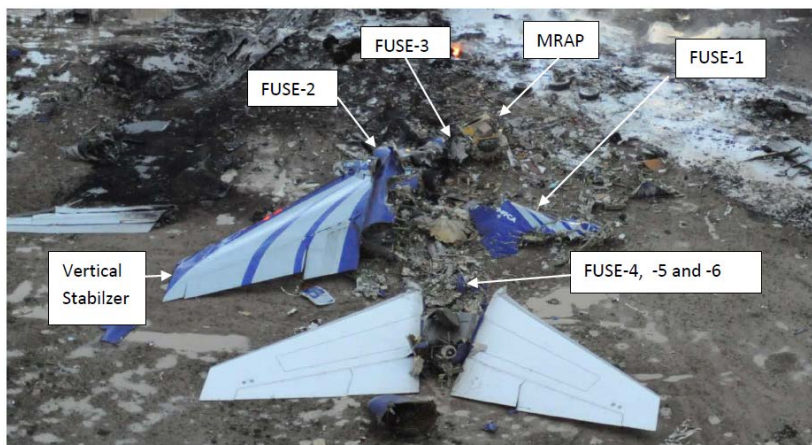
Figure 4 - Fuselage Section 46 Skin Panel Locations

Portions of six section 46 fuselage skin panels aft of the fire damage were identified and documented at the accident site (Figure 4).

FUSE-1 includes a deactivated and intact R5 door (Figures 5 & 7). The skin panel section also contained a section of the APB.

The FUSE-2 skin panel also contained a portion of the APB and exhibited fire damage (Figures 6 & 8). The fire damage was from about stringer 22L to about stringer 1 between STA 2320 and STA 2360. The FUSE-2 skin contained the E-8 rack that housed the FDR and CVR.

The FUSE-3 skin panel section was impaled on the left side of the aft most MRAP⁴ (Figure 6).

FUSE-4 and FUSE-5 were found next to and partially on top of each other near the bottom of the large impact crater that was approximately 30 feet in front of the horizontal stabilizer. The stringer stiffeners and frames common to these skin sections were flattened and had a smeared appearance (Figures 5 & 6).

FUSE-6 (Figures 5 & 6) was also found at the bottom of the large impact crater. This section of skin exhibited evidence of buckling, but did not have the flattened appearance of FUSE-4 and FUSE-5 (Figures 5 & 6).

All of the examined fracture surfaces exhibited features consistent with overstress failures with no evidence of fatigue.

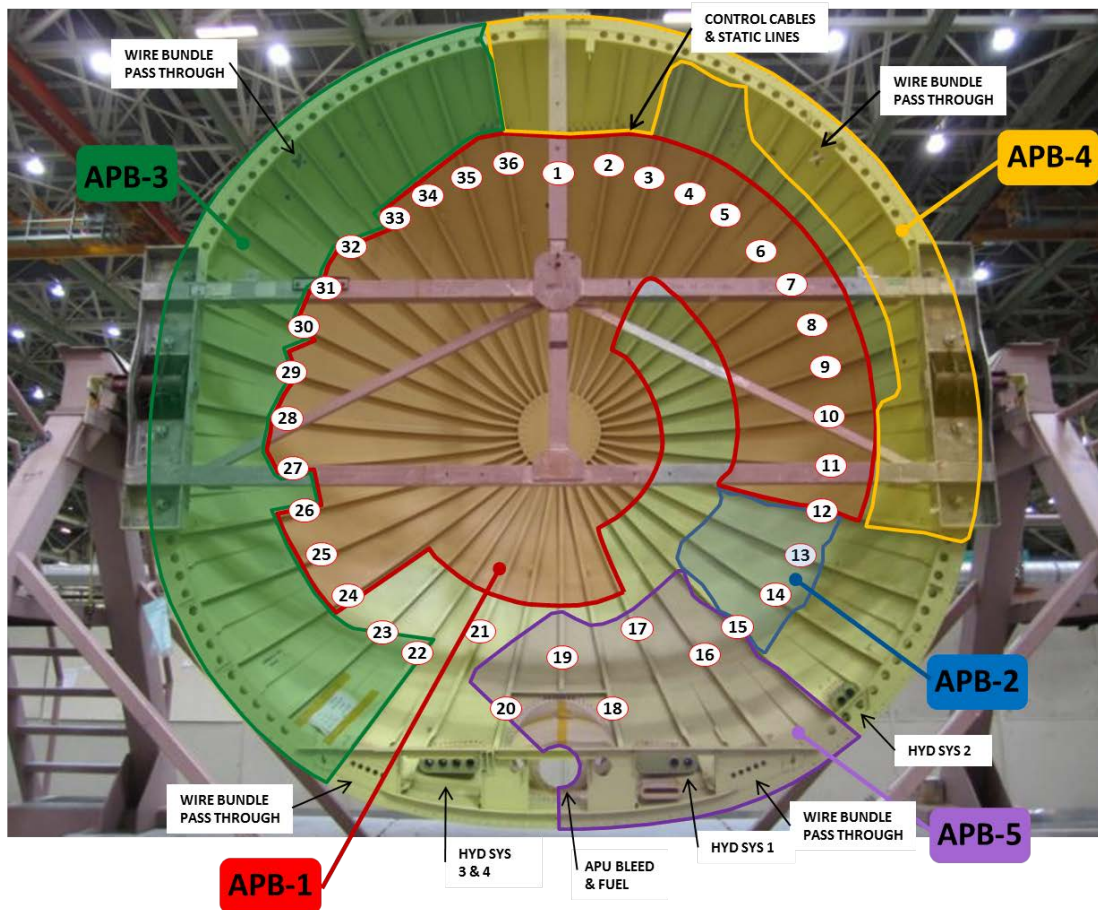
Figure 10 - APB, View Looking Aft

Five sections of the APB were identified at the accident site (Figures 9 & 10). The aft pressure bulkhead is dome shaped and curved aft. Three of these sections, APB-3, -4 & -5, were still attached to the faceplate “Y” chord and section 46 outer skin panels. APB-1 & -2 were found not connected to any fuselage structure.

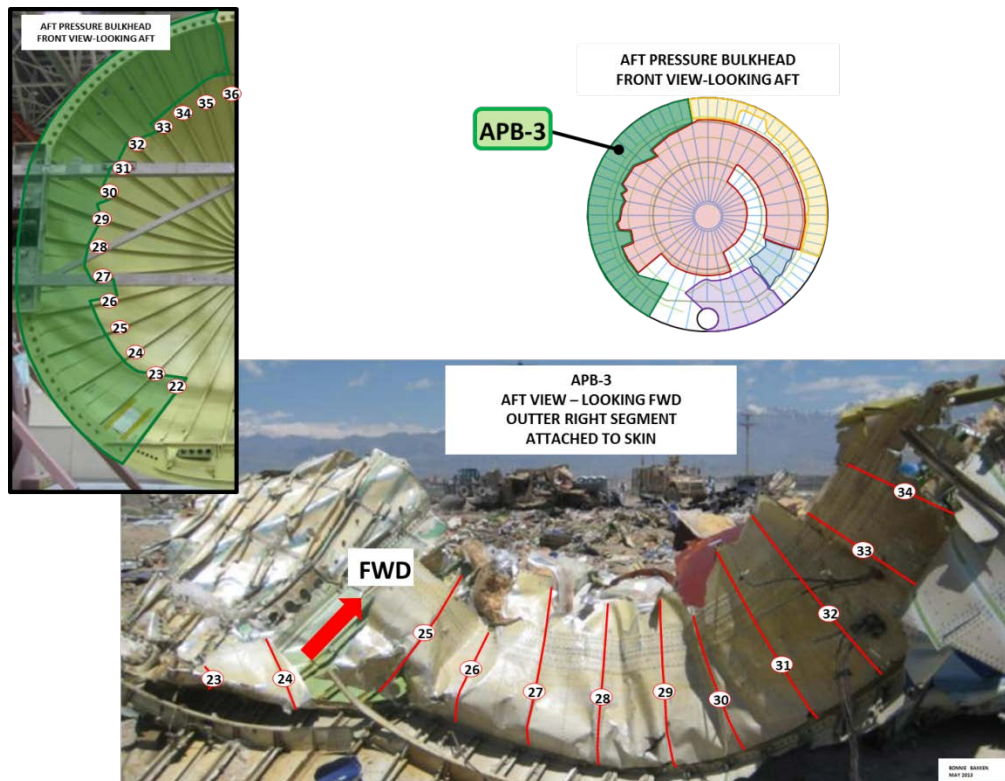
Figure 12 - APB-3, View Looking Forward

Section APB-1 was found on top of a pile of section 46 wreckage that was in an impact crater located approximately 30 feet forward of the horizontal stabilizer (Figure 11). APB-1 had a large crease just below the center dome. The upper half, above the center of the APB, was deformed aft. APB-2 was found under the horizontal stabilizer with the stiffeners deformed flat. APB-3, -4 and -5 were still attached to their respective STA 2360 Y chord and section 46 fuselage skins. APB-3 was attached to a large section of the right hand section 46 skin panel (Figure 12). APB-3 was deformed forward. The forward deformation was greater at the lower waterline levels and less pronounced near the crown.

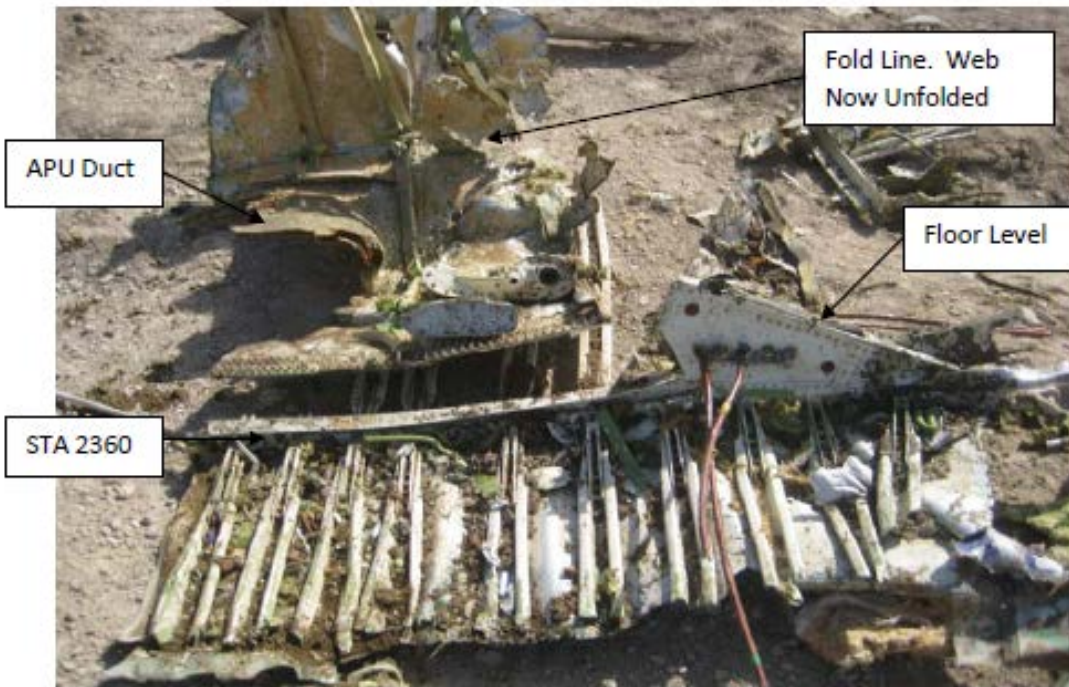
Figure 14 - APB-5 View Looking Aft

APB-4 was attached to a portion of the left hand section 46 skin panel (Figure 13). It was also deformed forward similar to APB-3. APB-5 was bent aft from the skin panel to about the top of the APU cutout and the remainder of the section was bent forward (Figure 14). APB-5 was located under the horizontal stabilizer near APB-2.

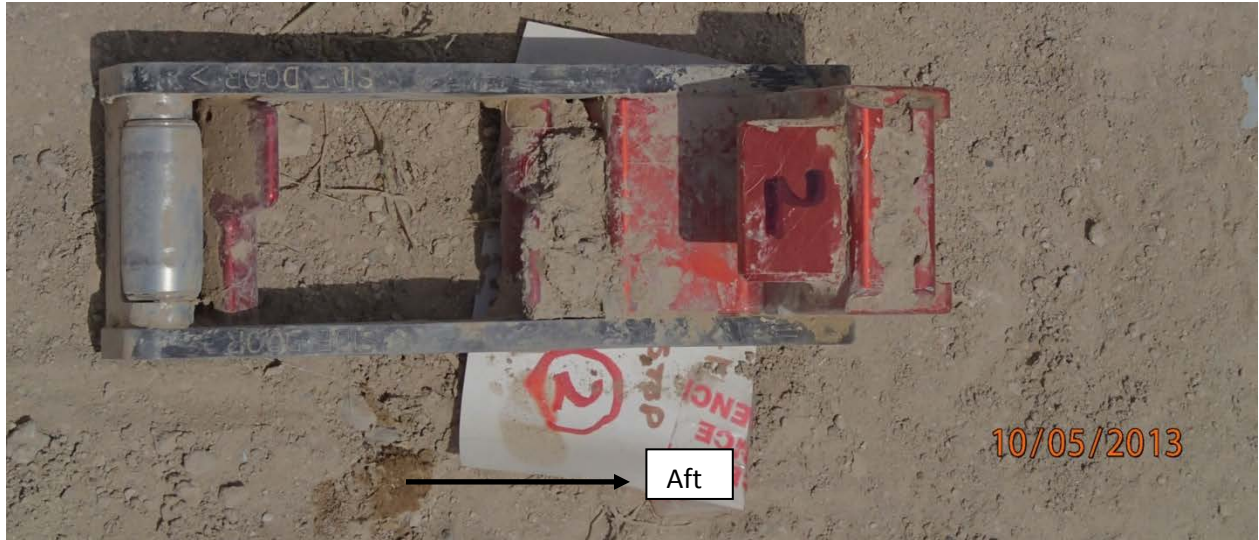
Figure 18 – N949CA Fixed End Stop (2) (part number 289100-1)

The fixed end stop and black housing in position 1 were recovered still mounted and secured to about a 40 inch section of silver aluminum roller tray (Figures 15 & 17). The roller tray was fractured about 40 inches forward of the aft end and about 5 inches forward of the power drive unit (PDU). The fixed end stop located in position 2 was recovered still mounted to the black housing and was no longer mounted to a silver aluminum roller tray (Figures 15 & 18). The fixed end stop located in position 3 was recovered separated from the black housing and the housing was no longer attached to the silver aluminum roller tray (Figures 15, 16 & 19). The housing fractured on the right hand side where the fixed end stop attaches to the black housing.

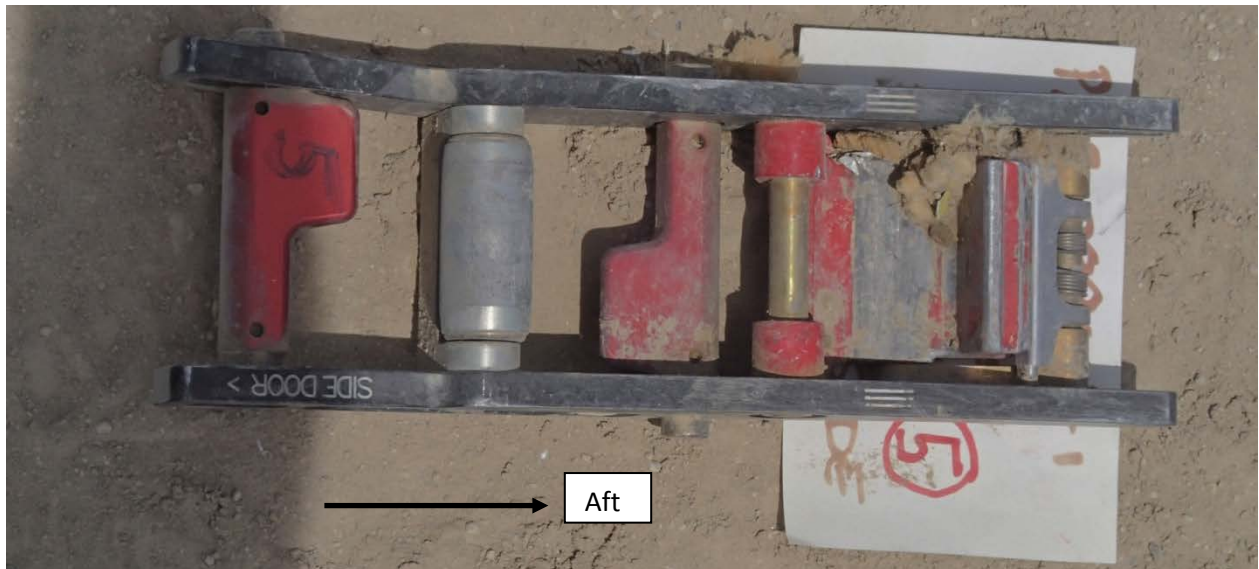
Figure 21 – N949CA Retractable End Stop (5) (part number 288100-1)

retractable end stop was not recovered in the wreckage debris. In position 5 the retractable red end stop was recovered in the down position attached to the black housing (Figures 15 & 21). The assembly was not attached to the silver aluminum roller tray. In position 6 the retractable red end stop was recovered in the up position and secured to the black housing (Figures 15 & 22). The assembly was attached to about 20 inches of the silver aluminum roller tray. The roller tray was fractured at the forward end.

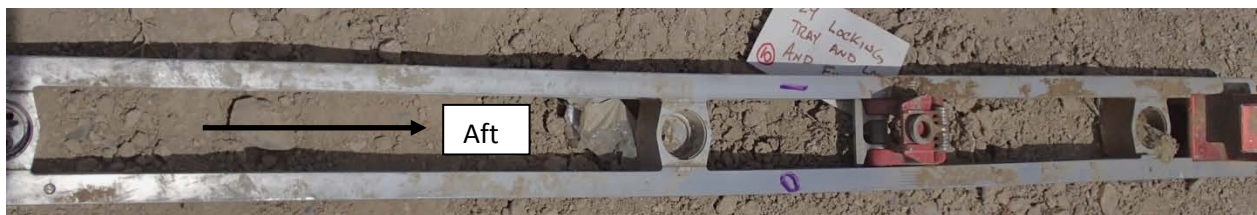
Figure 26 - P29 Aft Lock Tray (10) fixed and retractable end stops

In position 9 (Figures 15 & 25) the entire assembly was recovered with the forward retractable end stop in the down position (Figure 25). The silver aluminum lock tray was fractured about 44 inches from the forward end or about 7 inches from the aft end in the location of the aft roller. Material from the upper forward edge of the fixed end stop where the single stud and double stud attachment points are located was ground away. The upper surface of the silver aluminum lock tray also had diagonal scratches going from right to left on a 45 degree angle when viewed from the front looking aft. In position 10 the entire assembly was recovered with the retractable end stop in the up position and the fixed end stop attached and in place (Figures 15 & 26). The silver aluminum lock tray was fractured on the right hand side when viewed looking aft about 6 and ½ inches forward of the aft end of the tray. In position 9 the entire assembly was recovered with the forward retractable end stop in the down position. The assemblies in positions 9 and 10 are interchangeable and a determination of which was located on the left versus right hand sides of the airplane was not possible.

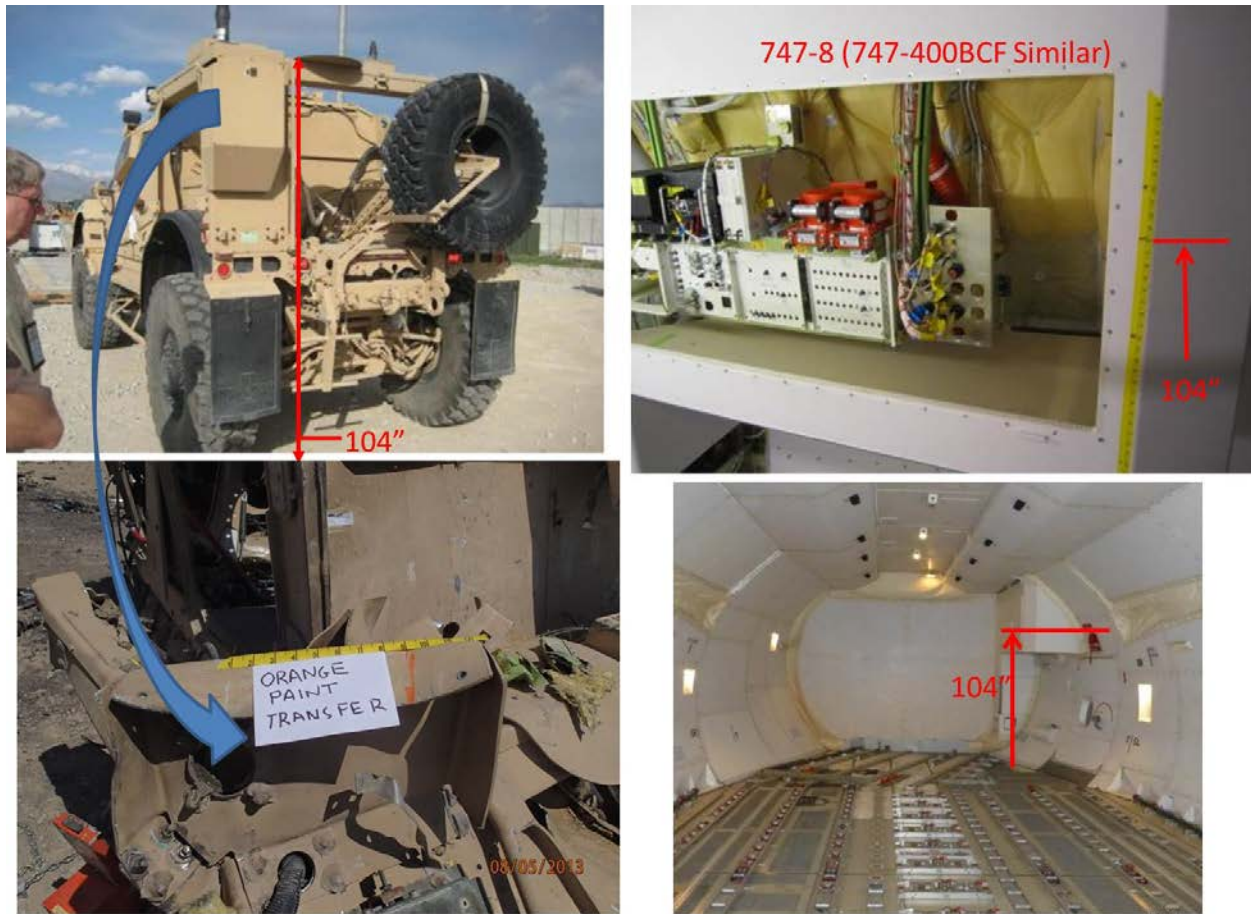
Figure 39 - MATV versus E8 Cabinet Positional Reference

The aft M-ATV was located from B.A. 1973 to 2211. The M-ATV was substantially damaged but was not consumed by fire. Pieces of the main deck interior panels were recovered from inside the M-ATV and orange and green paint transfers consistent with the orange paint on the CVR and the FDR cases and the green primer used on unpainted airplane structure were identified on the rear portion of the aft M-ATV. The paint transfer marks are consistent with airplane structure located aft of the M-ATV's tie down position (Figures 39 thru 42).

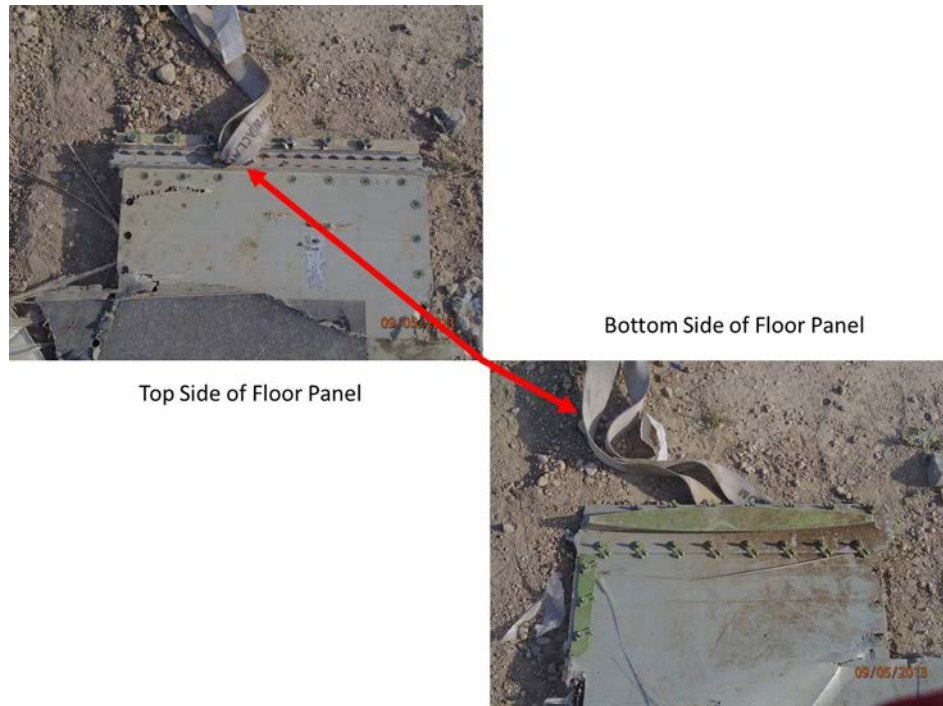
Figure 46 - Seat Track with attached Strap (1)

70 total sections of strapping were recovered aft of the last M-ATV and were torn at varying lengths. Twelve 5,000 LB straps of varying length were found attached to 6 sections of the cargo system side guide rail. The straps were submitted to the NTSB Material's Laboratory for examination.¹⁹ Four straps (Figures 46, 47, 48 & 49) were found attached to seat tracks. The double stud fitting shown in Figure 46 was installed in the right butt line (RBL) 75.9 seat track, between STA 1920 and STA 1940. There are no seat track allowables²⁰ for this track at this location per the Boeing Weight and Balance Control and Loading Manual. Figure 47 shows a part consistent with floor panel 814B6554-100. This would place the tie down location shown in Figure 43 on RBL 89.67 at approximately STA 2220. In Figure 48, the T/SL mark is a pallet mark on the left sidewall at the aft end of the side by side pallets (approximately STA 2218). The seat track appears to be the left butt line (LBL) 89.67 seat track at this location. There are seat track allowables²¹ for these tracks at these locations per the Boeing Weight and Balance Control and Loading Manual. It was not possible to determine the location of the fourth seat track and strap combination (Figure 49).

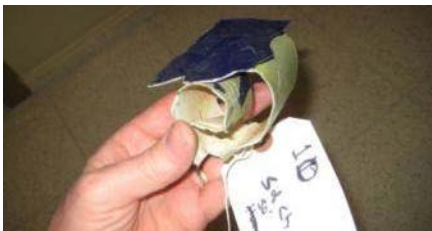
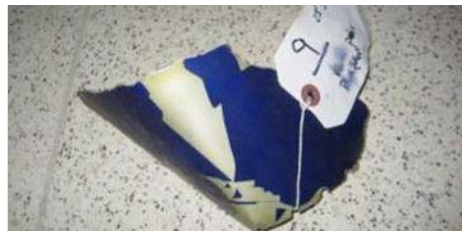
Figure 50 - Fuselage Skin Pieces recovered from the Runway

Twelve items were recovered from the runway following the accident in the vicinity of Taxiway C which was near the point of takeoff rotation. Eleven were identified as airplane structure and one was identified as being part of an MRAP. Of the eleven pieces of airplane structure, five were matched to specific parts of the airplane. The identified items included: 1) two small pieces of fuselage skin with blue National Airlines paint (Figure 50); 2) a green stanchion from the E8 CVR/FDR rack (Figure 51); 3) a bracket reinforcing a hydraulic line penetration in a fuselage frame located at body station 2377 (Figures 52 thru 54); 4) a body station 2377 frame intercostal; and 5) a section of tubing from hydraulic system 2 hydraulic line (Figure 55). The MRAP part was identified as being part of an antenna installation located on the rear upper left corner of a M-ATV (Figures 56 & 57). The rear M-ATV was missing its entire antennae assembly. The recovered piece of the antennae assembly was consistent with those installed on the accident M-ATVs.

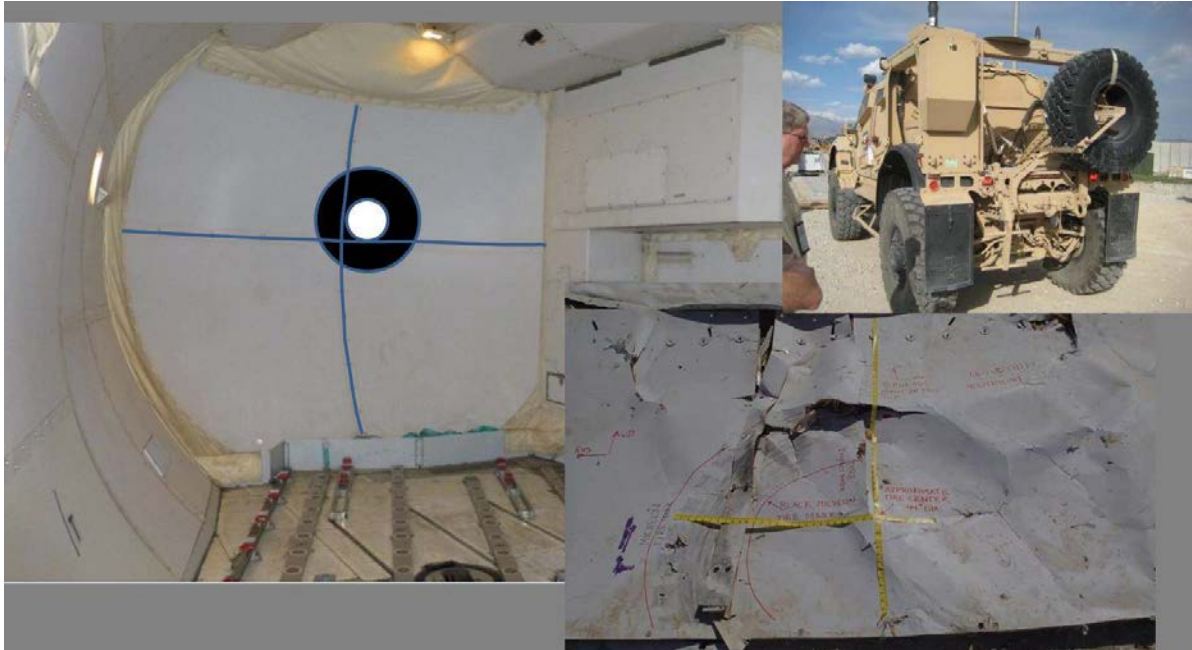
Figure 58 - APB Cargo Liner Tire Witness Marks

The APB interior liner had evidence of contact with an MRAP tire. There was a quarter tire witness mark from about the 9 o'clock to about 12 o'clock positions on the APB liner (Figure 58). The liner is comprised of 4 near equal quarter sections. The lower right quarter panel (viewed aft) was not identified in the wreckage. The estimated center of the 44 inch MRAP Michelin tire witness mark was located on the APB right upper quarter panel, about 50 inches from the top edge, about 15 inches from the lower and about 14 inches from the left edge when viewed looking aft. The tire imprint was consistent with a tire being parallel to the APB and located 81 and ½ inches above the main deck cargo floor. The spare tire on the aft most M-ATV is mounted parallel to the rear bumper of the vehicle and the bottom of the tire is located about 59 and ½ inches above ground level. This measurement was for the shored and secured configuration on the pallet, however, the spare tire on the aft accident

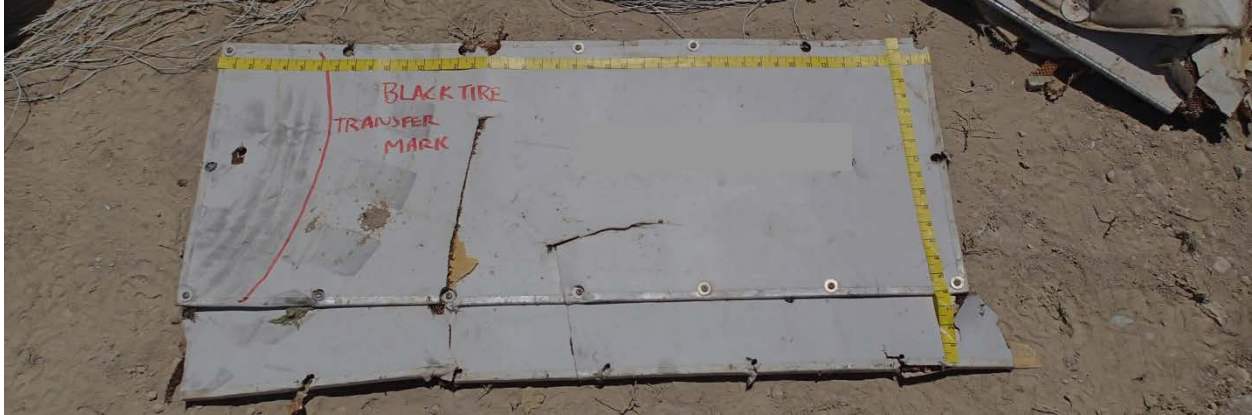
Figure 60 – Ceiling Panel 453U7135-1

Panel 411U2535-30 (Figure 61) from the CVR and FDR E8 rack also had tire witness marks. Ceiling panels 453U7135-1 (Figure 60), 845B3110-26 (Figure 62) and one other

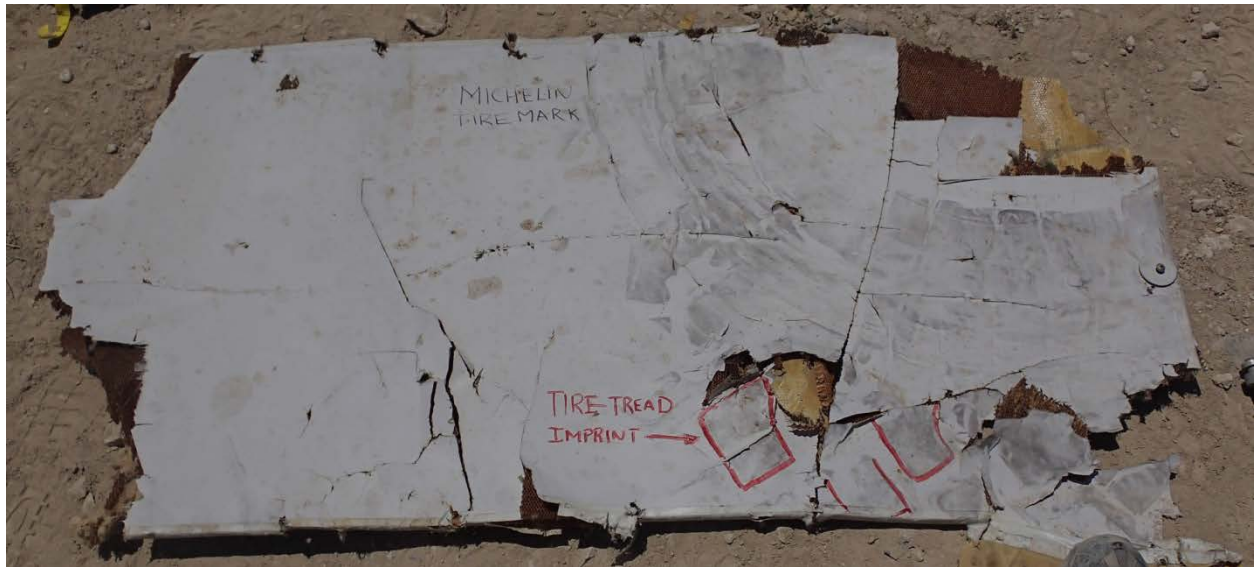
Figure 62 – Ceiling Panel 845B3110-26

panel with no part number identification but with an interior cabin light and grounding wire attached to it, had tire witness marks on them (Figure 65). There was evidence of multiple contacts between panel 845B3110-26 and a Michelin tire at opposing 90 degree angles (Figures 62 & 63). Another unidentified panel with tire witness marks was also recovered in the area of the aft M-ATV and the vertical stabilizer (Figure 64).

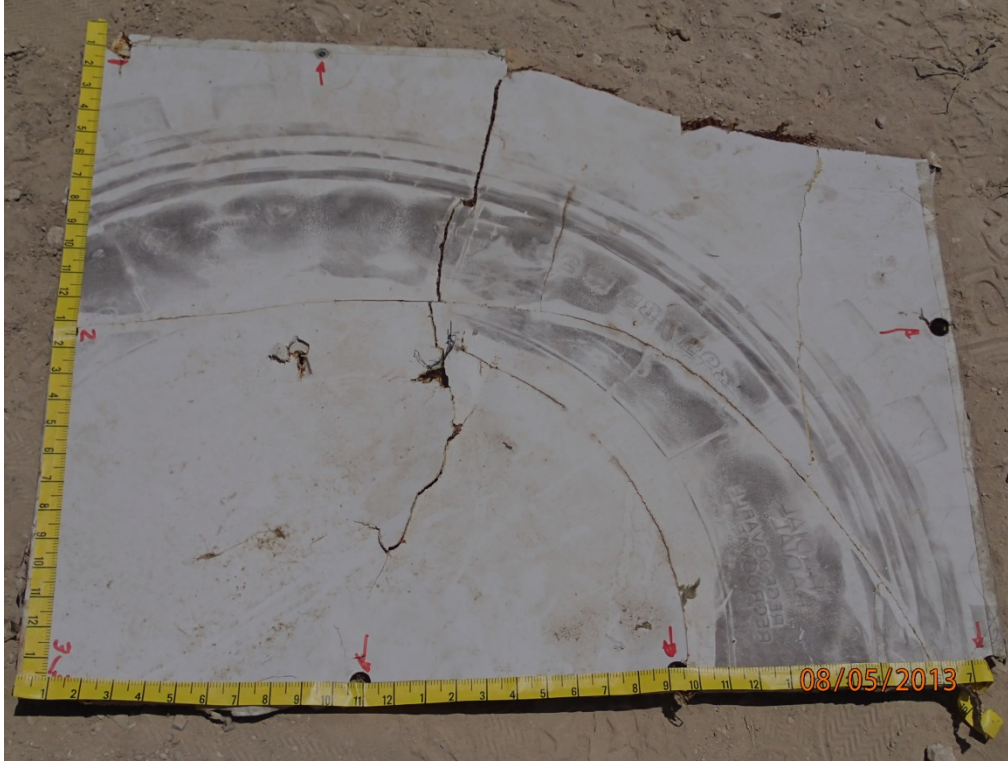
Figure 64 – Unidentified Panel

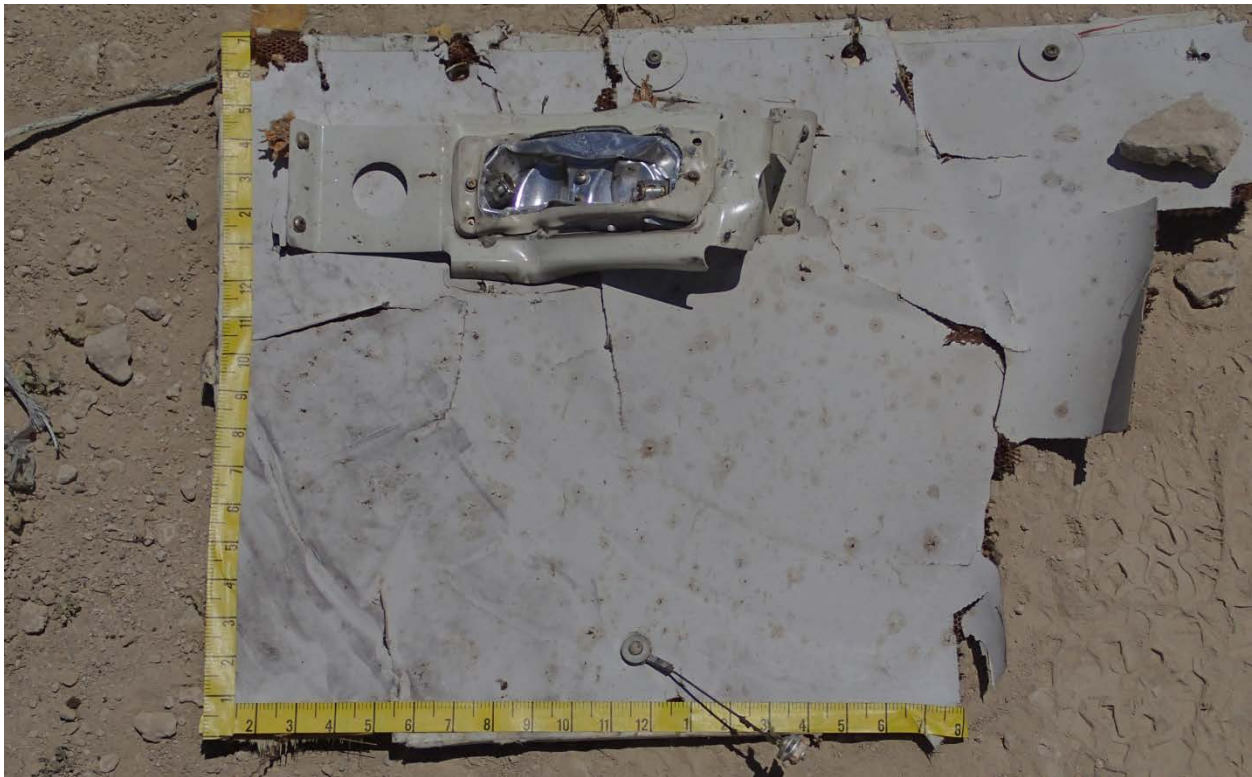
Figure 65 – Unidentified Panel with Interior Light Fixture & Grounding Cable

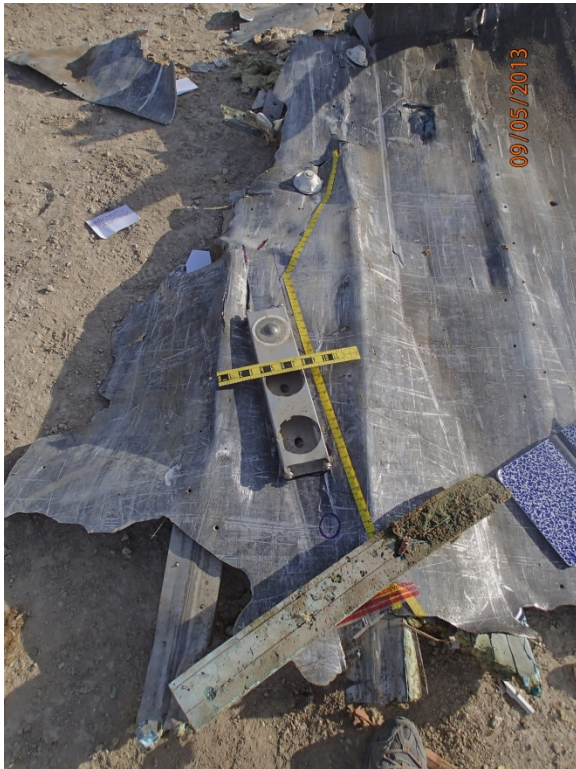
There were red paint transfer marks and material smearing on the bottom of a 20 foot aluminum G code pallet that was used for staging and loading the MRAP's. The pallet was recovered aft of the last M-ATV in the crater adjacent to the vertical stabilizer. The marks began at the forward edge of the pallet, common to a fracture, and moved aft in a right to left direction at a 103 degree angle relative to the plate centerline for about 3 feet. The witness marks then changed to a 30 degree left to right direction for about 4 feet. There were red paint transfer marks along both the 3 and 4 foot sections (Figures 66 & 67). The material smearing was present on both the 3 and 4 foot sections and measure about 4 inches in width (Figure 66 & 67). There were two 4 inch circular witness marks with 1 and ¼ inch circular indentations in their center along the 4 foot section at about 20 and 48 inches from the beginning of the 30 degree witness mark. The caster trays are constructed from a 4 inch aluminum channel and house 1 and ¼ inch roller bearings in a 4 inch diameter plastic fixture (Figure 68). The aft end of the plate was curled down and back forward onto the surface of the plate containing the witness marks (Figure 69).

Figure 66 - 20 foot G code Pallet Witness Marks

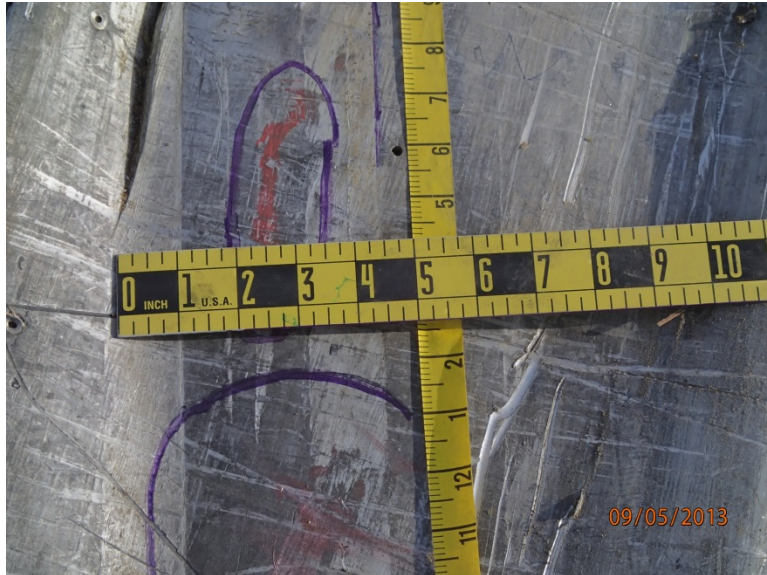
Figure 67 - 20 foot G code Pallet Red Paint Transfer Marks & Material Smearing.

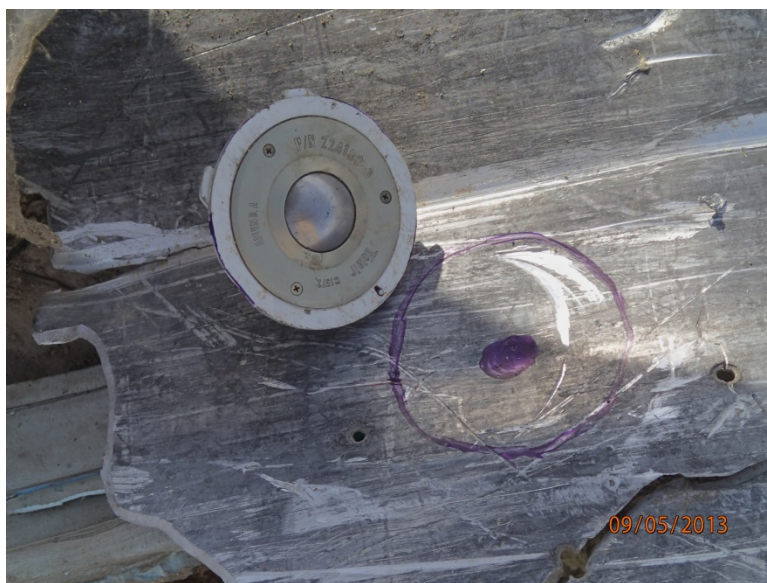
Figure 68 - Roller Bearing Witness Mark at 48 Inches

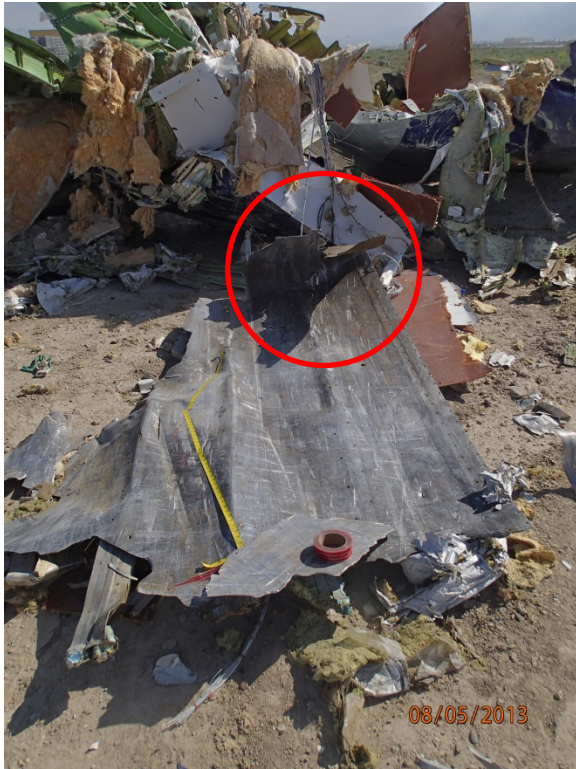
Figure 69 - Curled Deformation of a Partial G code Pallet

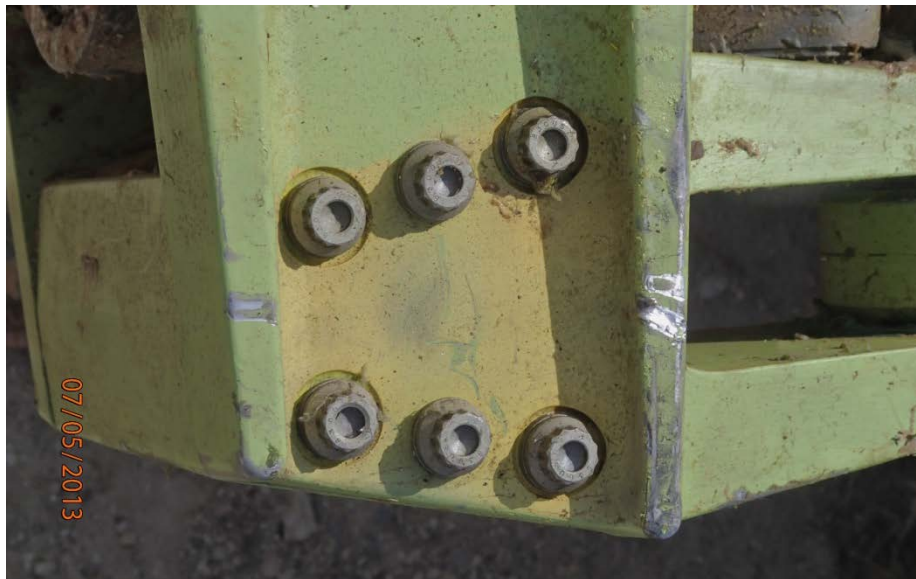
The upper collar fitting of the jack screw assembly had a longitudinal witness mark and material smearing exposing the bare aluminum under the green primer (Figures 70, 71 and 72). The jack screw is located aft of the APB and attached to the fuselage structure about 3 feet above the main cargo floor and the fitting was positioned about 8 feet above the main cargo deck floor (Figures 73, 74 and 75). The aft side of the M-ATV was about 8 feet 8 inches (104 inches) tall (Figures 39, 73 and 7571).

Figure 71 - Jack Screw Collar Fitting Witness Mark Close-up

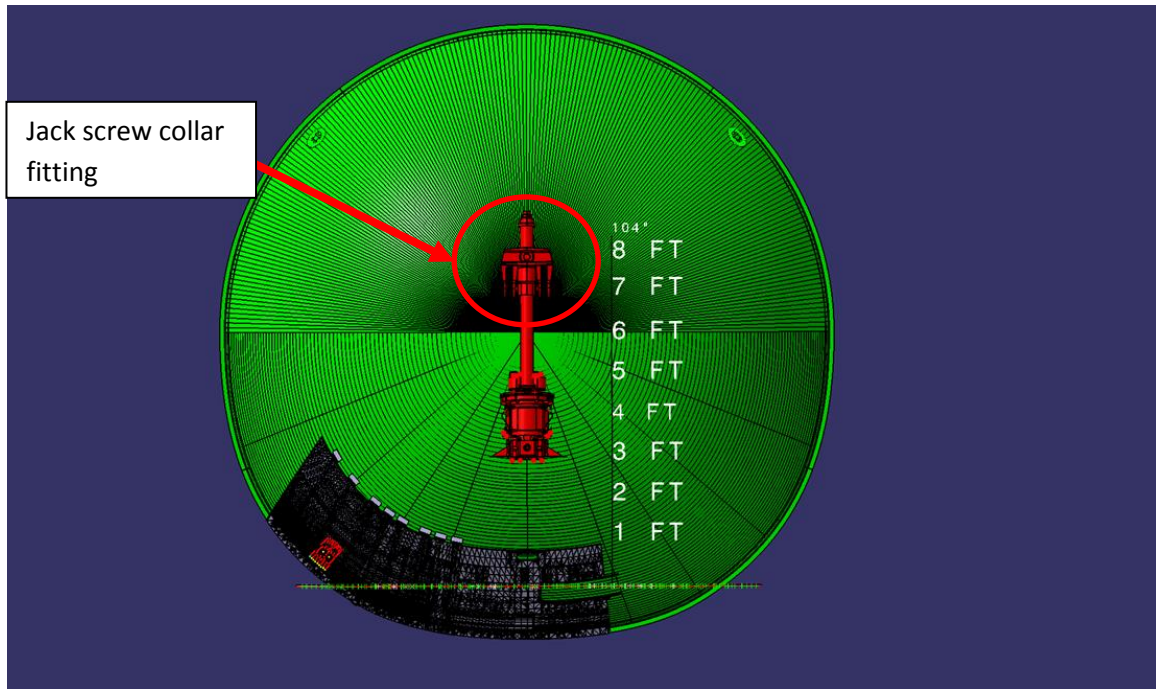
Figure 72 – Aft Pressure Bulkhead and Jackscrew viewed looking aft

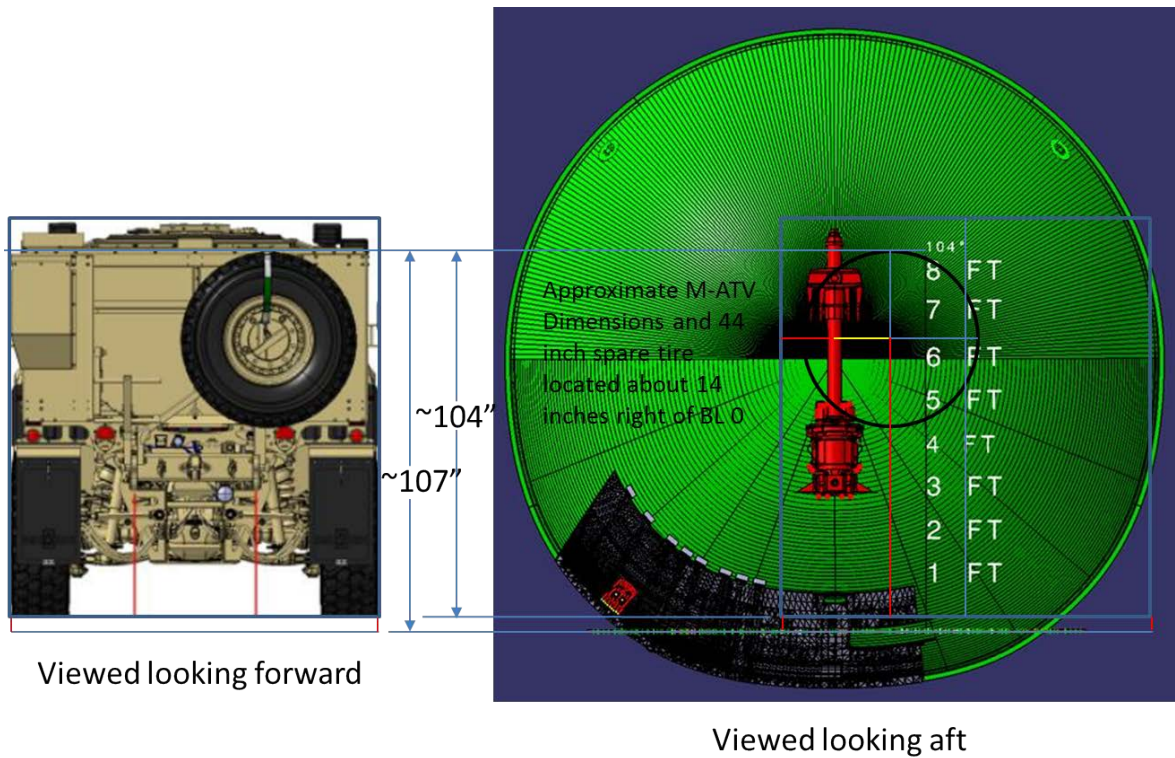
Figure 73 – Aft Pressure Bulkhead, Jackscrew and M-ATV viewed looking forward & aft

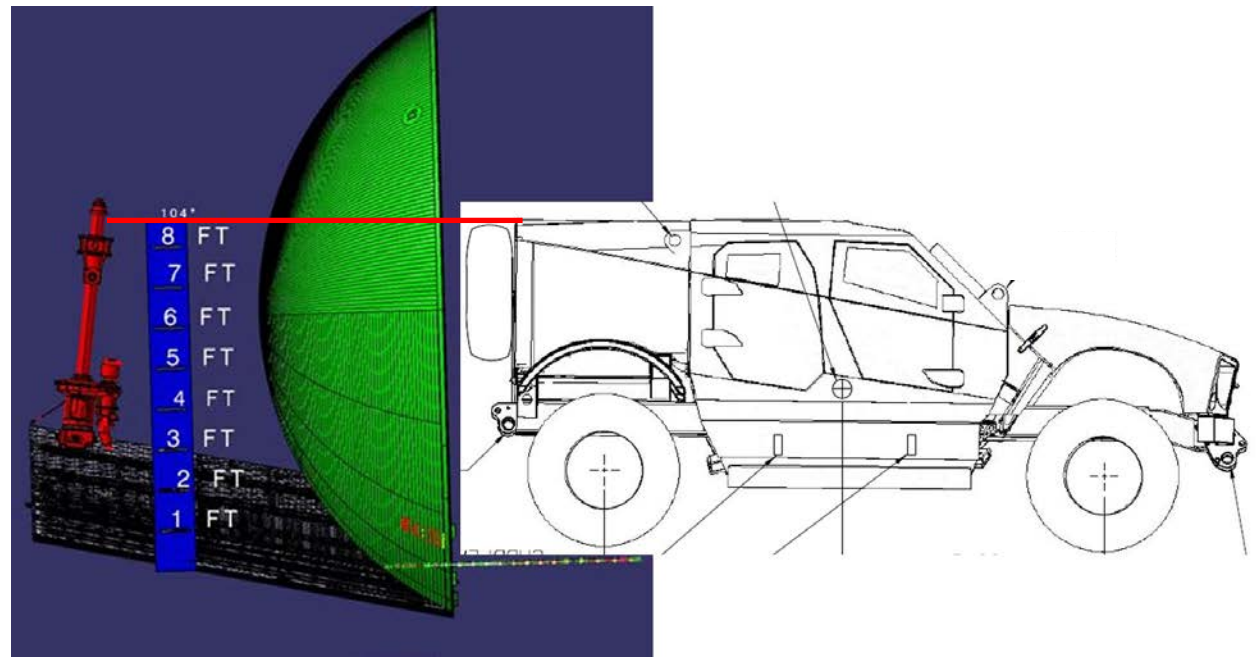
Figure 75 – Aft Pressure Bulkhead, Jackscrew and M-ATV side view #1

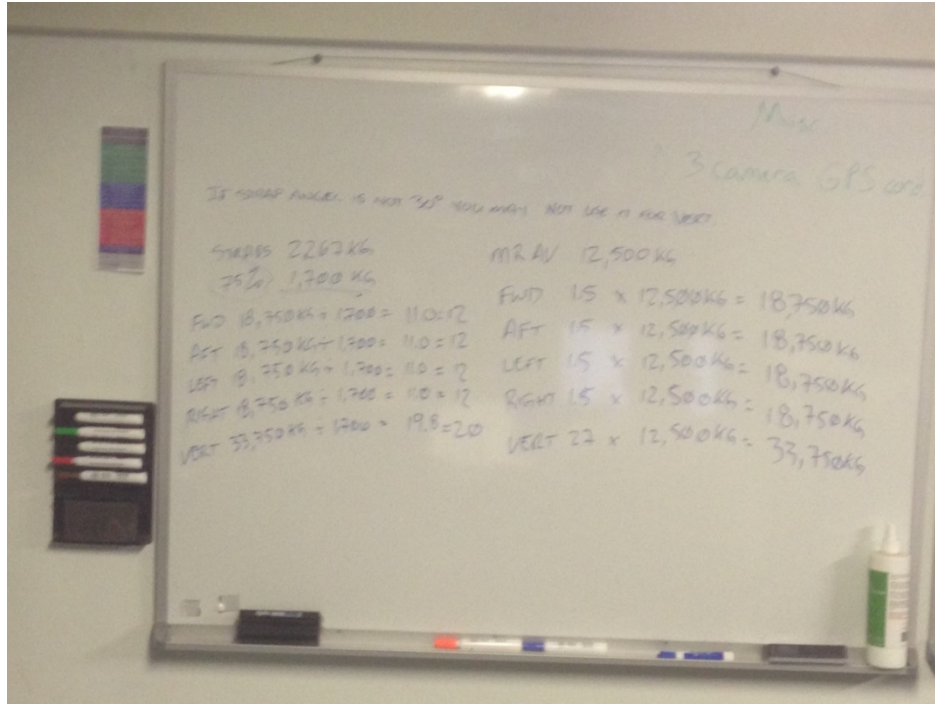
Based on the NAC employee witness statements the two M-ATV's were tied down using 24 straps and the three Cougar's were tied down using 26 straps²⁷ While on scene in Afghanistan the NAL Chief Loadmaster performed the following example strap calculations (Table 2 & Figure 79) for a 27,566 LBS (12,500 kg) or about a 12 ton M-ATV. The following load factors were used to calculate the required number of straps; 1.5G forward, 1.5G aft, 1.5G lateral and 2.2G vertical²⁸. The strap allowable load was 5,000 LBS (2,267 KG). NAL incorporated an additional safety factor of 75% in their strap calculations and reduced the strap allowable load to 3,750 LBS (1,700 KG). The NAL guidance further assumed that all of the straps were installed at 30 degree angles when measured relative to both the airplane centerline and the airplane floor. They further assumed that all of the floor attachment points were capable of reacting 3,750 LBS (1,700 KG) in all three directions, forward and aft, lateral and vertical, simultaneously.

Figure 79- National Airlines Tie Down Strap Calculations³³

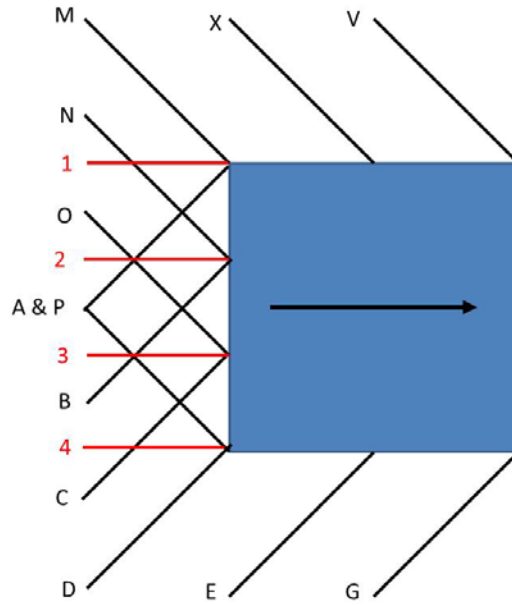
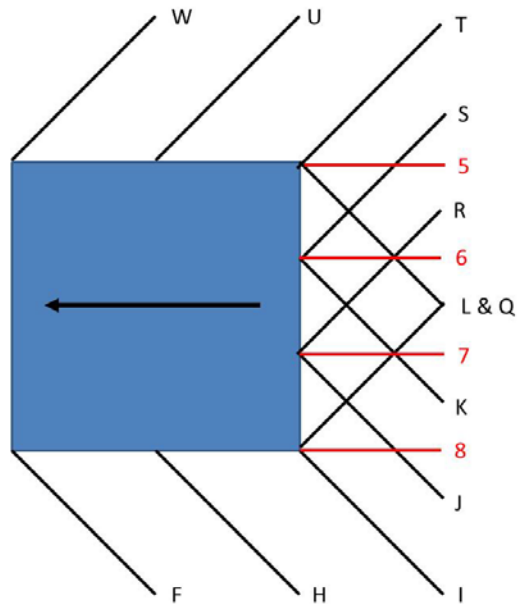
LBS and 55,370 LBS. (Figures 87 & 88). According to the NAL Cargo Operations Manual these 32 straps could all be used to restrain the vehicles in the vertical, forward, aft and lateral directions. This approach was contrary to the airplane manufacturer's and the main deck cargo handling system manufacturer's Weight and Balance Manual requirements.

Figure 87 - NAL Straps Needed to Restrain Right Loads (16)

Figure 88 - NAL Straps Needed to Restrain Left Loads (16)

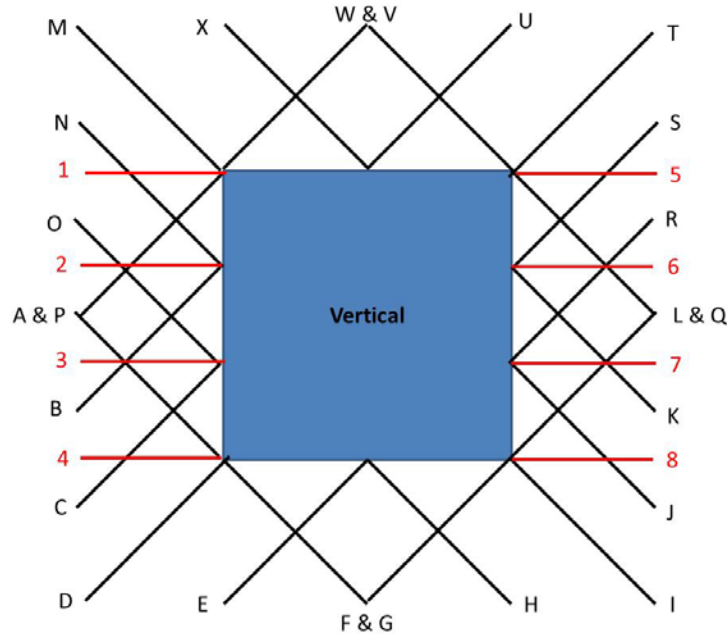
Based on the NAL guidance 69,377 LBS and 69,212 LBS needed to be reacted for each of the M-ATV's in the vertical direction. Using the NAL guidance the 32 straps will provide 120,000 LBS in the vertical direction (Figure 89). This value was greater than the NAL required values of 69,377 LBS and 69,212 LBS. Per the NAL Cargo Operations Manual and the Cargo Operations Manager the M-ATV's could be carried by attaching 32 straps (Table 4) to each vehicle and to any part of the airplane as long as the attachment points were separated by 20 inches or more. The strap angles and airplane attach fitting allowables are not considered in their guidance. This was contrary to both the airplane manufacturer's and the main deck cargo handling system manufacturer's Weight and Balance Manual requirements.

Figure 89 - NAL Straps Needed to Restrain Vertical Load (32)

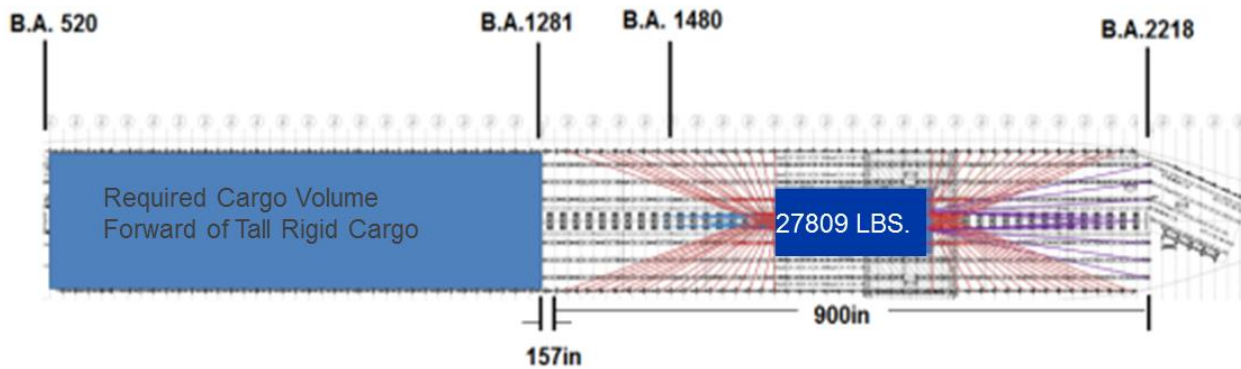
Figure 91 - Boeing M-ATV Tie Down

For their study Boeing used the following G load factors: 1.5G forward, 0.75G aft, 1.45G side and 2.20G up. Boeing determined that it would require 900 inches of linear space and sixty 5,000 LB rated straps to tie down one M-ATV weighing about 27,809 LBS (12,614 KG) (Figure 91). For their study Boeing utilized all available tie down points including the available seat tracks and also allowed for the movement of the pallet locks as necessary to gain additional tie down points forward and aft of the MRAP's (Tables 5 & 6).

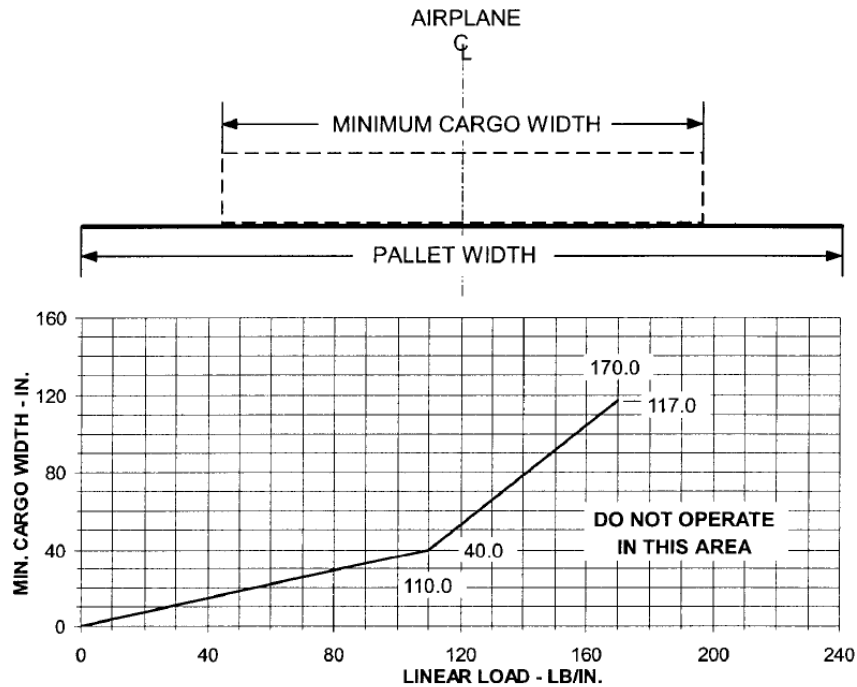
Cougar to be secured at least as far aft as the M-ATV, resulting in the Cougar being located in a position aft of B.A. 1480 (Figure 91). Due to the running load per foot limitations aft of B.A. 1480 it was not possible to carry a Cougar. The linear load limit for centerline loaded cargo based on a 96" pallet width is approximately 155 LBS per inch (Figure 89). The running loads per inch for each Cougar are 172⁴², 170 and 167 LBS per inch. To utilize the 170 LBS per inch running load on a centerline load aft of STA 1480, the cargo needs to be shored to a width of 117 inches (Figure 92).

Figure 92 – Cargo Width versus Linear Load LB/IN
