NATIONAL TRANSPORTATION SAFETY BOARD

Group Chairman's Factual Report

SURVIVAL FACTORS

ERA14MA271

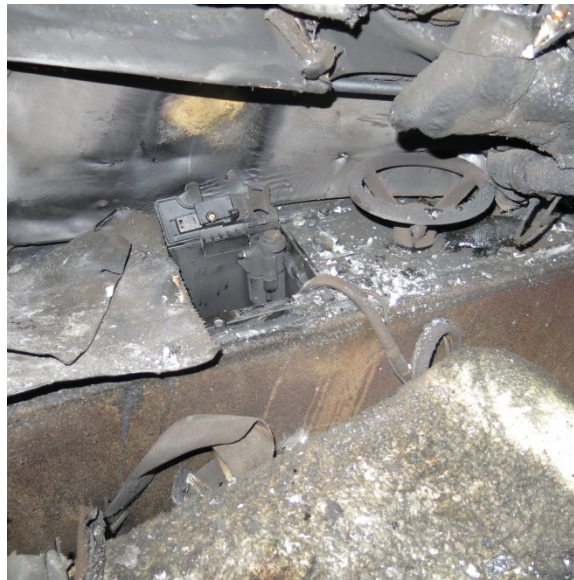
Photograph 15. Left cockpit seat oxygen compartment.

An automatic defibrillator, first aid kit, oxygen walk-around bottle and a bottle that resembled a 2.5 lb. fire extinguishing unit were identified near the forward entry closet. Figure 4 is an excerpt of the passenger information safety card showing the stowage locations of the emergency equipment on the accident airplane. The left cockpit seat oxygen mask compartment was found in the open position with the mask removed and lying in front of the seat (photograph 15). The right cockpit seat oxygen mask compartment was found closed and the mask was stowed. The remaining emergency equipment was not located at the accident site during the initial on-scene documentation.

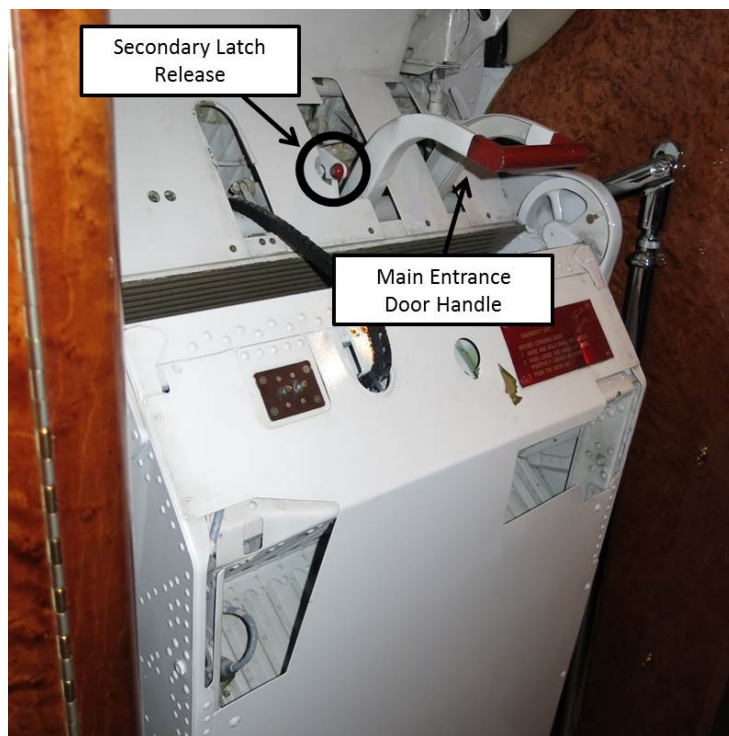
Photograph 16. G-IV main entrance door interior handle and secondary latch release.

Opening the door from the inside is a 2-handed operation requiring the lifting of the secondary latch release followed by pushing up on the main entrance door interior handle (photograph 17), before pushing the door open (the door is designed to then free fall open) as shown in the passenger safety information card (figure 6). From the outside of the airplane, the door is opened by first pressing the secondary latch release, which causes release of the main entrance door exterior handle so it can be lifted to unlock the door (photograph 18). The mechanical door latches and locks are interconnected within the door. This allows the respective interior and exterior handles to move together at the same time during door operation.

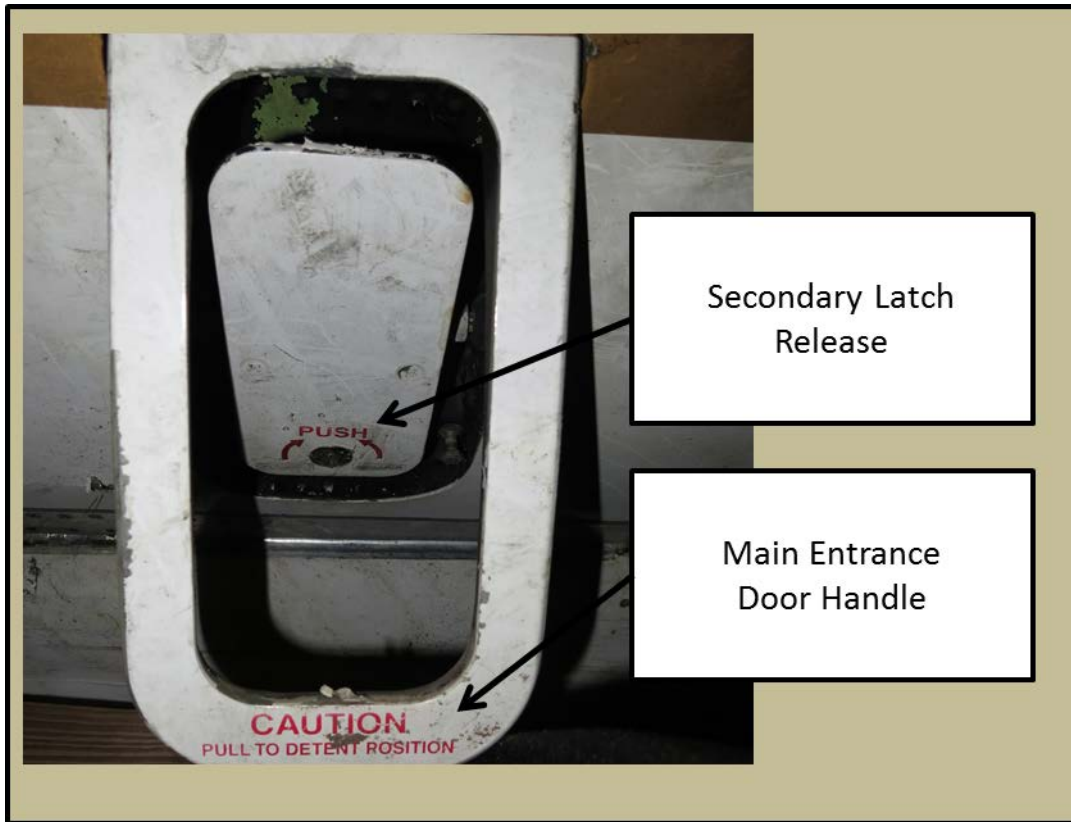
Photograph 18. G-IV main entrance door exterior handle.

The accident airplane's main entrance door remained closed during the accident sequence and post-crash fire. Recorded radio communications from Hanscom AFB Fire/Rescue indicated that Hanscom AFB firefighters first opened the main entrance door at 2351:42, about 2 hours and 11 minutes after the accident. According to firefighters' statements, a Halligan tool was used to depress the secondary latch release on the lower exterior door. Firefighters then pulled the handle open and the door free fell to a partially-opened position, (photograph 19) terrain obstructions prevented it from opening further.

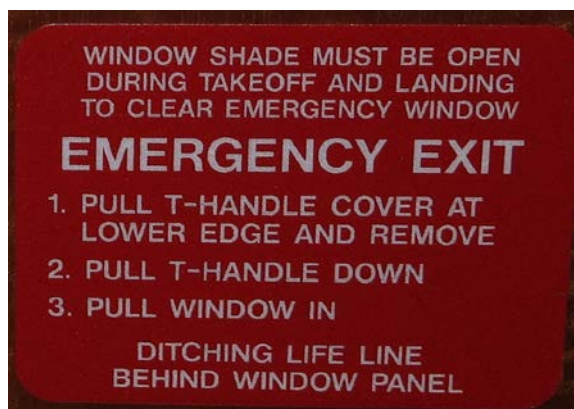
Photograph 21. Emergency overwing exit window placard.

The accident airplane was equipped with 4 Type III (equivalent) emergency overwing exit windows, 2 on the right side and 2 on the left side of the airplane. Three steps are required to operate the emergency overwing exit windows from the cabin: 1) remove the “Emergency Exit” cover from above the window; 2) pull the “T” handle down (figure 7); and 3) pull the window into the airplane. To open the overwing window exit from outside the airplane, An exterior handle for each overwing window exit is accessible through a panel beneath each exit; and placards (photograph 21) adjacent to the access panel provide instructions for access and handle rotation to open the corresponding overwing window exit.

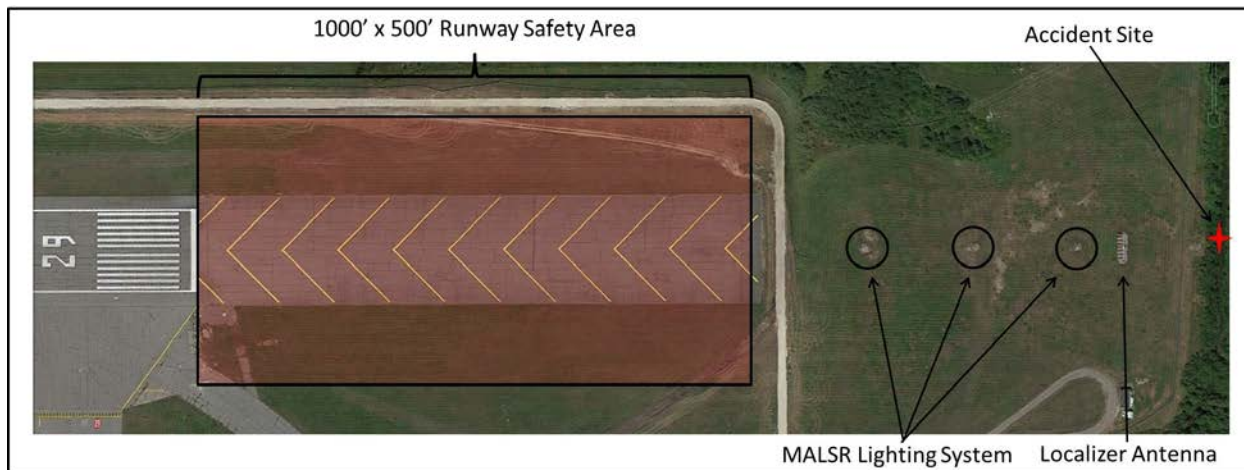
Photograph 24. Departure end of runway 11 BED.

equipped with high-intensity runway edge lights (HIRL). A medium intensity approach lighting system with runway alignment indicator lights (MALSR) exists on the approach ends of both runway 11 and 29. A localizer antenna was located on the centerline approximately 1700 feet from the end of runway 11 (photograph 24). The BED airport is owned by Massachusetts Port Authority and overseen by a full-time director.

As a result of the accident, part of the approach lighting system, localizer antenna and 39 sections of the airport perimeter fence were destroyed (photograph 25). The lighting system and localizer antenna were located between the runway safety area and perimeter fence and constructed with 2.5 inch aluminum poles, bolted to concrete pillars. The airport perimeter fence was replaced by the airport operator. The FAA replaced the localizer antenna and MALSR light stations with a new lightweight system, anchored with frangible bolts to new concrete pillars.
