## **NATIONAL TRANSPORTATION SAFETY BOARD**

### **Group Chairman's Factual Report**

# **SURVIVAL FACTORS**

**ERA13MA139**

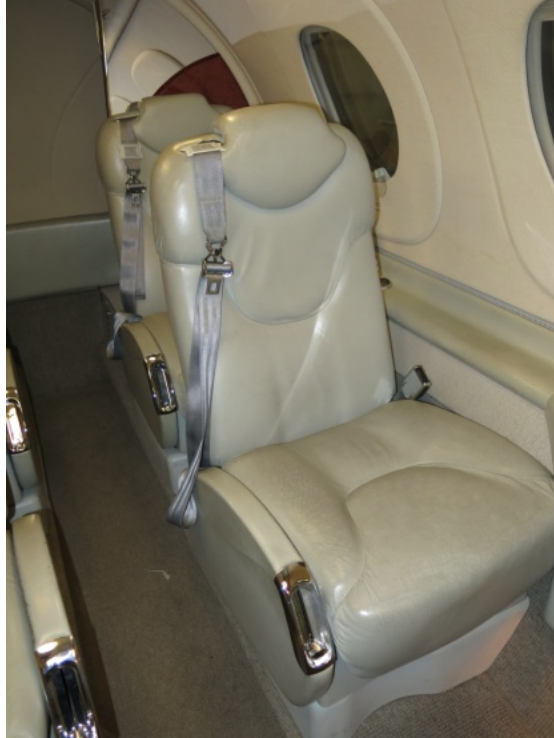
Photograph 4 – Exemplar passenger cabin seat.

The Beechcraft Model 390 had 6 passenger cabin seats; 4 were adjustable club-style seats and 2 were manual club-style seats (photograph 4). All 6 seats were located at the accident site and had been forcefully detached from the floor track rails.

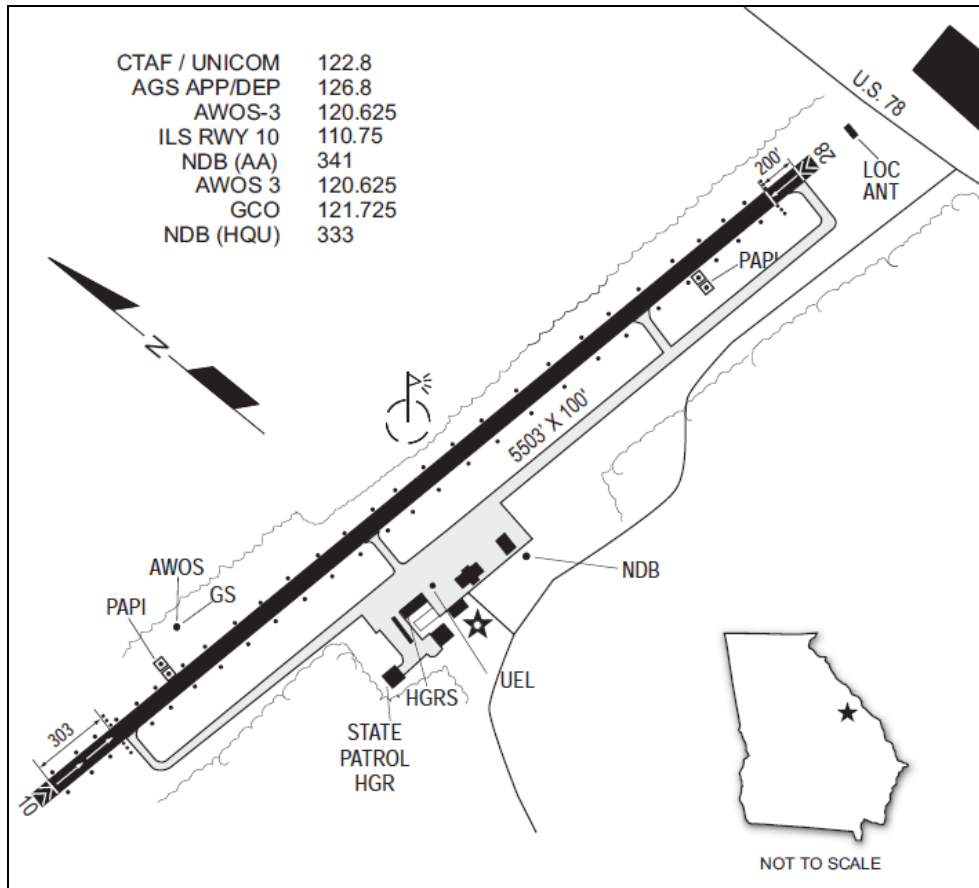
Figure 4: HQU airport diagram

Thomson-McDuffie regional Airport was owned and operated by the City of Thomson and McDuffie County, and was located 4 miles north of Thomson, Georgia. It was a general aviation airport with one asphalt runway (runway 10-28) measuring 100 by 5,503 feet, with precision instrument markings on both ends (figure 4). The runway had high-intensity runway edge light (HIRL) that changed from white to amber for the last 2,000 feet, in both directions. Both ends had red threshold lights and green approach lights. Adjacent to the touchdown zone for both ends of the runway was a two-unit (L-881) precision approach path indicator (PAPI) system set at 3 degrees.
