NATIONAL TRANSPORTATION SAFETY BOARD

SURVIVAL FACTORS

Specialist's Factual Report

ANC15MA041

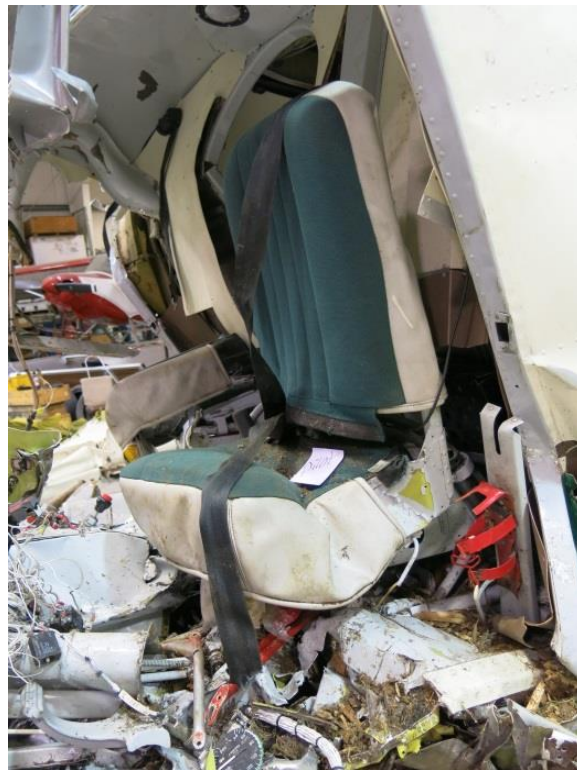
Photograph 4- Photograph of the pilot seat area.

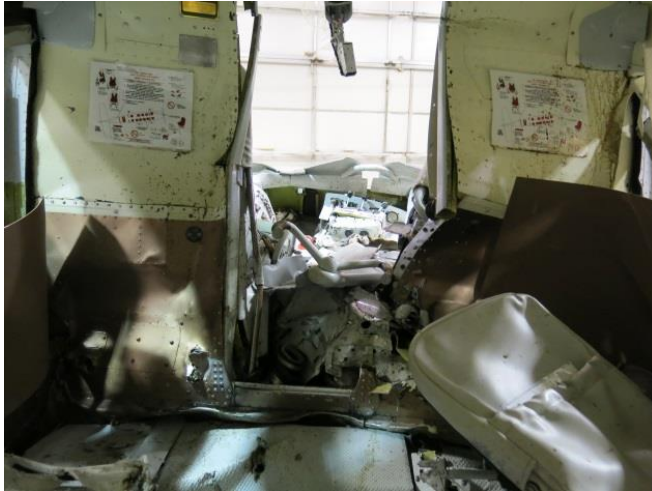
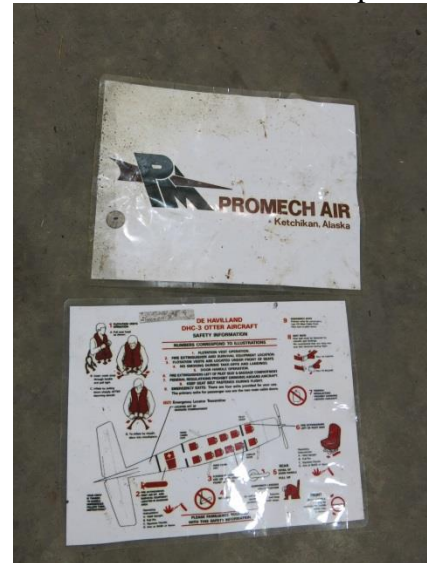
There were 7 safety cards found in the wreckage. Two safety cards were placarded against the forward fuselage bulkhead in front of seats L1 and R1 and behind the cockpit.

Photograph 44 – Photographs of the safety information cards placarded on the fuselage bulkhead and the seatback pocket safety information cards.

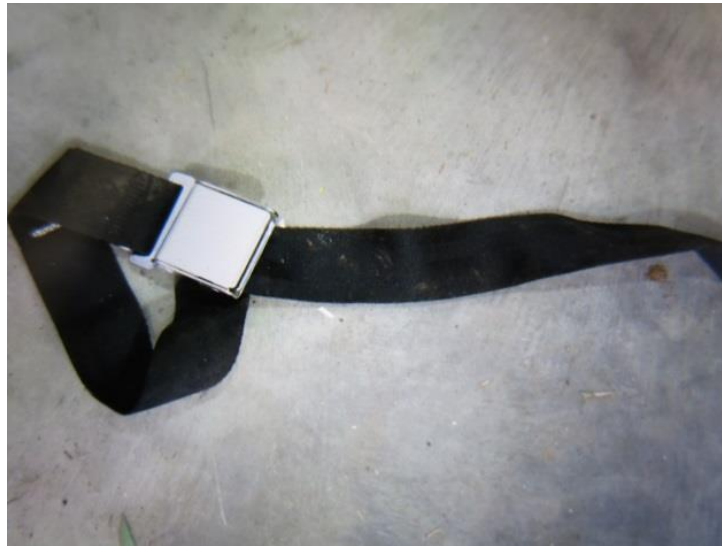
One seatbelt extender was located in the wreckage.

Photograph 46 - Seatbelt Extender.

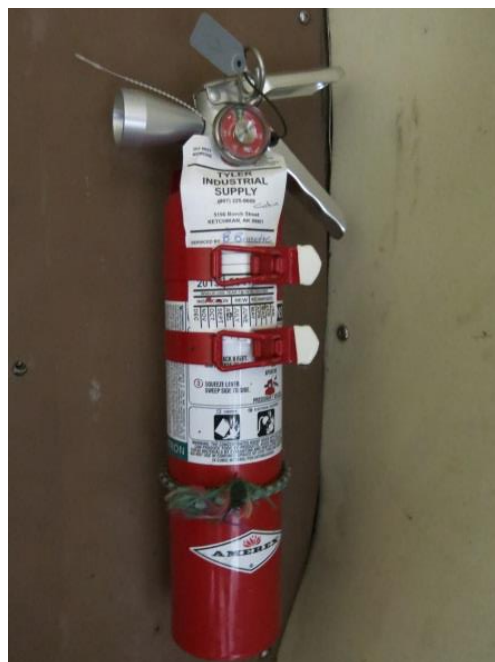
A halotron fire extinguisher was attached the aft bulkhead. It was Amerex Model, B385, No: Y-272907. Brackets for a fire extinguisher was found in the cockpit, however the fire extinguisher was missing.

Photograph 47 - Fire Extinguisher.

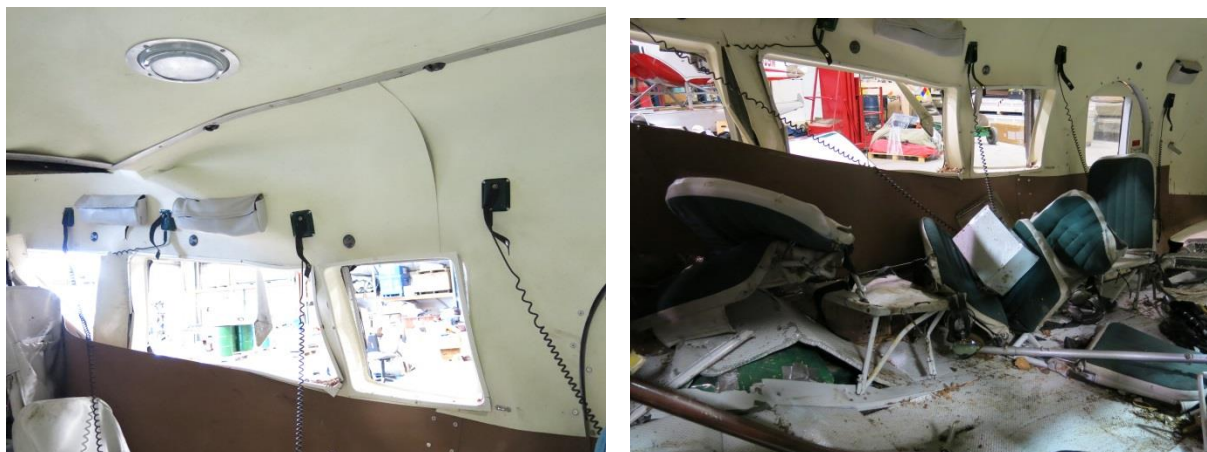
Head sets were connected to R1, R2, R3, and the R4 connectors. Head sets were not connected to the left side and found in the aft of the airplane.

Photograph 48 - Headsets connected to the right side of the airplane.

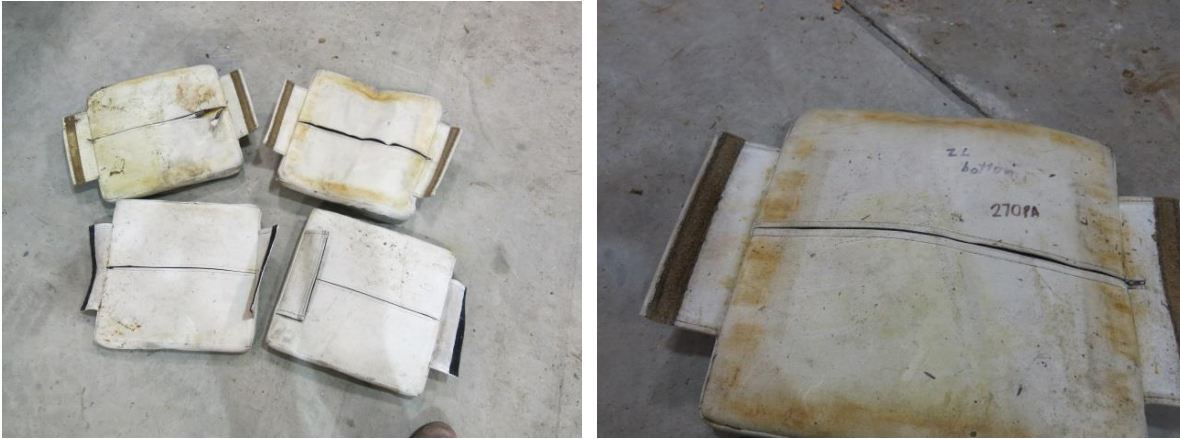
There were 6 seat bottom cushions found. 4 of the cushions were not labeled. They were found outside the airplane.

Photograph 51 - Seat Cushions.

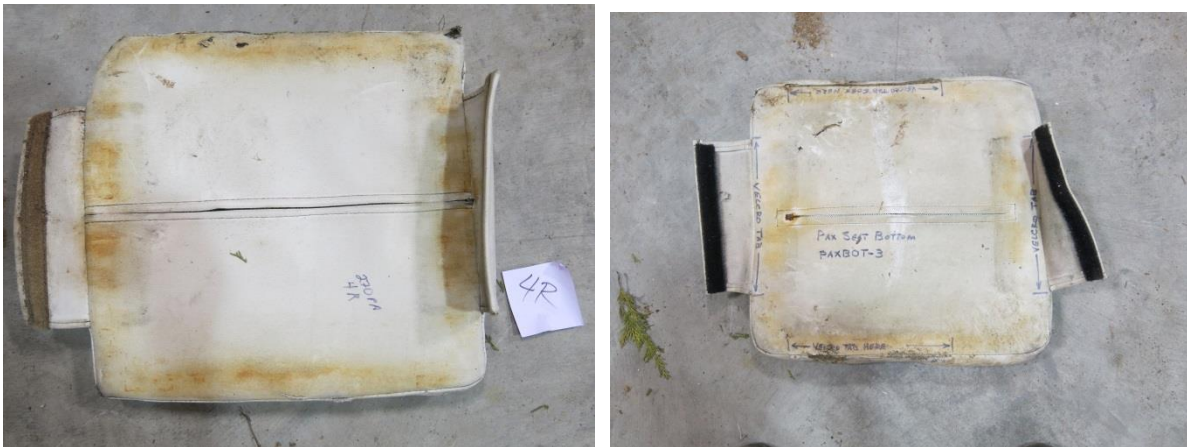
Photograph 52 - Seat Cushion.

A seat cushion for seat 3 was found outside the airplane. The seat cushion was marked “Pax seat bottom, Pax Bot-3”. It was unclear if the seat cushion belonged to R3 or L3.

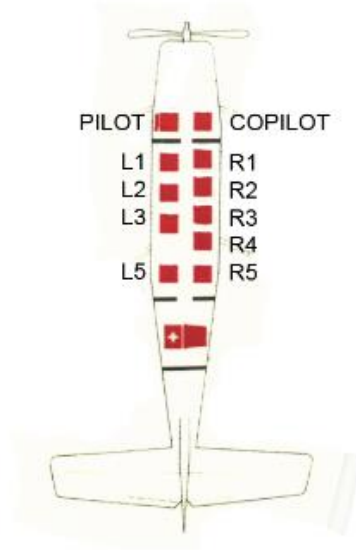
Information from autopsy reports, seat documentation, photographs from first responders at the accident site, and video/photographs recovered from onscene devices was used to determine occupant seating locations. According to this data, the pilot was seated in the left cockpit seat, and shown as “PILOT” in figure 1. A passenger was seated in the “COPILOT” seat

and the 7 other passengers were seated in the passenger seats shown in figure 1 as L1-L5 and R1-R5.

Figure 6- Occupant seat location.
