NATIONAL TRANSPORTATION SAFETY BOARD Office of Aviation Safety Washington, D.C. 20594

ADDENDUM 1

SURVIVAL FACTORS GROUP FACTUAL REPORT OF INVESTIGATION

I. <u>ACCIDENT</u> : DCA11IA040

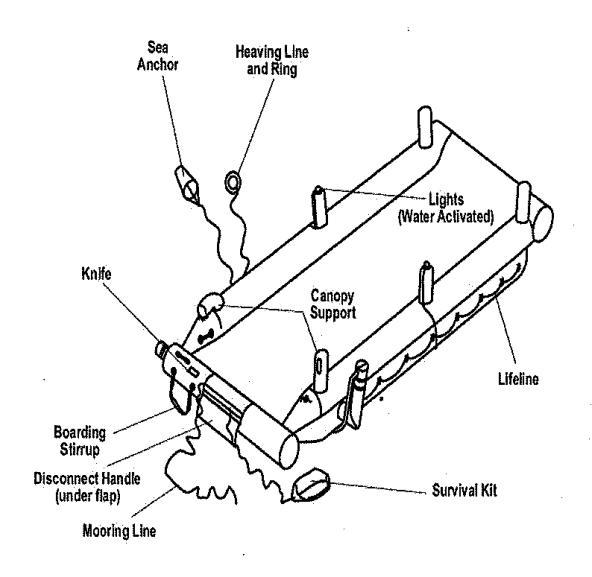
Figure 1. A320 Slide/Raft

The 1R emergency evacuation slide and pack board were removed from the shipping crate and examined on the shop floor. Figure 1 shows a diagram of the A320 emergency evacuation slide/raft nomenclature highlighting the location of the sea anchor.
