C. SUMMARY

On August 5, 2008, about 1941 Pacific daylight time,² a Sikorsky S-61N helicopter, N612AZ, impacted trees and terrain during the initial climb after takeoff from Helispot 44, located at an elevation of about 6,000 feet in mountainous terrain near Weaverville, California. The airline transport pilot, the safety crewmember and seven firefighters were killed; the commercial copilot and three firefighters were seriously injured.³ Impact forces and a postcrash fire destroyed the helicopter. The helicopter was being operated by the United States Forest Service (USFS) as a public flight to transport the firefighters from Helispot 44 to another location. The helicopter was registered to Carson Helicopters, Inc. (CHI) of Grants Pass, Oregon, and leased to Carson Helicopter Services, Inc. (CHSI) of Grants Pass. The USFS had contracted with CHI for the services of the helicopter.⁴ Visual meteorological conditions prevailed at the time of the accident, and a company visual flight rules flight plan had been filed.

D. DETAILS OF THE INVESTIGATION

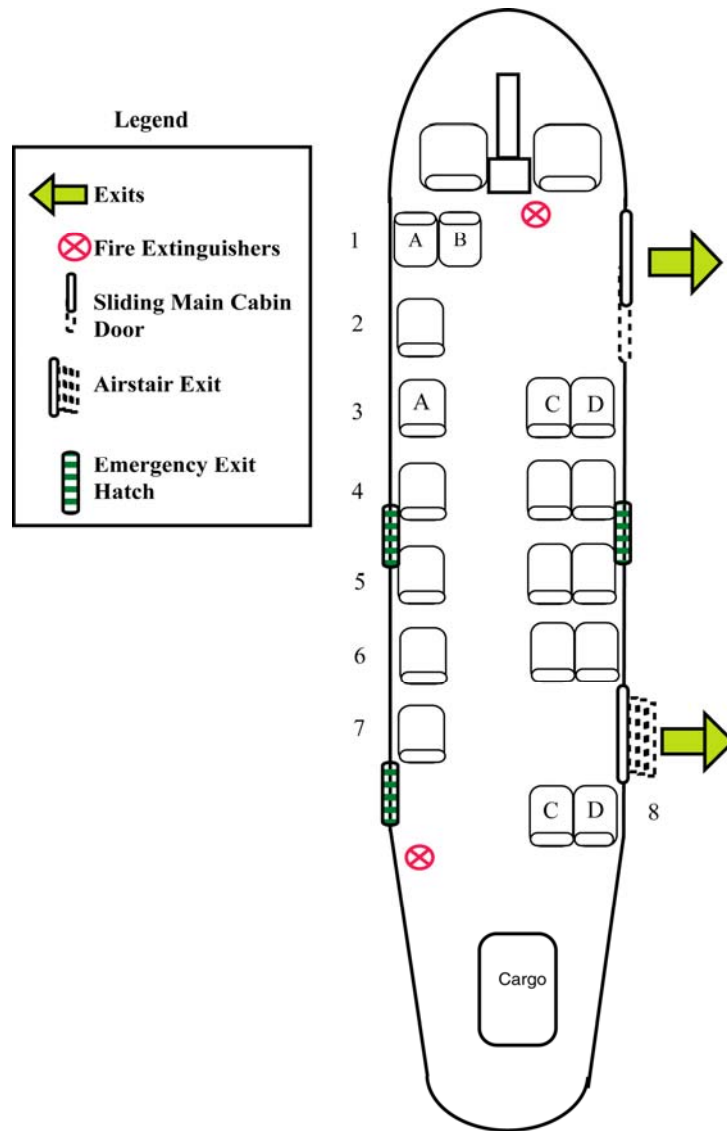
Figure 1 N612AZ Cabin Diagram

N612AZ was equipped with a pilot seat, a co-pilot seat and 18 passenger seats. There were five rows of forward facing double passenger seats on the right side of the cabin. A double crewmember seat faced aft on the forward left side of the cabin and six rows of forward facing single passenger seats on the left side of the cabin. The aft facing double and first single seats, on the left side of the cabin, were designated for helicopter crewmembers. An aisle in the center of the cabin separated the passenger seats on either side of the cabin. Two main entry doors were located on the right side of N612AZ and two emergency exit hatches were located near the center of the cabin on each side of the fuselage. A third emergency exit hatch was located on the left side of the aft fuselage. The helicopter was configured with 20 windows⁵ (one on either side of the cockpit, and 10 on the left and 8 on the right side of the fuselage) equipped with removable rubber seals that allowed the window frames to be utilized as emergency exits. See Figure 1 for N612AZ's cabin diagram.

in the helicopter and he noted that the Forest Service HECM got into the seat that he described as the seat identified as 1A on Figure 1
