NATIONAL TRANSPORTATION SAFETY BOARD
OFFICE OF AVIATION SAFETY
WASHINGTON, D.C.

**SURVIVAL FACTORS SPECIALIST'S FACTUAL REPORT OF
INVESTIGATION**

A. ACCIDENT : ERA12FA056
LOCATION : Key West, Florida
DATE : October 31, 2011
TIME : 1940 eastern daylight time (edt)¹
AIRPLANE : Gulfstream G-150, N480JJ

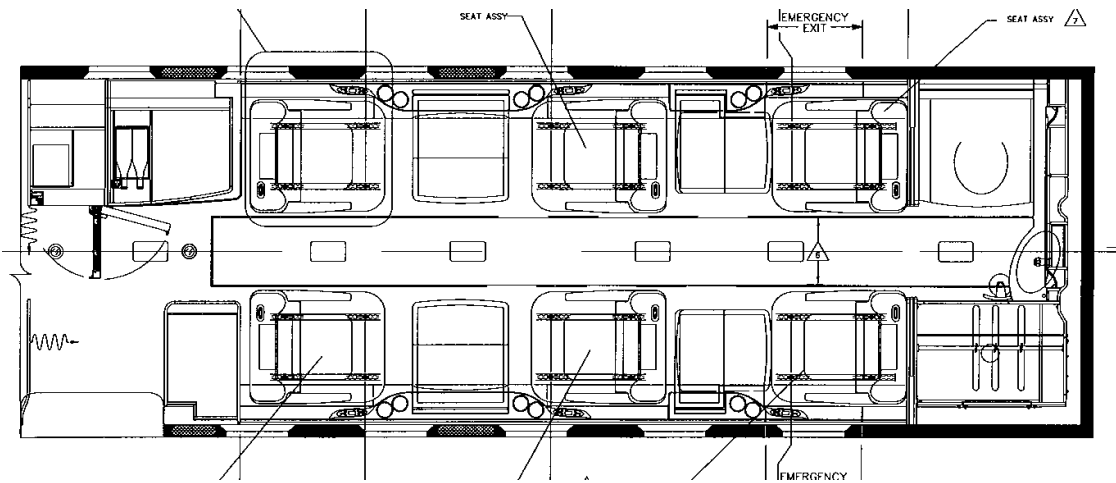
The accident airplane was configured with two pilot seats and six passenger seats (see figure 1). Two passenger seats were aft-facing and four passenger seats were forward-facing. For the purpose of this report, the seats are identified by row number and position on the left (L/H) or right side (R/H) of the cabin. Row 1 is at the front of the cabin and includes the aft-facing seats designated L/H #1 or R/H #2. Row 2 is the center row of seats the seats are designated L/H #2 or R/H #2, and row 3 is the aft row of seats designated L/H #3 or R/H #3.

Figure 1
Cabin configuration (front of airplane on left).
