NATIONAL TRANSPORTATION SAFETY BOARD  
Office of Aviation Safety  
Washington, DC 20594

**SURVIVAL FACTORS GROUP CHAIRMAN'S FACTUAL REPORT**

Operator : Comair, Inc.  
Aircraft : Bombardier CL-600-2B19 [N431CA]  
Location : Lexington, KY  
Date : August 27, 2006  
Time : 0609 Eastern Daylight Time<sup>1</sup>  
NTSB # : DCA06MA064

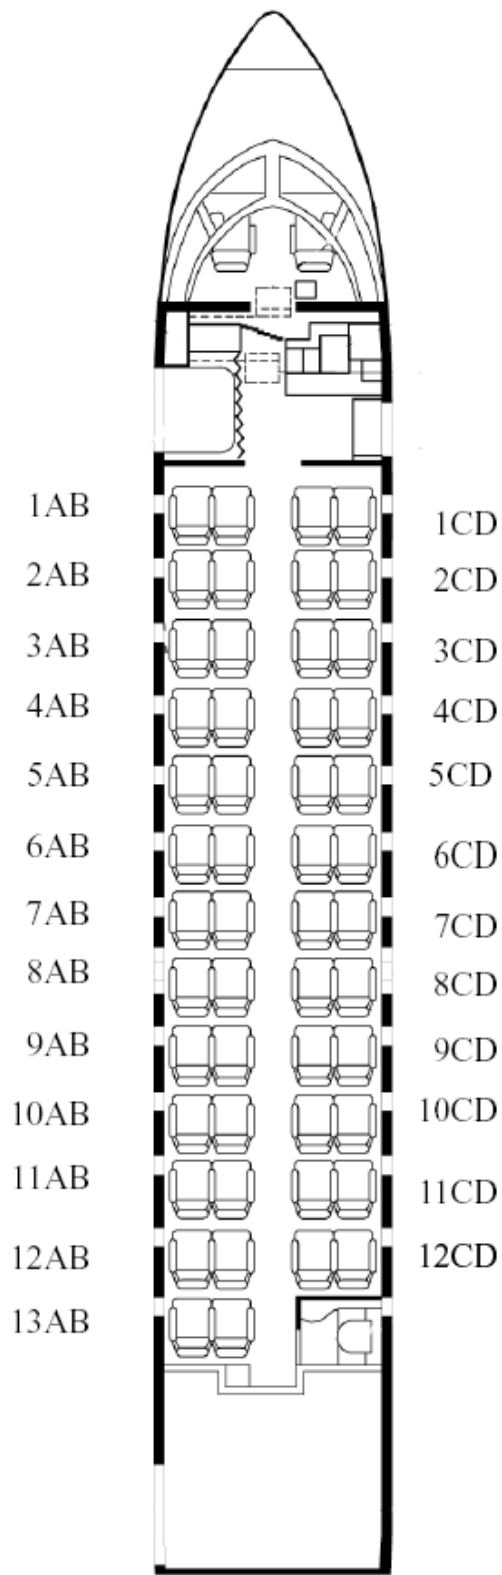
**Figure 1. Cabin Configuration**

The airplane was configured with 50 coach-class passenger seats, two cockpit flight crew seats, one cockpit observer's seat, and a retractable, aft-facing, single flight attendant jumpseat mounted on the forward bulkhead. (See Figure 1)

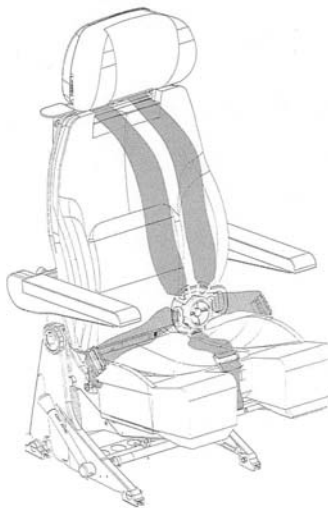
**Figure 2. Aircraft Interior Products model 145 flight crew seat**

The first officer's seat was identified in its standard position in the cockpit wreckage. It was examined in detail on November 20, 2006 in a hangar in Griffin, GA. The seat's data plate contained the following information<sup>4</sup>:

Goodrich  
1405045511AA  
Manufacture date: 04-09-03  
TSO C-127A

The first officer's seat was separated in two, with one piece consisting of the main seat structure (including the seat back and the left-side portion of the seat base) and a second piece consisting of the remaining portion of the right side of the seat base. The left forward and aft seat legs were attached to the left floor rail and a fractured section of floor structure (in addition to the seat back). The right forward and aft seat legs were also attached to a floor rail, which was attached to fractured floor structure. The left and right lap belts were attached to each side of the main seat structure, and the rotary buckle (attached to the right lap belt) was operable. The belt was marked "AmSafe, conforms to FAA TSO C-114." The shoulder restraints were not observed while on-scene and were not present during the November 20, 2006 examination. The seat pan and crotch strap were also not observed during the November 20, 2006 examination; however, while on-scene, a seat pan from a pilot seat (with attached cushion) was documented on the ground three feet forward of the cockpit. The crotch strap was attached to the seat pan. The seatbelt buckle insert fitting on the crotch strap was not damaged.

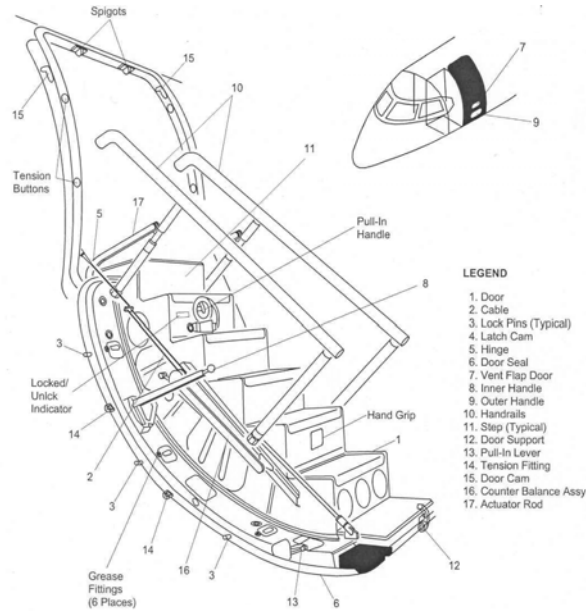
**Figure 3. Diagram of the main cabin door  
(from Bombardier maintenance training manual)**

Upon arrival on-scene on August 27, 2006 the main cabin door was noted to be closed and intact in the door frame.<sup>6</sup> It was blackened by heat and a majority of the paint had blistered and peeled from the door's exterior. There was an approximately 1'x 1' hole in the lower center portion of the door in the area of the exterior door handle. The interior portion of the door had been consumed by fire; however, it was observed that four of the lock pins were engaged in the door frame in the closed position. The interior door handle had been consumed by the fire.

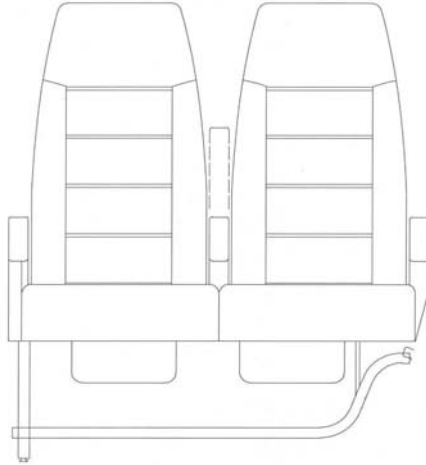
**Figure 4. B/E Aerospace 926 series tourist seats (front view)**

The seats and restraint systems throughout the cabin were severely damaged or destroyed by impact and fire. All of the identifiable seats were fragmented and the pieces were documented lying on the cabin floor, or on the ground outside the cabin area, except where noted below. No data tag information was identified on any of the fragments<sup>7</sup>. Fracture surfaces on the seat fragments were covered by soot and/or were melted. The webbed belts on the restraints were almost entirely consumed by fire. Some short sections of unburned belt material were found throughout the cabin; however, all of these sections exhibited some fire damage and/or melting. Longitudinally fractured sections of floor track of varying lengths were found throughout the cabin. None of the seat track sections showed evidence of lip damage from seat attachment fittings. Some of the seat legs remained attached to sections of floor track while other were found lying loose in the cabin area.

<sup>7</sup> According to Comair, all of the passenger seats were manufactured by B/E Aerospace (926 series tourist seats). They were manufactured to TSO-C127.
