Survival Factors Factual Report Attachment 1

Railroad:National Railroad Passenger Corporation (Amtrak)TrainTrain 89Location:Chester, PennsylvaniaDate:April 3, 2016Number:DCA16FR007

Car 82524 – Train 89 – Investigation

Car 82993 – Train 89 – Investigation

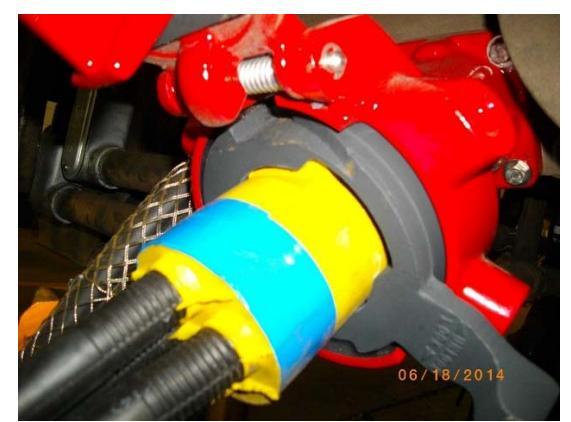
Photo – 480V Trainline Plug and Receptacle

480 Volt, 3-phase, 60Hz power is generated by the locomotive, and carried to the first car in the train by four, 400 Amp jumpers. Identical jumpers at the other end of the car pass power to the rest of the train.
