**NATIONAL TRANSPORTATION SAFETY BOARD
OFFICE OF HIGHWAY SAFETY
WASHINGTON, D.C.**

**SURVIVAL FACTORS GROUP CHAIRMAN'S
FACTUAL REPORT**

Location: Northbound US Highway 83 (US-83) near milepost 553.4 in Uvalde County, 6.5 miles north of Concan, Texas

NTSB #: **HWY17MH011**

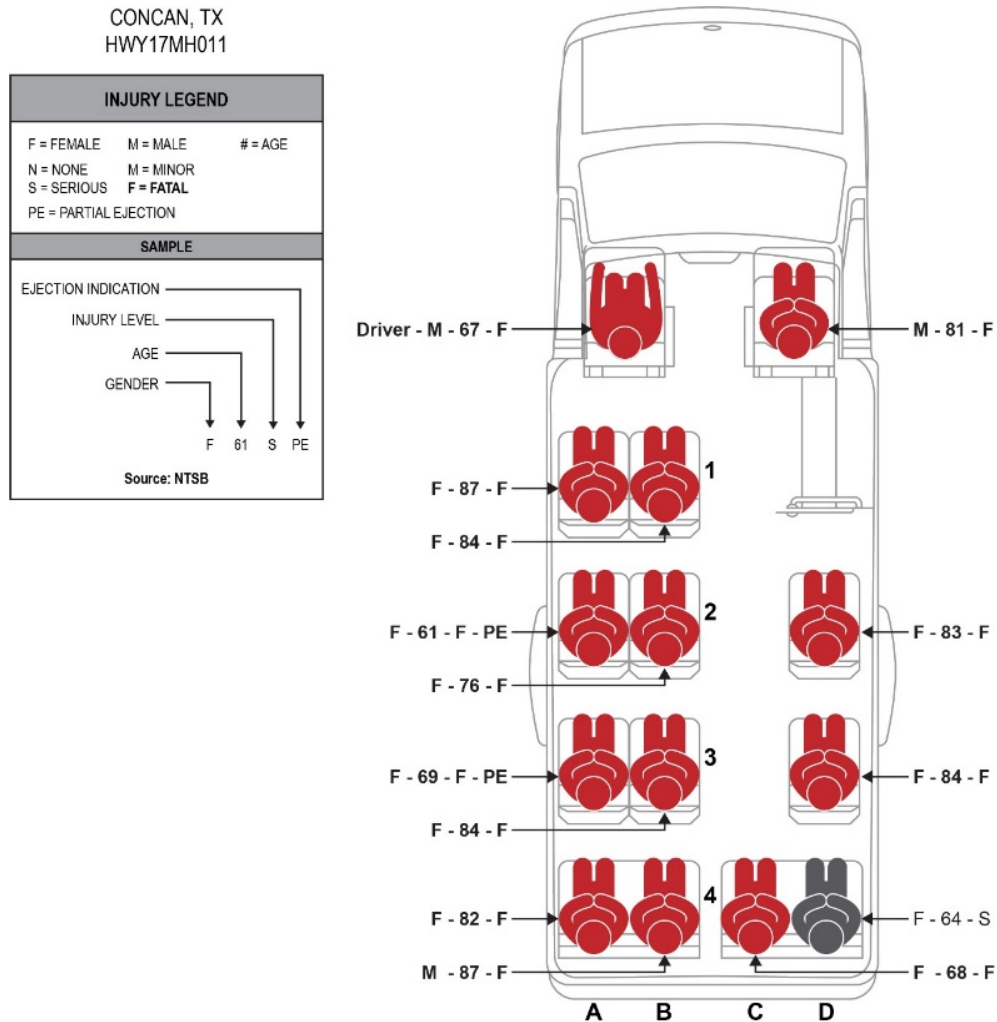
Figure 9. Seating Chart

A seating chart was established based on the numbering system developed by a volunteer firefighter and mortician who responded to the crash as a firefighter. This volunteer numbered the fatalities based on their seating position and identified those occupants who initially survived the crash and were worked on by emergency responders. The seating chart is shown in **Figure 9**.
