**SURVIVAL FACTORS GROUP CHAIRMAN'S
FACTUAL REPORT**

HWY17MH007

**NATIONAL TRANSPORTATION SAFETY BOARD
OFFICE OF HIGHWAY SAFETY
WASHINGTON, D.C.**

Location: Eastbound Frederick Avenue between South Monastery Avenue and South Morley Street, Baltimore, Baltimore County, Maryland

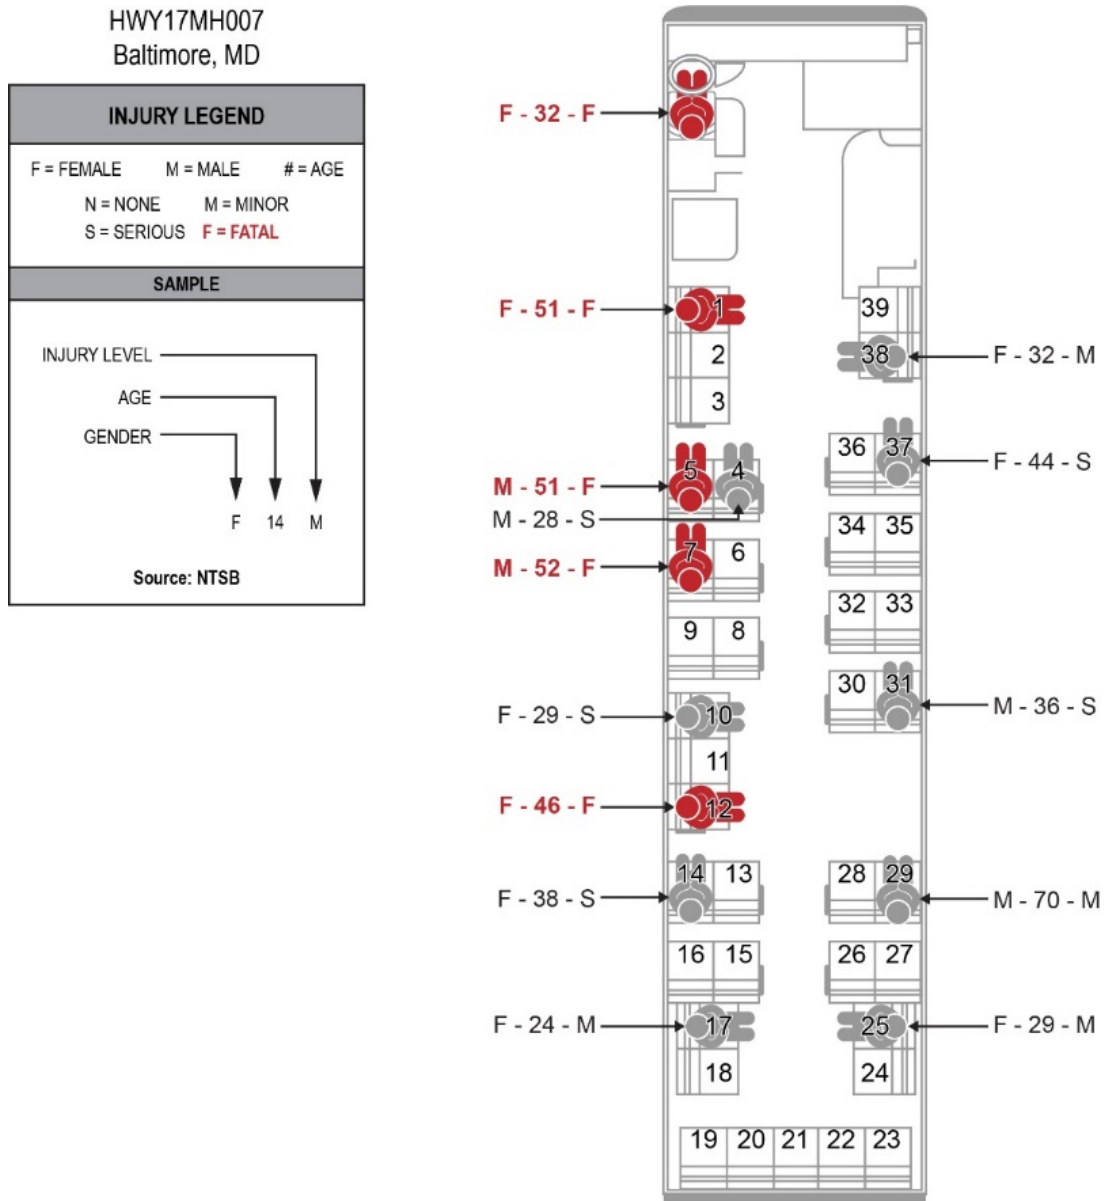
Figure 6. MTA Bus Seating Chart

yellow handrails down the entire left side. All the seats on the right side (seats 24-39) remained attached to floor and sidewall as did the last row of (seats 19-23) across the back of the bus. Seat numbers are shown on the seating chart **Figure 6**.

The interior seating configuration was transit style with five inward facing seat rows (three on left side two on right side) and eleven forward facing rows (five on left side and six on the right side). The very last row of the bus extended from side to side with five forward facing seats. Refer to **Figure 6**. MTA Bus Seating Chart for layout configuration.

The transit bus was occupied by the driver and thirteen passengers at the time of the crash. Based on interviews with five passengers (in seats 37, 31, 25, 14, and 10) interior video, autopsy reports, and police post-crash photographs, a seating chart (Figure 6) was established.^{15, 16}

The transit bus driver and four transit passengers that sustained fatal injuries were all seated on the left side of the transit bus, in the area of impact. Refer to **Figure 6**. MTA Bus Seating Chart for the exact seat positions of the deceased.

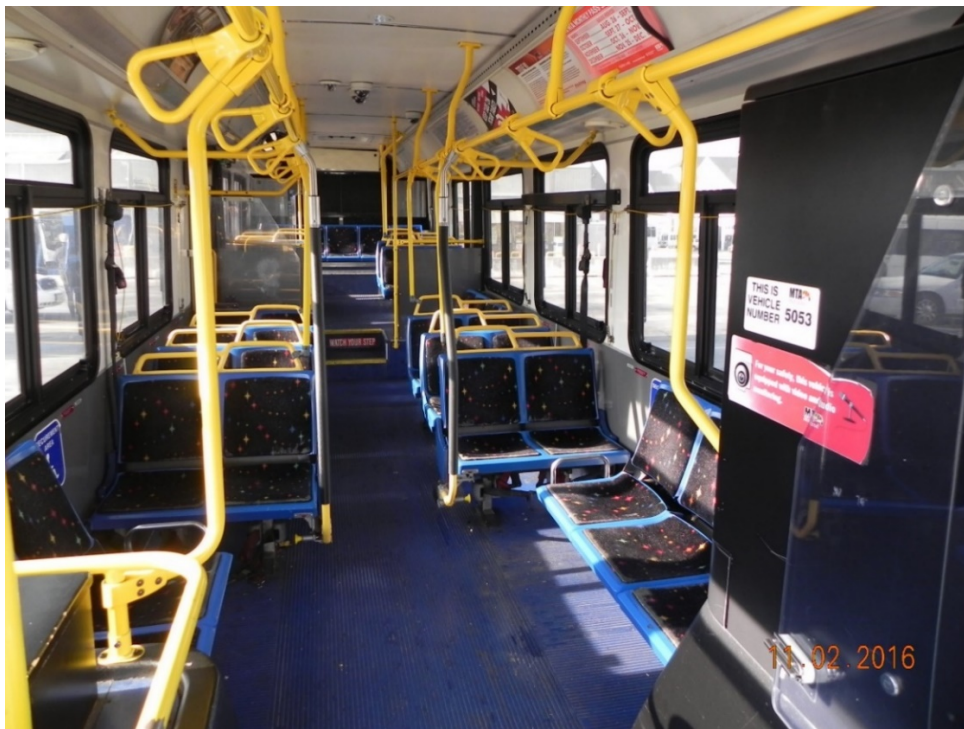
Figure 7. Interior view of exemplar New Flyer transit bus looking from front to rear. **Note:** Seat configuration.

The driver's seating area was closed off on the entry door area by a thick clear Plexiglas shield that locked from the inside. A portion of the plexiglass shield is shown to the far-right side of the **Figure 7**, where it is seen attached to the radio box behind the driver's seating area. The driver seat was air cushioned and equipped with a lap and shoulder belt. All 39 seats in the transit bus were constructed of the same molded fiberglass shell and high-strength thermoplastic back as on the accident bus.
