NATIONAL TRANSPORTATION SAFETY BOARD

Group Chairman's Factual Report

SURVIVAL FACTORS

DCA16FA013

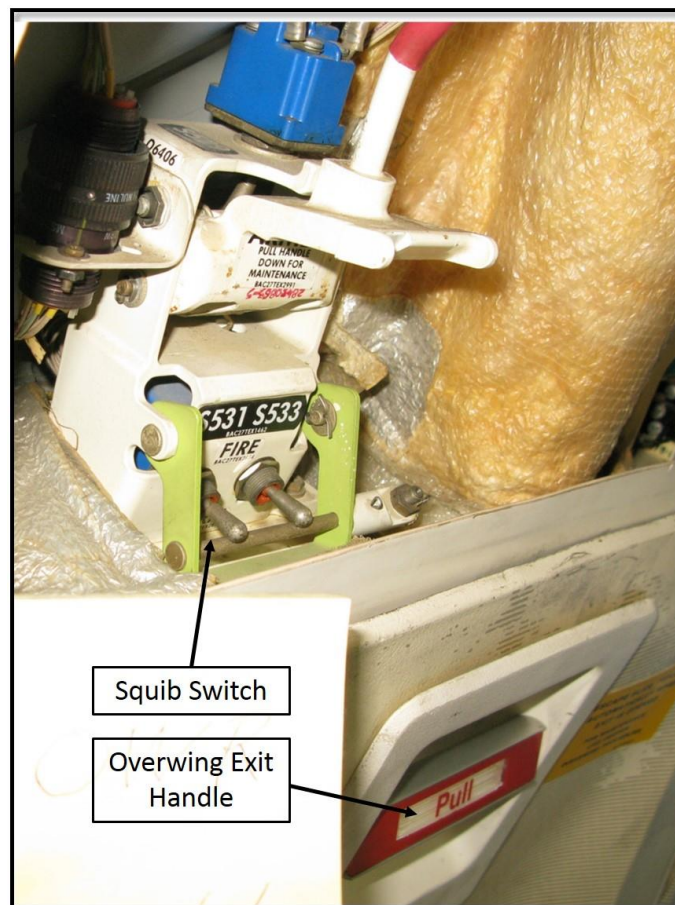
Photograph 1 – Right side squib switch and exit handle.

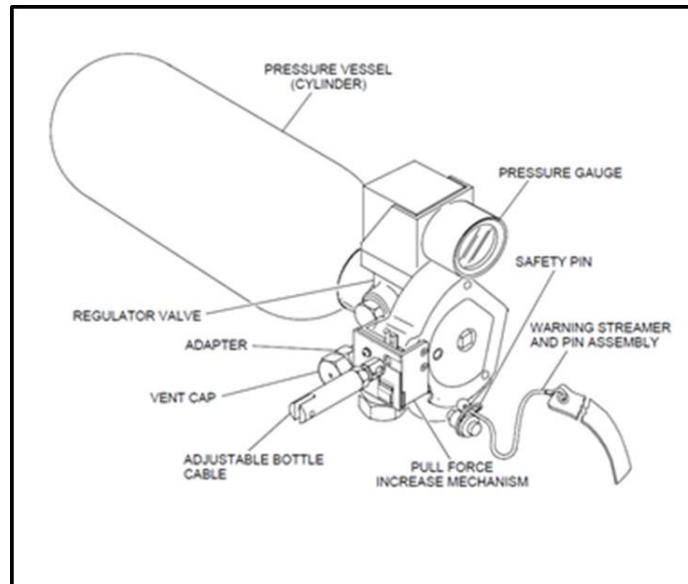
Figure 3 – Reservoir assembly.

The right reservoir assembly (figure 3) was visually inspected, weighed and pressure tested for remaining gas in the reservoir at United Technologies Aerospace Systems (UTAS) facility in Phoenix, AZ on November 19, 2015.

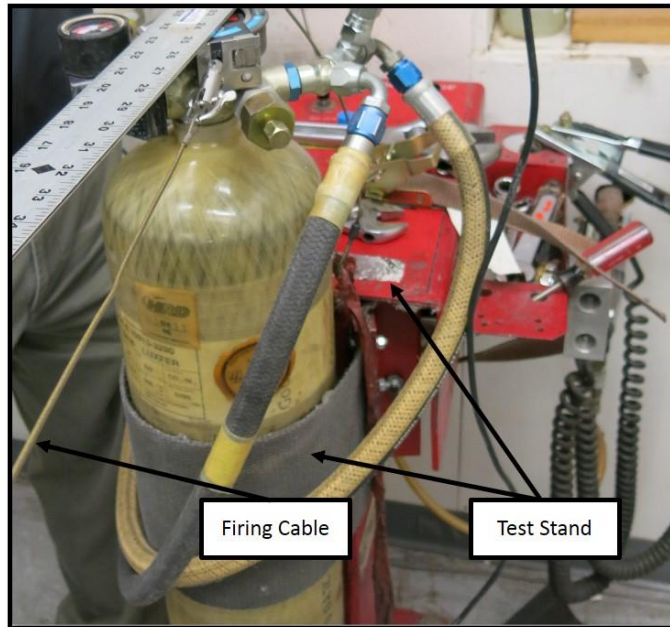
Photograph 10 – Reservoir assembly mounted in the test stand.

The reservoir assembly was mounted vertically in the test stand belt vise and prepared for a firing cable manual pull force test and a regulator output trace (photograph 10).

The safety pin was removed and the firing cable was pulled at an equivalent angle to that seen on the aircraft between the bell crank and the PFIM (approximately 15 degrees). It was pulled until the analog pull force gauge read 50 pound-force (lbf), which was 5 lbf above the maximum Goodrich Component Maintenance Manual (CMM) 25-61-24 limit of 45 lbf. At no time during the test did the firing cable actuate the valve.

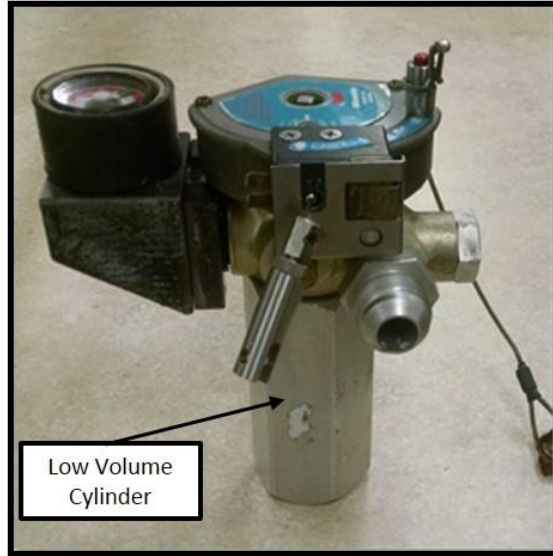
Photograph 11 – Regulator valve installed on low volume cylinder.

The empty cylinder was inspected for foreign object debris (FOD) with no findings noted. The valve was examined from the bottom which gave partial visibility to the ball and ball seat with no anomalies noted. The regulator valve was then installed on a low volume cylinder (photograph 11) as a holding fixture to complete further bench tests.

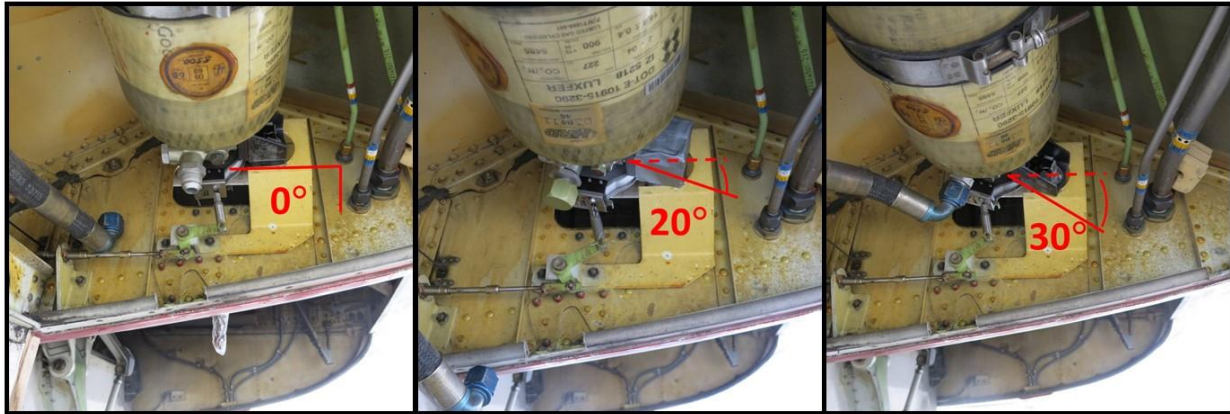
Photograph 15 – Reservoir valve test positions.

The reservoir valve was tested in four positions, starting with a baseline of zero degrees. The reservoir valve was then turned to the right for the remaining tests until it reached the worst case scenario of 30 degrees. (photograph 15):

- 0 degrees
- 18 degrees
- 20 degrees
- 30 degrees
