**NATIONAL TRANSPORTATION SAFETY BOARD**

**Group Chairman's Factual Report**

**SURVIVAL FACTORS**

**DCA17FA076**

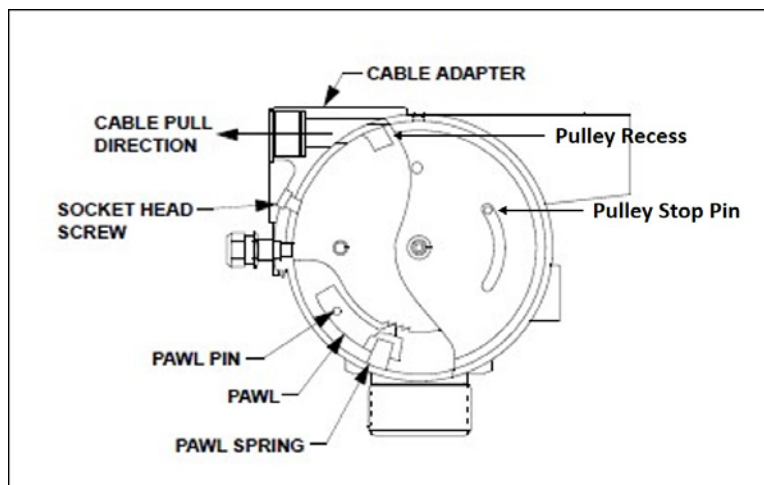
**Figure 6 – Inflation valve.**

The operation of the inflation valve (figure 6) is based on a 'ball type' valve design. On the valve assembly, a pulley is used to turn the internal ball from a closed position to a fully open position when release of the inflation gases from the reservoir is required to inflate the evacuation slide. When the inflation valve is rigged for use, the inflation cable is inserted into the pulley housing and wound onto the pulley as the valve is moved from an open position to a closed position. With the valve closed and the inflation cable in place, the reservoir is then charged with the appropriate amount of compressed gas. The reservoir and valve assembly is then connected to the evacuation slide and the system is packed. When the evacuation system is deployed, the packed slide releases below the aircraft door. The inflation cable is manually pulled and then releases out of the pulley housing on the inflation valve. The withdrawal of the inflation cable rotates the pulley in the inflation valve to the open position, releasing the inflation gas into the slide assembly and inflating the evacuation slide.

The slide had partially deployed during the evacuation (photograph 4) with no evidence of gas flow from the RVA into the slide.

The RVA was inspected and found with a fully charged reservoir with the valve pulley in the closed position. The manual inflation release cable (pulled by the flight attendant during the evacuation) was located inside the shipping box. The cover plate on the valves internal mechanism was removed to reveal the pulley, pulley recess, lock pin and pawl<sup>11</sup> (photograph 5).

<sup>11</sup> The pawl was worn but maintained its ratchet function to keep the valve closed.

A test gauge was attached to the outlet fitting and the pulley was rotated to the “open” position by withdrawing the valve release cable. The pulley motion appeared smooth with no hesitation and the system pressure reading of 2,832 pounds per square inch gauge (psig) was noted on the test gauge. The expected value was 2,840 psig. per the assembly section of component maintenance manual<sup>12</sup> (CMM). The valve pull force reading was 15 lbs., the expected value per the testing section of CMM was 15 lbs. max. The pulley was rotated to the “closed” position and the RVA was re-attached to the slide assembly. A ‘floor run’ inflation of the slide assembly was performed by withdrawing the valve release cable from the RVA. The slide successfully inflated. The resulting internal slide tube pressure was 2.72 psig. The expected value per testing section of CMM is 2.3 to 3.25 psig.

Zodiac Aerospace made modifications to the CMM valve testing procedures to ensure the cable ball is retained in the pulley recess in revision #29, dated July 14, 2017. Attachment 3 shows the CMM revision. The CMM was revised on page 711 (D) (5) to read, *Ensure valve is in the fully open position. Install ball end valve release cable (50B, 50D, 50F, 50I, 50J, IPL Figure 1; 50A 50B, 50C, IPL Figure 2) into pulley and cable adapter (260) until it is ~~pulled~~ fully inserted into pulley.* Page 711 (D)(6) adds *Verify that the valve release cable is pulled into the pulley housing as the pulley is rotated to the valve closed position.* (D)(7) is replaced with *Gently pull or tug on the valve release cable. Looking closely around the gaps in the valve cover assembly on the inflation valve, verify that there is slight movement of the pulley and the lock pin due to the movement of the valve release cable. The valve release cable should not pull free of the inflation valve assembly. If the valve release cable can withdraw from the valve assembly, either the lock pin is not fully engaged or the inflation cable was not fully inserted into the pulley during the arming procedure. Repeat steps (5) and (6) to resolve unacceptable cable movement.*
