**SURVIVAL FACTORS GROUP CHAIRMAN'S
FACTUAL REPORT**

HWY17MH009

**NATIONAL TRANSPORTATION SAFETY BOARD
OFFICE OF HIGHWAY SAFETY
WASHINGTON, D.C.**

Location: 300 block of Talley Road, Chattanooga, Hamilton County, Tennessee
Vehicle #1: 2008 Thomas Built School Bus
Operator #1: Durham School Services LP of Warrenville, IL
Date: November 21, 2016
Time: Approximately 03:20 p.m. Eastern Standard Time (EST)
NTSB #: **HWY17MH009**

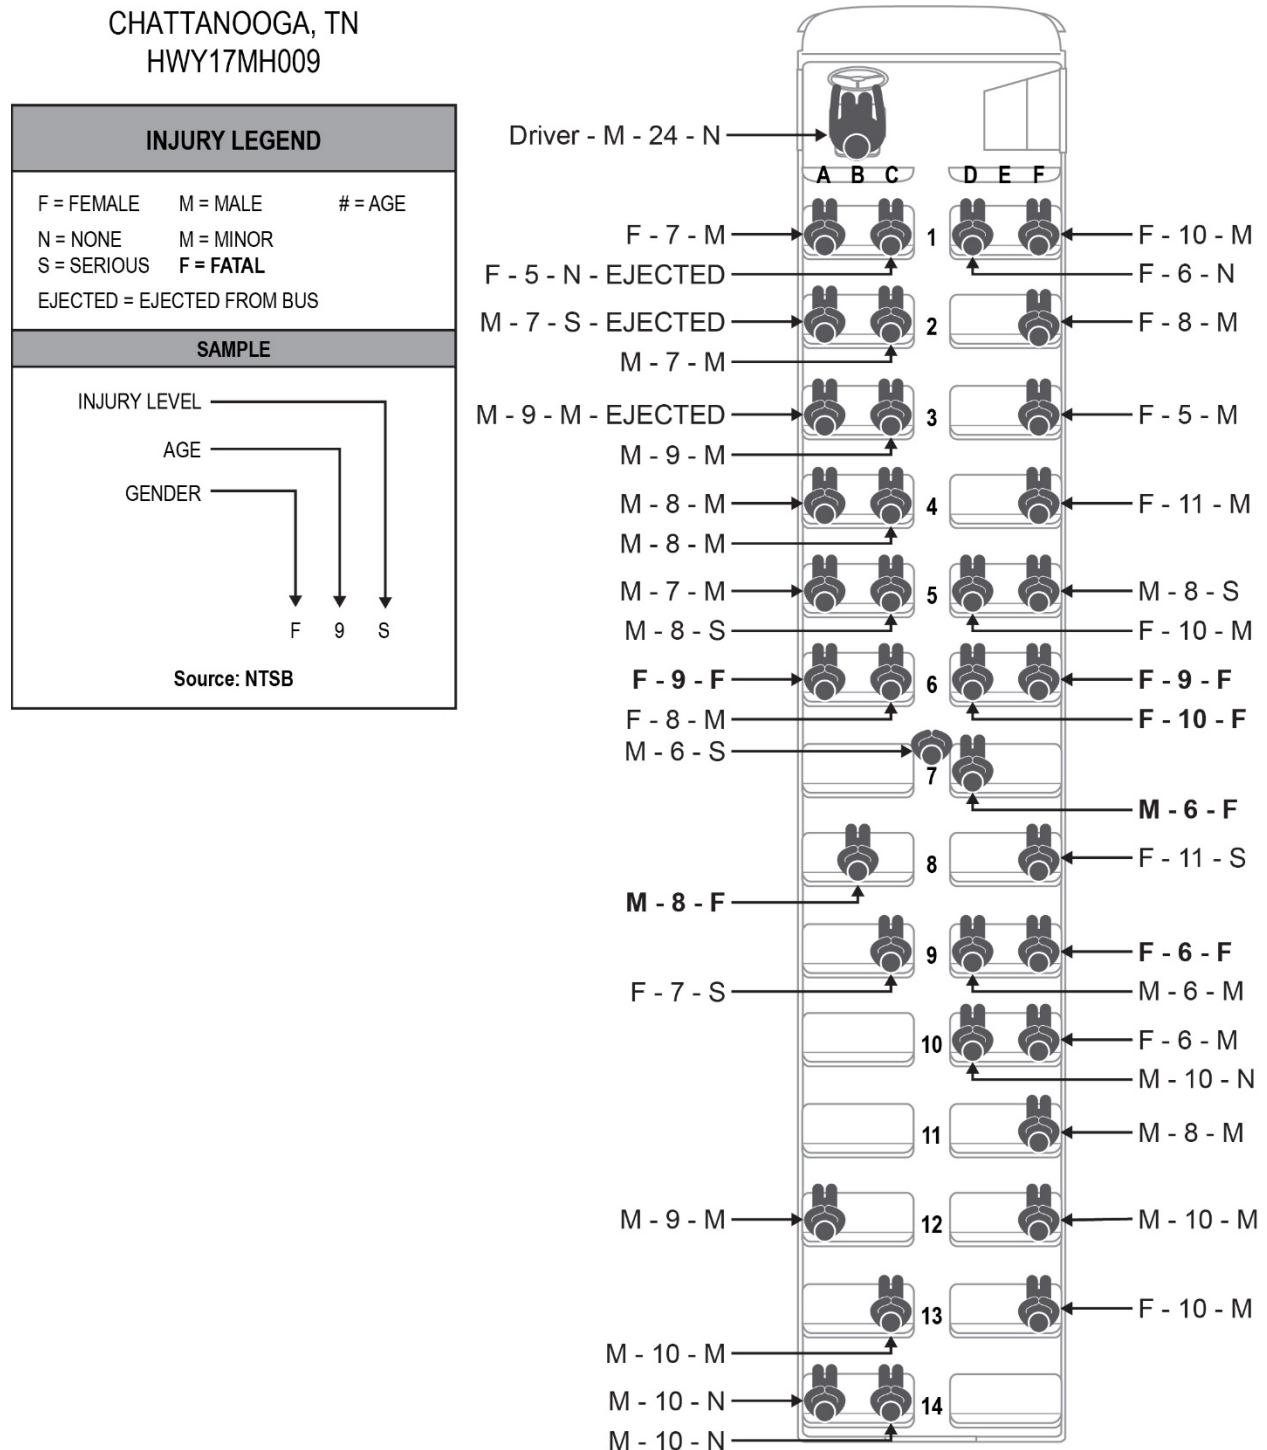
Figure 6: School Bus Seating Chart

The seat position of the passengers just prior to the crash was established based on the internal school bus video evidence. The process involved first identifying the passengers that boarded the bus, including making note of their clothing or other identifying features that were visible in the video. Each student's identity was also confirmed with help from the school staff. Second, the initial seating position was established, and then movements of students were noted

prior to the crash, with a final identification of the seat position just prior to the crash, as provided in Figure 1. Note that the passenger reference number corresponds to the number assigned in Section 2 of this report.
