**SURVIVAL FACTORS GROUP CHAIRMAN'S
FACTUAL REPORT**

HWY17MH015

**NATIONAL TRANSPORTATION SAFETY BOARD
OFFICE OF HIGHWAY SAFETY
WASHINGTON, D.C.**

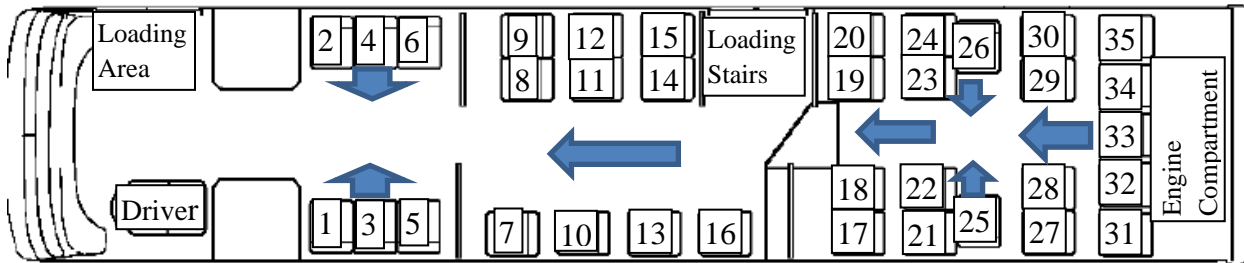
Figure 10: Transit Bus Interior Layout

interior layout is shown in figure 10, with passenger seat positions numbered and arrows depicting the direction of the groups of seats.

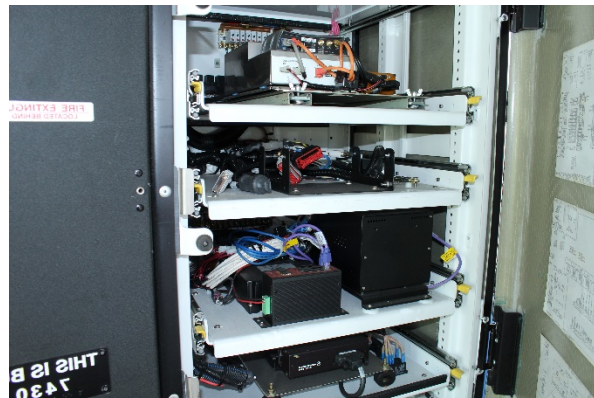
Figure 12: Transit Bus Electronics Cabinet

The driver seat compartment was not damaged. The driver seat was a suspended seat with a two point lapbelt. The lapbelt was found buckled in place, as shown in figure 11. Behind the driver's compartment was an electronics cabinet, which contained equipment for the video camera system and other electronics, as shown in figure 12 with the door of the cabinet open.

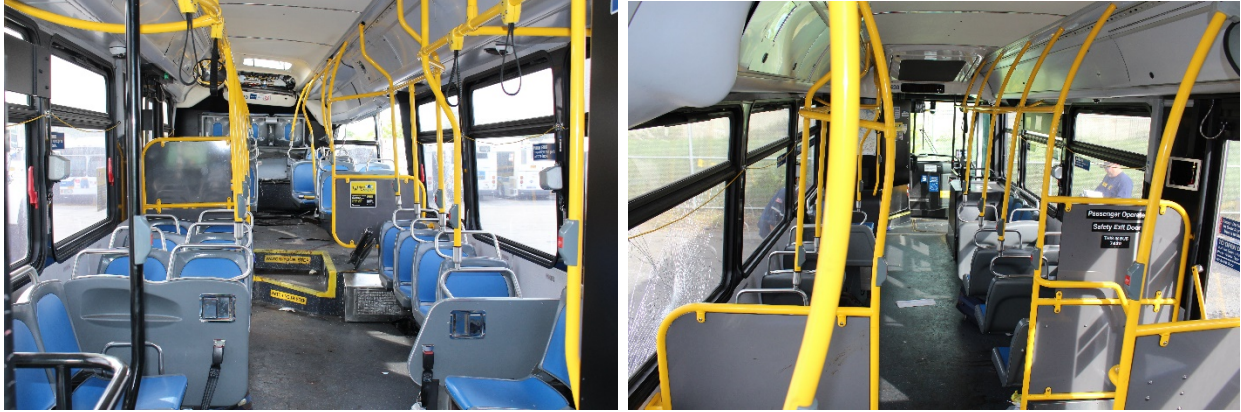
Figure 13: Transit Bus Interior, Looking Aft Figure 14: Transit Bus Interior, Looking Forward

The transit bus interior seating arrangement is shown in Figures 13 and 14. Figure 13 is a view from the front looking back, and Figure 14 is a view from the back looking forward. Behind the electronics cabinet were three inward facing seats. There were barriers separating the inward facing triple seat assemblies from the seats further aft. The triple seat assemblies are labeled 1,3,5 (left side) and 2,4,6 (right side) in Figure 10. These seats fold up to allow for wheel chair access, and wheel chair tie down straps are mounted to the floor and the barriers in this area. There were also barriers separating the loading stairways and elevated seating area. The last row of seats was comprised of five forward facing seats. The three center seats were one assembly which was hinged at the top of the seatbacks, which allowed the front of the seats to be lifted upward giving access to the engine compartment from the interior of the bus.

The seats near the front, which included the set of three inward facing seats (1,3,5) and all four single-place forward facing seats (7, 10, 13, 16) were undamaged. The first elevated double seat on the left side (seat positions 17, 18) was intact, and the yellow metal support bar was shifted forward and upward so that bar was raised slightly out of center metal securement collar. There was a small amount of gray hair found on rear seatback. The second elevated row of double seats (21, 22) were intact, but the sidewall of the bus was deformed and bowed outward adjacent to the window seat.
