NATIONAL TRANSPORTATION SAFETY BOARD

Survival Factors Group Chairman's Factual Report

ERA18MA099

Operator : Liberty Helicopters
Airplane : Airbus Helicopter AS350B2 [N350LH]
Location : New York, NY
Date : March 11, 2018
Time : 1908 eastern daylight time (EDT)

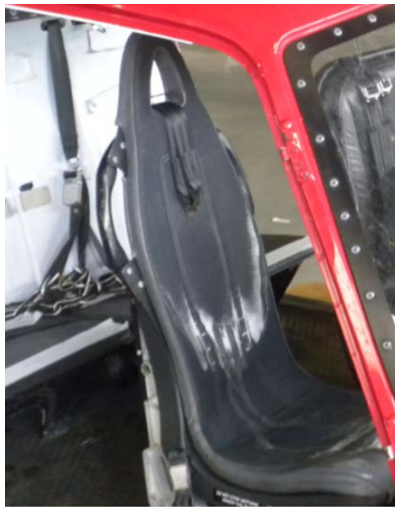
Photograph 2- Pilot seat.

The helicopter was equipped with a pilot seat installed on the right side of the cockpit. The seat manufactured by Zodiac Seats France (formerly Sicma Aero Seat) was designed to comply with TSO-C127A. The seat was attached to seat tracks mounted to the cockpit floor and was adjusted to full rearward position. There was no indication of vertical stroking. There was a data tag that read:

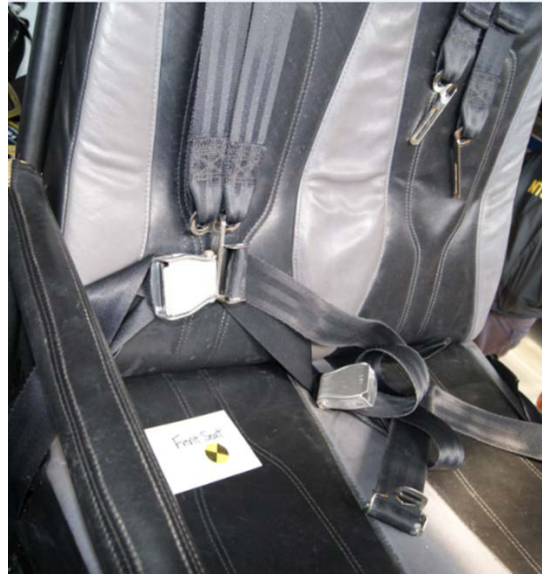
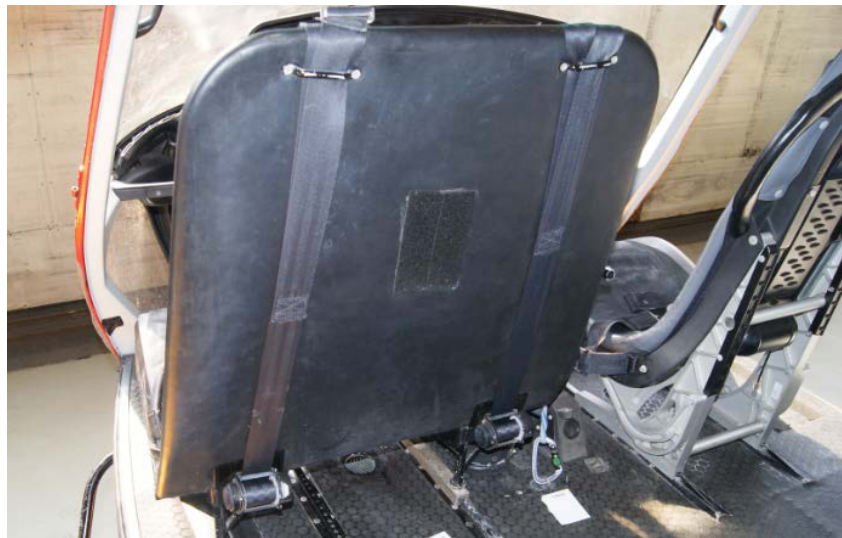
Photograph 3- Front double bench seat.

Photograph 4- The back of the front double bench seat.

The front double bench seat was manufactured by Dart Aerospace. It was adjusted to the furthest forward position. The top of the armrest to the floor measured 19.75". The distance from front seatback to the front of the rear bench seat was 20". The front seat cushion measured 16" deep by 27" wide. The seatback cushion thickness was 2-3". The horizontal distance from the upper portion of the cushion to airframe was 16.5". The vertical distance from front corner of cushion to airframe was 21" and the horizontal distance from the front of the seat bottom cushion to airframe was 9.5".

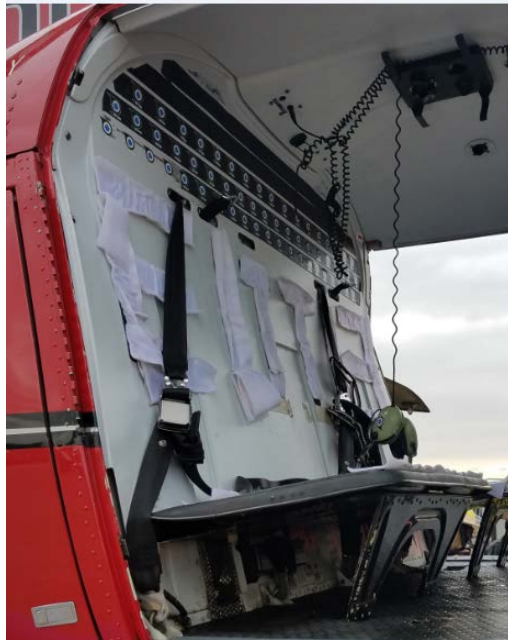
Photograph 5- Picture showing rear double bench seats.

The two rear bench seats were manufactured by Airbus and each consisted of two seating positions. Each bench seat was attached to the floor of the helicopter with 2 screw points. The aft seat tube was attached to the rear bulkhead via a locking yoke. Each bench measured 32.5" across and had a height at the front edge of 8.25" from the floor.

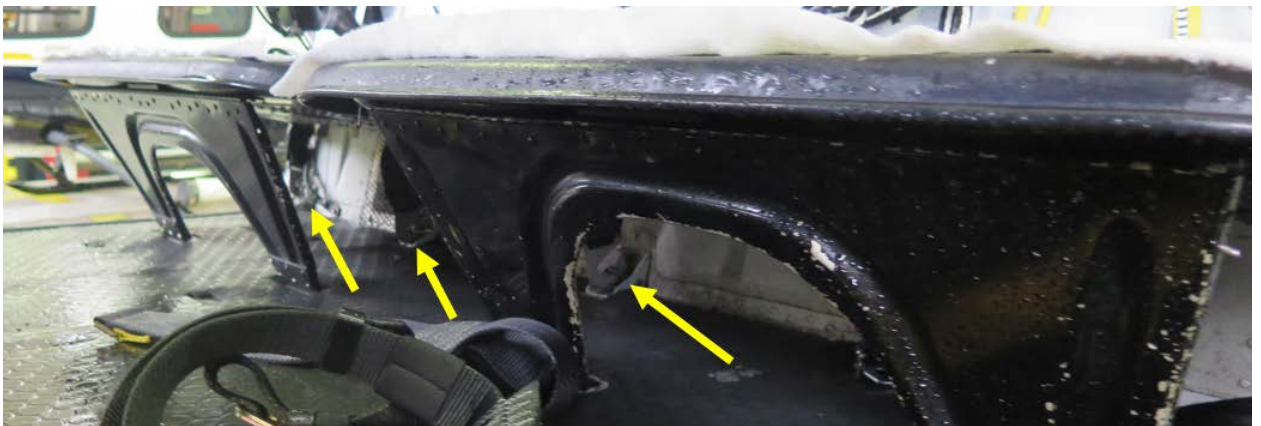
For all four seat positions on the rear bench, each seat’s lapbelts were found connected to the floor anchors/hard points adjacent to the rear bulkhead. According to the AS350 B2 Maintenance Manual section 25-22-00, chapter 4-4 (“Removal / Installation – Rear Seat Bench Passenger Seats”), tasks requested that the seat lapbelts to be disconnected/connected to the rear bench tube anchor for the four-seat rear bench configuration. No task was available to disconnect/connect the seat lapbelts on the floor. Figure 1 of the AS350 B2 Maintenance manual section 25-22-00, chapter 4-4 (“Removal / Installation – Rear Seat Bench Passenger Seats”) showed a partial representation of the lap seat belt connected to the rear bench bar tube anchor for the four-seat rear bench configuration. A diagram showing the complete lap seat belt connection configuration for all four-seat positions on the rear bench was not available in the AS350 B2 Maintenance Manual.

Photograph 10 - Floor anchors/hard points adjacent to the rear bulkhead

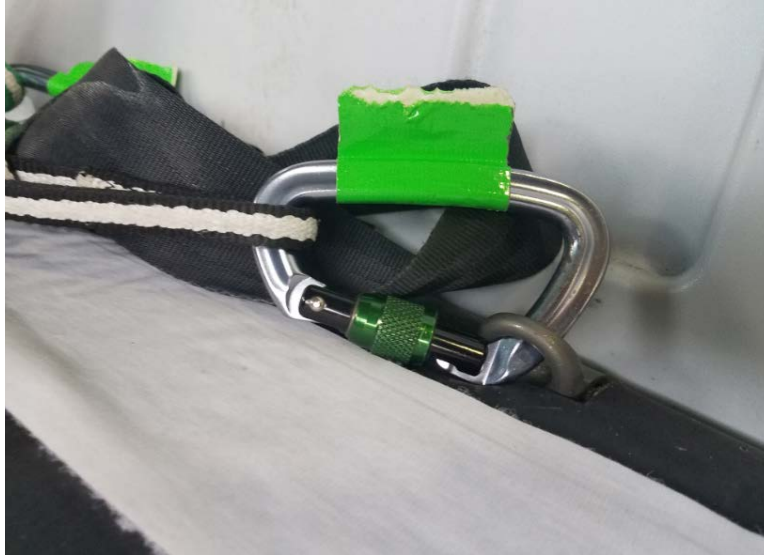
Photograph 11- Carabiner attaching tether to a rear bench seat tube hard point in helicopter.

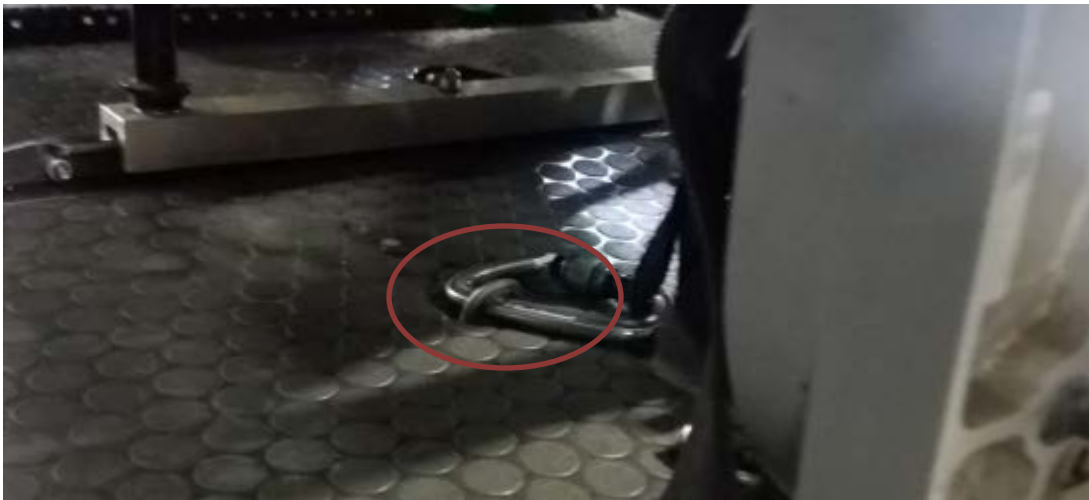
Photograph 12- Carabiner attaching tether to the front seat floor hard point in helicopter.

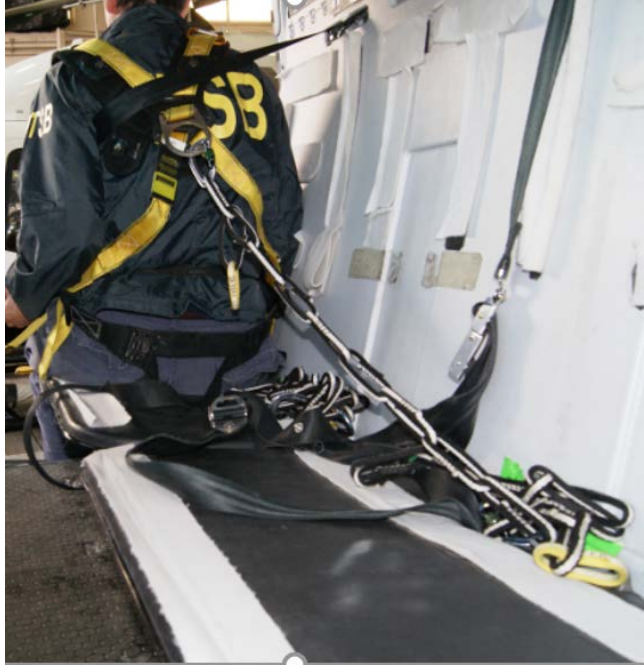
Tether 4, attached to the hardpoint at seat position 1, and consisted of a total of 11 loops, with 10 black loops and 1 yellow loop, no green loop was present. The carabiner was in the 9th loop. The 9th loop was black. The tail consisted of 2 loops, one black and 1 yellow, and was 7 inches long. The length from the hard point to the passenger harness attachment point was 39.5". The carabiner at the hard point had a green screw, a silver body, and was fully locked. It was labeled 25/8/8kN. The carabiner at the occupant connection had a green screw, a silver body, and fully locked. It was labeled 25/8/8kN. There was no data tag on the tether.

Photograph 17- Investigator in seat position 4 wearing harness connected to tether (Tether number 4 attached to seat position hardpoint 1).

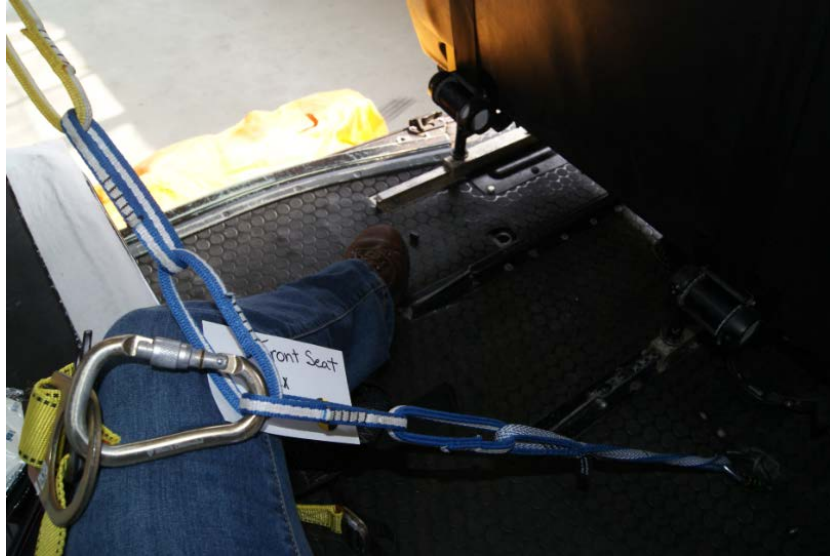
The front seat occupant's tether was of a different design than the rear passengers. It was also manufactured by METOLIUS and rated for 22 kN. There was a total of 6 loops. There was 1 long 15-inch blue loop, 4 short 5-inch blue loops, and 1 5-inch yellow loop. The tether measured 40 inches. The carabiner was in the third loop. The tail contained 3, 5-inch loops for a total length of 15 inches and the terminating loop on the tether tail was yellow (see photograph 16). However, the length of the tail could be 20 inches in some configurations depending on positioning of the carabiner within the loop it was attached to. (See photograph 20). The data tag read:

Photograph 18- Front seat occupant tether.

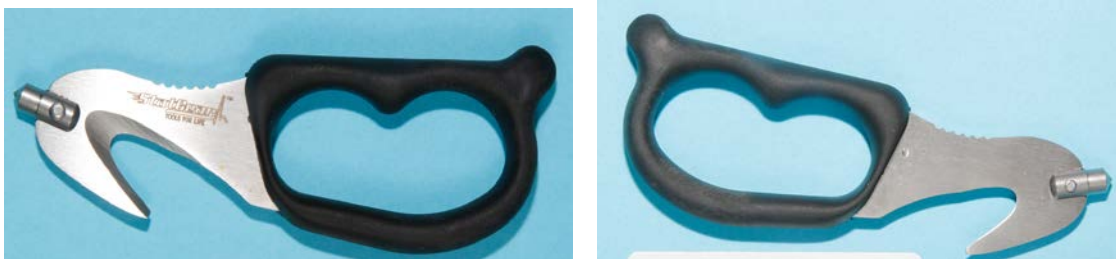
Photograph 35- Cutter found with harness D.

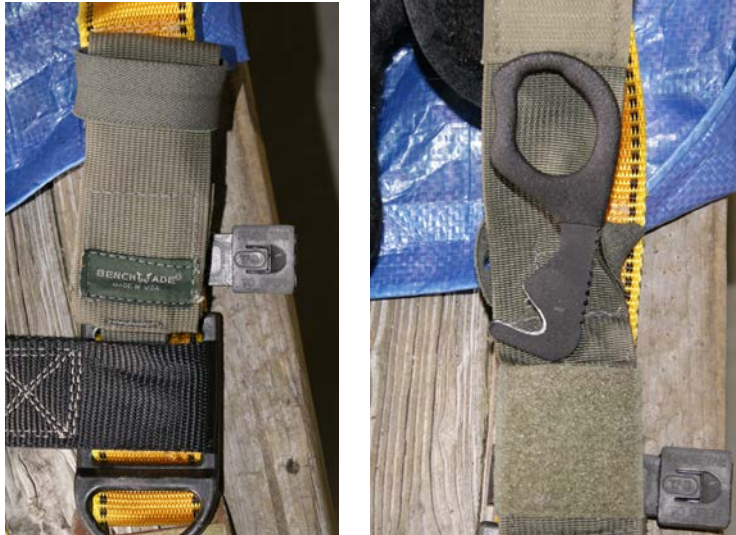
Photograph 36- *Harness A cutter (Benchmade olive green pouch with a Benchmade Model 7 rescue cutter).*

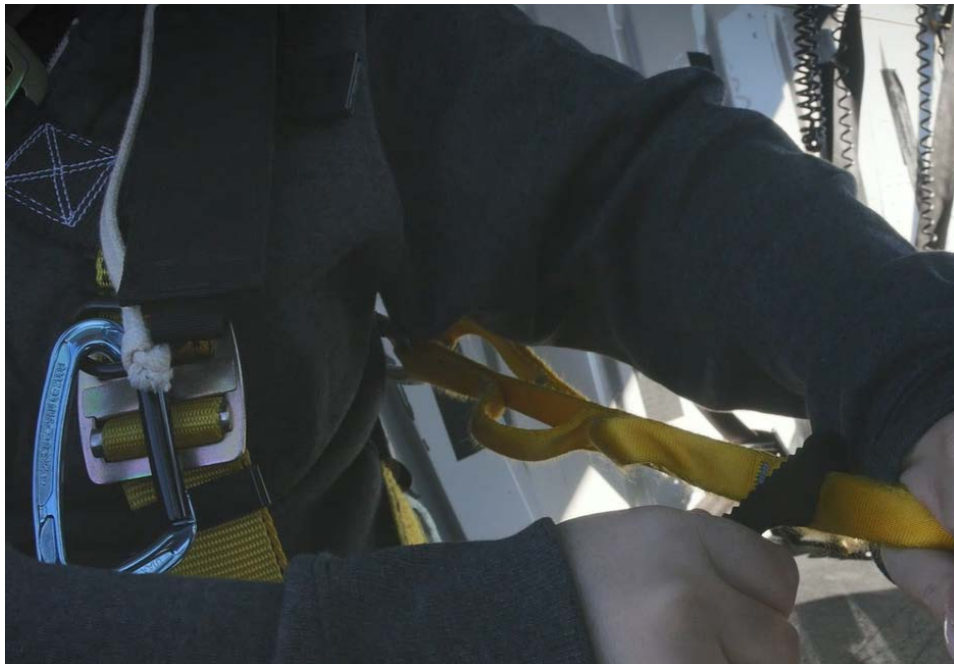
Photograph 37- *Screen capture from the NYONair safety passenger video showing use of a cutter.*

As shown photographs 37-39, the survival factors group documented a passenger removing a cutter from its pouch and reaching for the tether as shown in the passenger safety video. The group noted that, due to the routing of the tether behind the passengers, it was not possible to access the tether while two passengers were seated next to each other (as one passenger's upper body was obstructing it). The inboard passenger needed to lean over for the outboard passenger to have access to the tether. It was also noted that the outboard passenger's inboard rotation to reach the tether was restricted due to the tension in the tether caused by the rotation of the upper body.

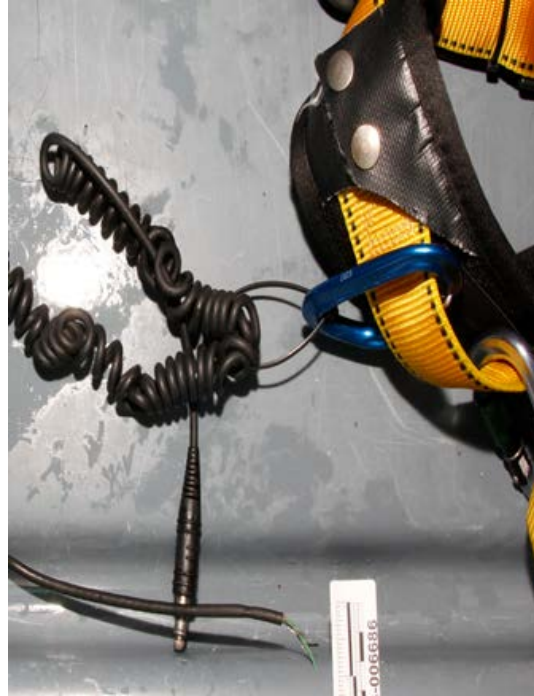
Once the passengers were seated in the helicopter, headsets with coiled cords, were provided by the CX or the pilot. The headsets were plugged into audio jacks above the aft bench seat by the CX or pilot. There were no frangible links or break away points positioned between the headset and the jacks. The headset cords were routed through the rack on the ceiling to keep them from being entangled with one another and secured with zip ties to carabiners that were clipped to the back of the passenger harness. The passengers used the headsets to hear the pilot. They could not speak with one another nor could they speak to the pilot. The front seat passenger headset was plugged into the front instrument control panel in the 'passenger 6' position and was labeled FlyNYON 4 and LHI 13.

Photograph 41 –Headset cord connected to harness using zip ties and carabiner.

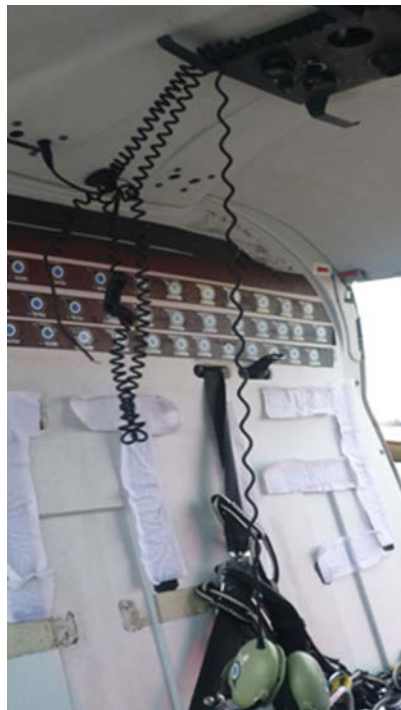
Photograph 42 –Headset coiled cord connected to overhead audio panel.
