NATIONAL TRANSPORTATION SAFETY BOARD
OFFICE OF HIGHWAY SAFETY
WASHINGTON, DC 20594

Survival Factors Specialist's Factual Report

Accident: CHI06FA210
Location: Sullivan, MO
Vehicle #1: Dehavilland DH-6, N203E
Date: July 29, 2006
Time: Approximately 1349 CDT

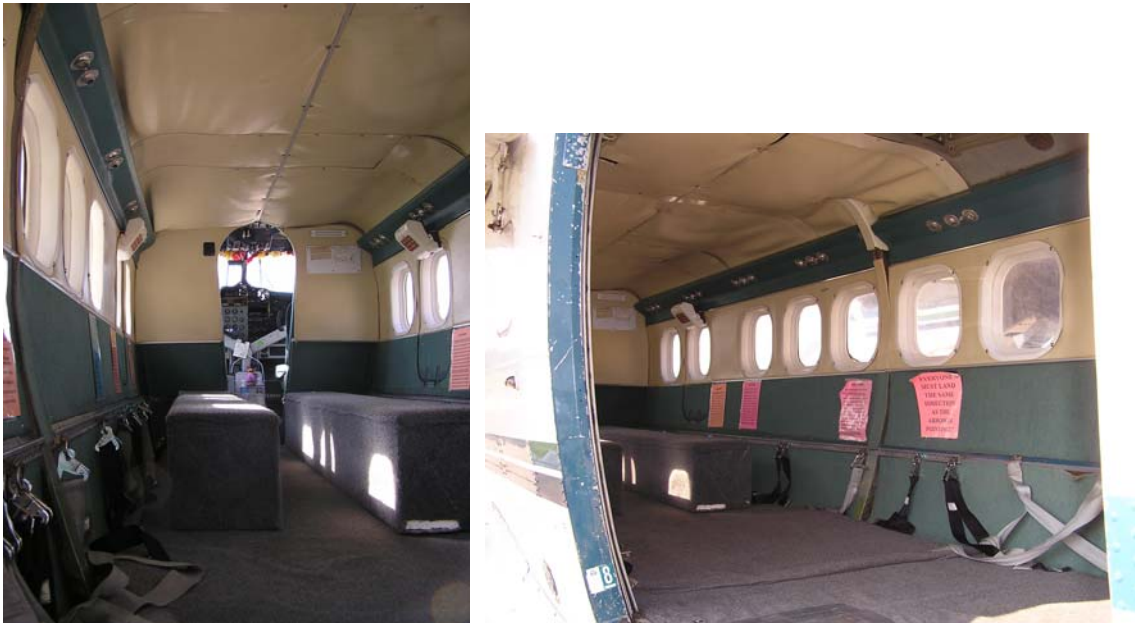
The cabin had no traditional aircraft seats or benches. The parachutists' restraints were mounted along the sidewall and can be seen in Figure 1. Two cushions were present along both the left and right sides of the aircraft and extended from the bulkhead rearward to approximately the end of window 3, as also shown in Figure 1 below.

Figure 1: Pre-accident photographs showing the interior on both aircraft left and right.

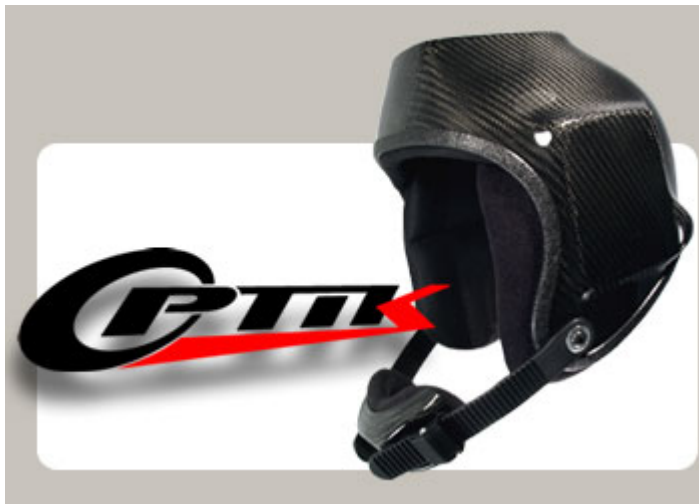
Figure 2: A photograph of the Bonehead Composites Optik helmet commonly used for mounting cameras.

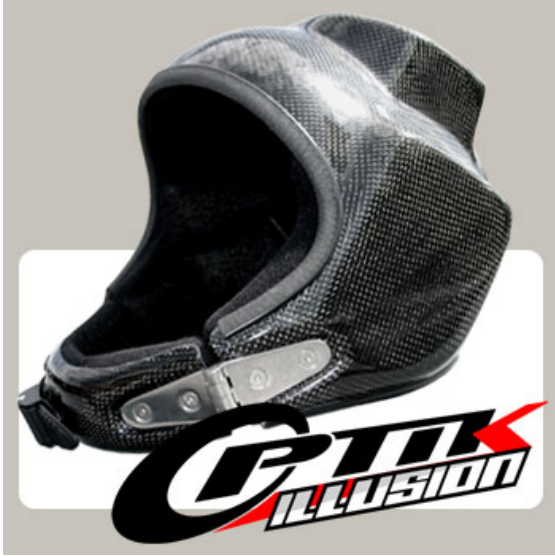
Figure 3: A photograph of the Bonehead Composites Optik Illusion helmet commonly used for mounting cameras.

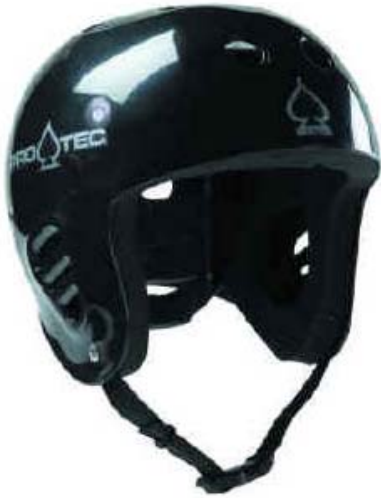
Female 3 was wearing a helmet that was reported⁶ to be a classic ProTec⁷ helmet. The ProTec website lists helmets for use in a variety of activities including skate, bike, snow and water but not Air (or skydiving). The Classic Full Cut helmet, which appears most consistent with the shape and coverage of the helmet worn by Female 3, meets various specifications depending on the application including CE EN 1385 Water Sport Safety Standard for the water helmet and ASTM 2040 or CE EN 1077 for the snow helmet. Other websites⁸ offer a Classic Full Cut Air ProTec model but that model is not listed on the ProTec website. A picture of an exemplar ProTec Air helmet is shown in Figure 5.

Figure 5: A photograph of Classic Full Cut Air Skydiving helmet.⁹

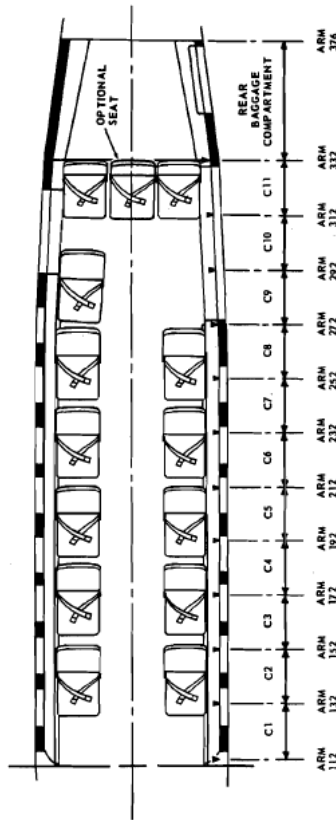
The airplane was originally certificated with passenger seats that were equipped with lap belts. A typical seating arrangement can be seen in Figure 6. To accommodate parachuting operations, the FAA must approve of any changes to the interior configuration.¹⁰ For example, FAA Regulations 14 CFR.91.107(a)(3)(ii) allows occupants to: “Use the floor of the aircraft as a seat, provided that the person is on board for the purpose of engaging in sport parachuting.”

Figure 6: A typical seating arrangement for this aircraft.¹²

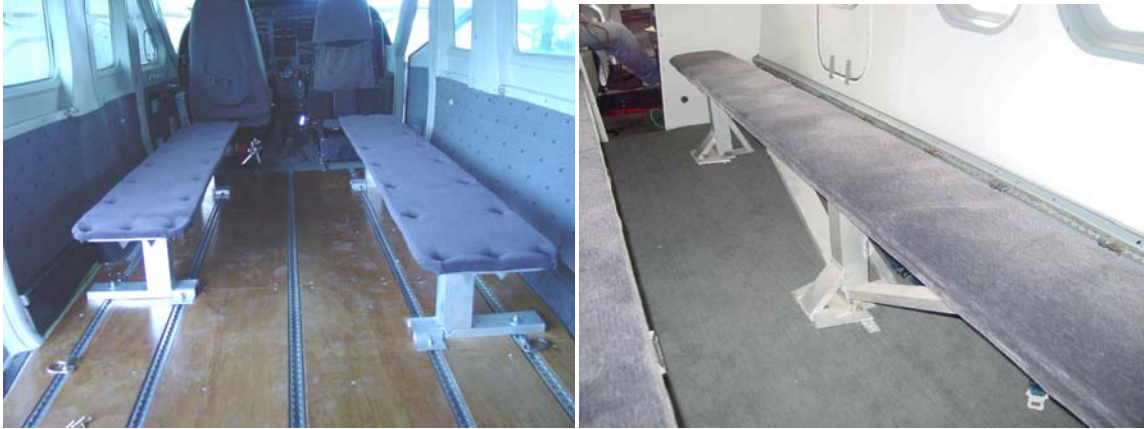
Figure 7: Straddle bench seats commonly installed in aircraft to accommodate parachuting operations.¹³

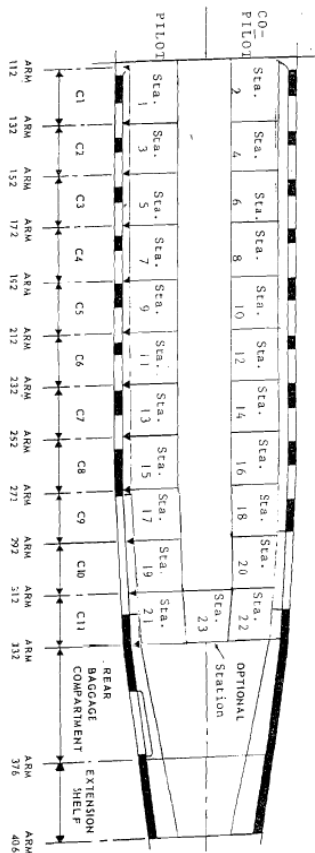
Figure 8: Jumper station assignments.¹⁴

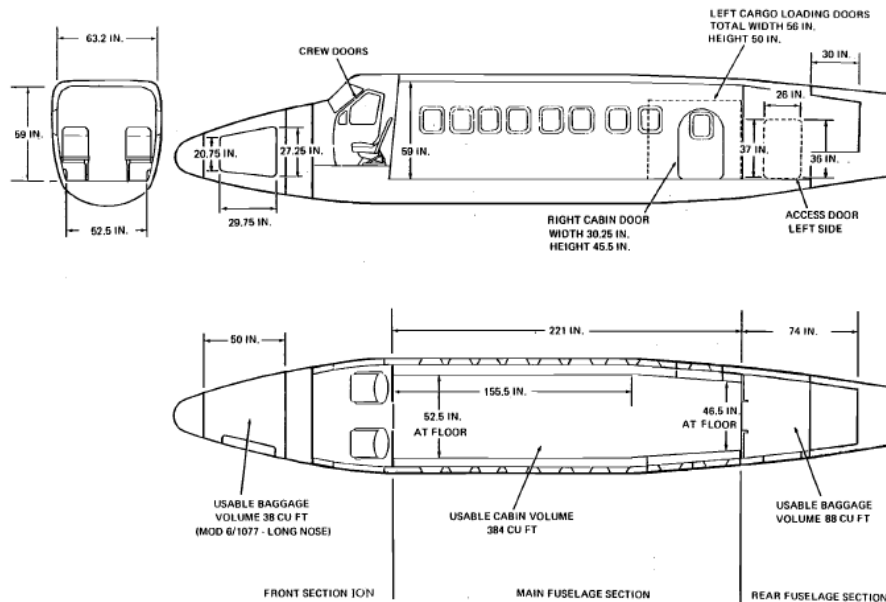
Figure 12: A diagram of the cabin and baggage compartment dimensions.¹⁶ Note that the third window in the passenger compartment aft of the pilot station was not on the accident aircraft.

Approximate dimensions of the aircraft and the region of crush were scaled from the diagram in Figure 12. Since this is a long nosed version of this aircraft, that crush line would correspond to approximately 172 inches of crush. But, the nose region of the aircraft is not structural.¹⁷ The nose is constructed from balsa wood and fiberglass. Thus, the region forward of station 60 (the approximate location where the nose wheel attaches) can not be considered structural and will not add measurable resistance to crush. As a result, the length of crush is approximately 172 inches – 81 inches = 91 inches long (7'7").

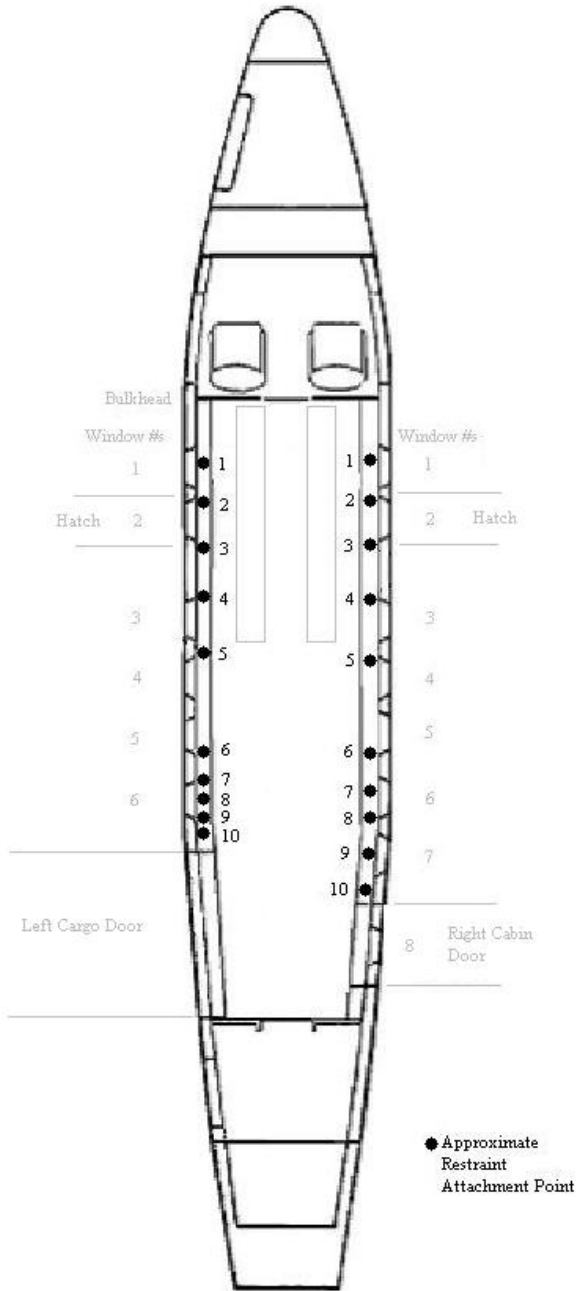
Window locations and approximate seat attachment points are shown and labeled in Figure 13. Based on these window locations and attachment points, the location of the post-accident restraint photographs can be identified. The post-accident photographs of the restraints along aircraft left are shown in Figure 14 and those from aircraft right are shown in Figure 15.

Figure 13: An aircraft diagram showing the window locations and the approximate locations of the restraint attachment points.
