**NATIONAL TRANSPORTATION SAFETY BOARD
OFFICE OF AVIATION SAFETY
WASHINGTON, D.C. 20594**

**ADDENDUM NUMBER 5 TO THE SYSTEMS GROUP CHAIRMAN'S
FACTUAL REPORT OF INVESTIGATION- AUTOPILOT SERVOMOTOR
EXAMINATION**

DCA02MA001

Operator: American Airlines
Aircraft: A300-600R
Location: Belle Harbor, New York
Date: November 12, 2001
Time: 09:16 EDT

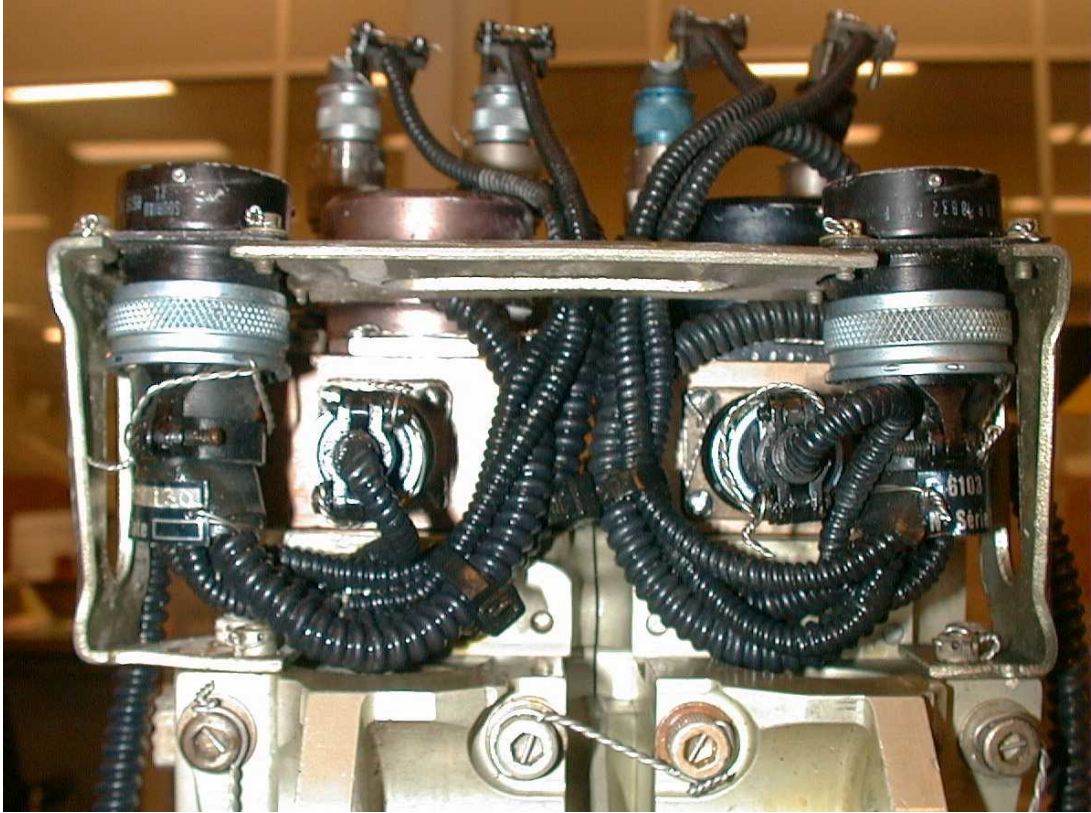
Figure 9. Bottom View of Undamaged APSM

The actuator was observed to be thermally damaged, the plastic wiring looms and wiring insulation was melted. The Driving side connector was intact, while the Driven connector was thermally and impact damaged. The identification plate was recovered from the Driving electrical harness, which confirmed the correct harness P/N 338827-140 was installed. The wires from the connector were no longer attached to any of the solenoids though some of the wire routing appeared to be unaltered. Figure 9 and Figure 10 show the wire routing of an undamaged APSM.

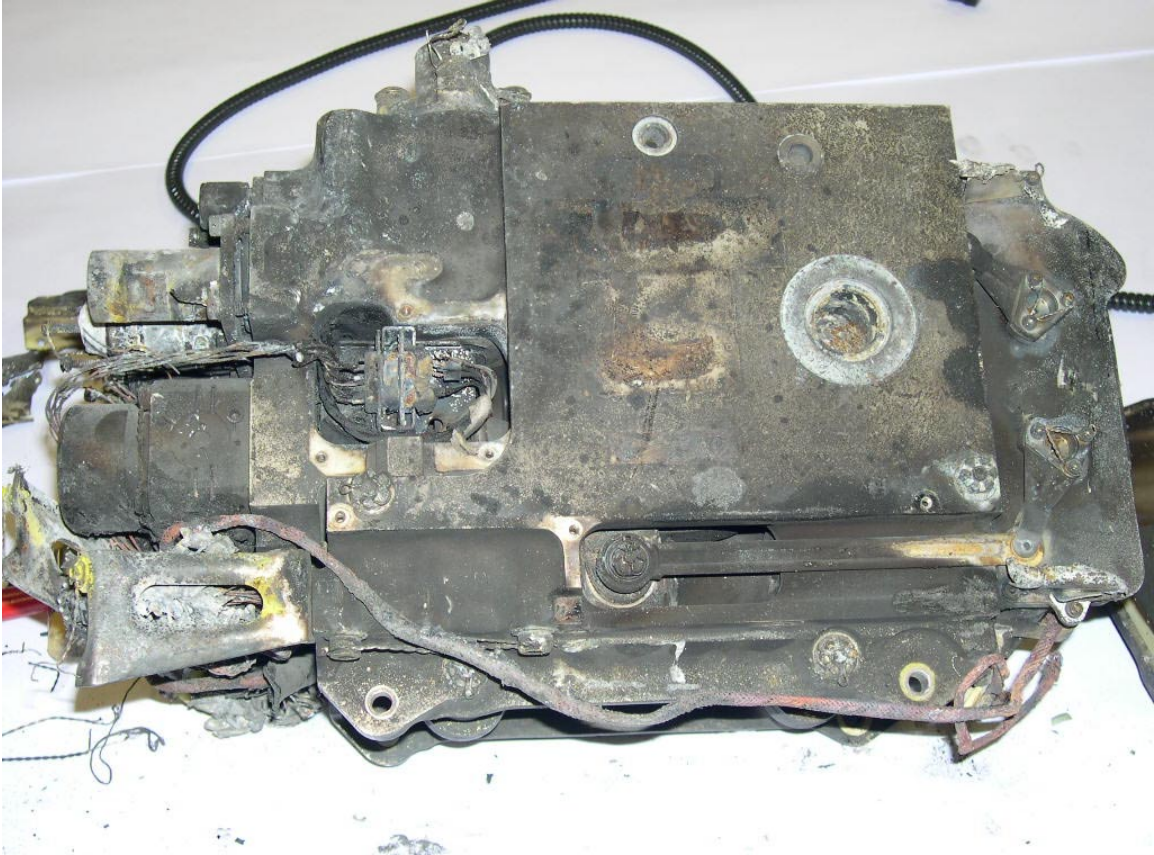
Figure 3. Driven Side With Cover Plates Removed.

Appendix A, Figure 3 showed the Driven side with the cover plates removed.

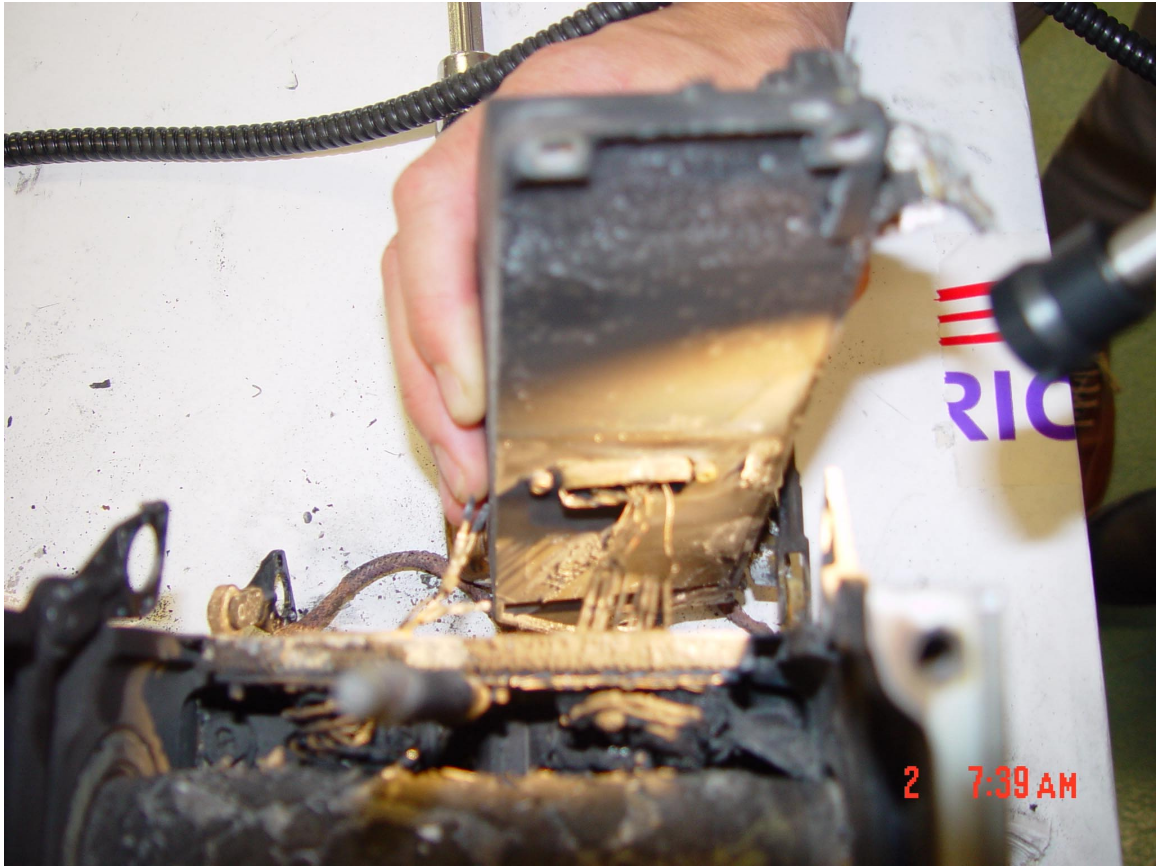
Figure 4. Driven Side Detection Box Removal.

The Driven side detection box was removed, Appendix A, Figure 4 and 5.

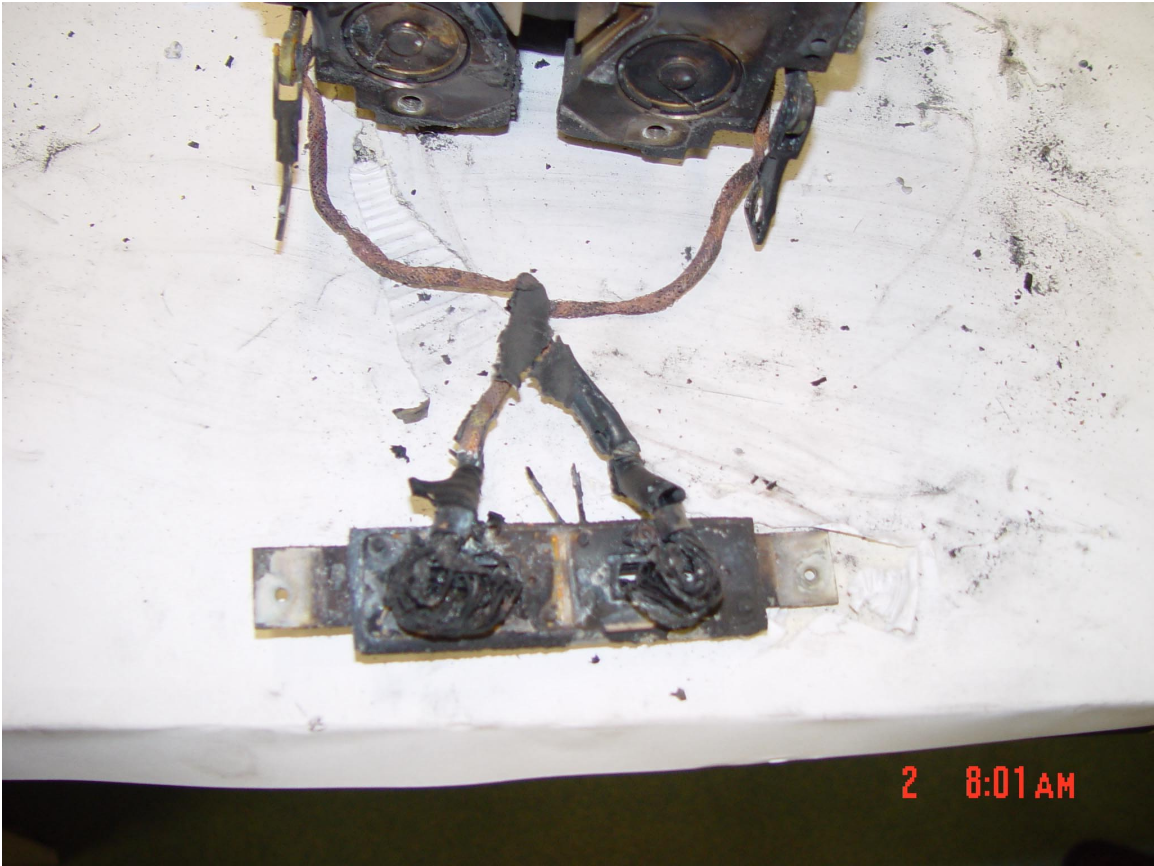
Figure 6. Detection Box Wiring.

The detection box electrical connectors and wiring were removed, Appendix A, Figure 6.

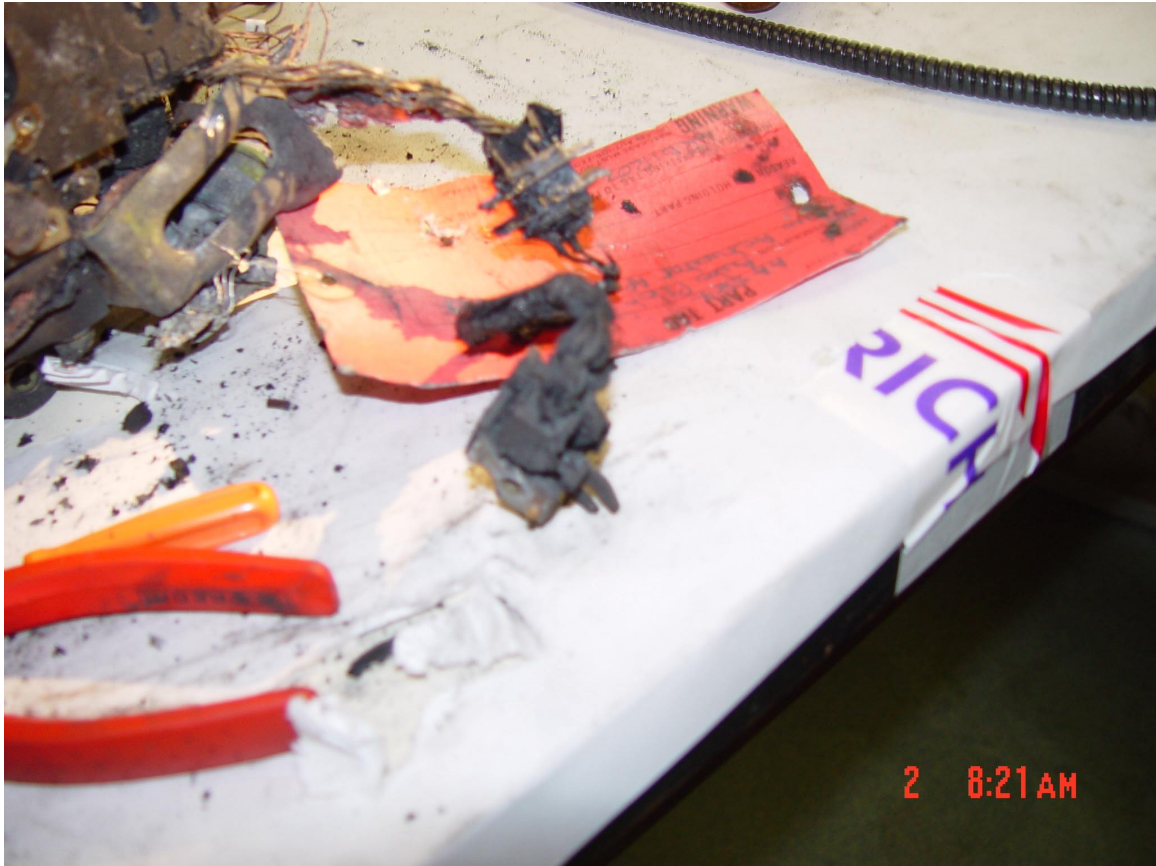
Figure 9. Driving Side Engage Switch and Wiring.

The Engage switches (IPL 1-280A) were removed, Driving Appendix A, Figure 9 and Driven Appendix A, Figure 10.

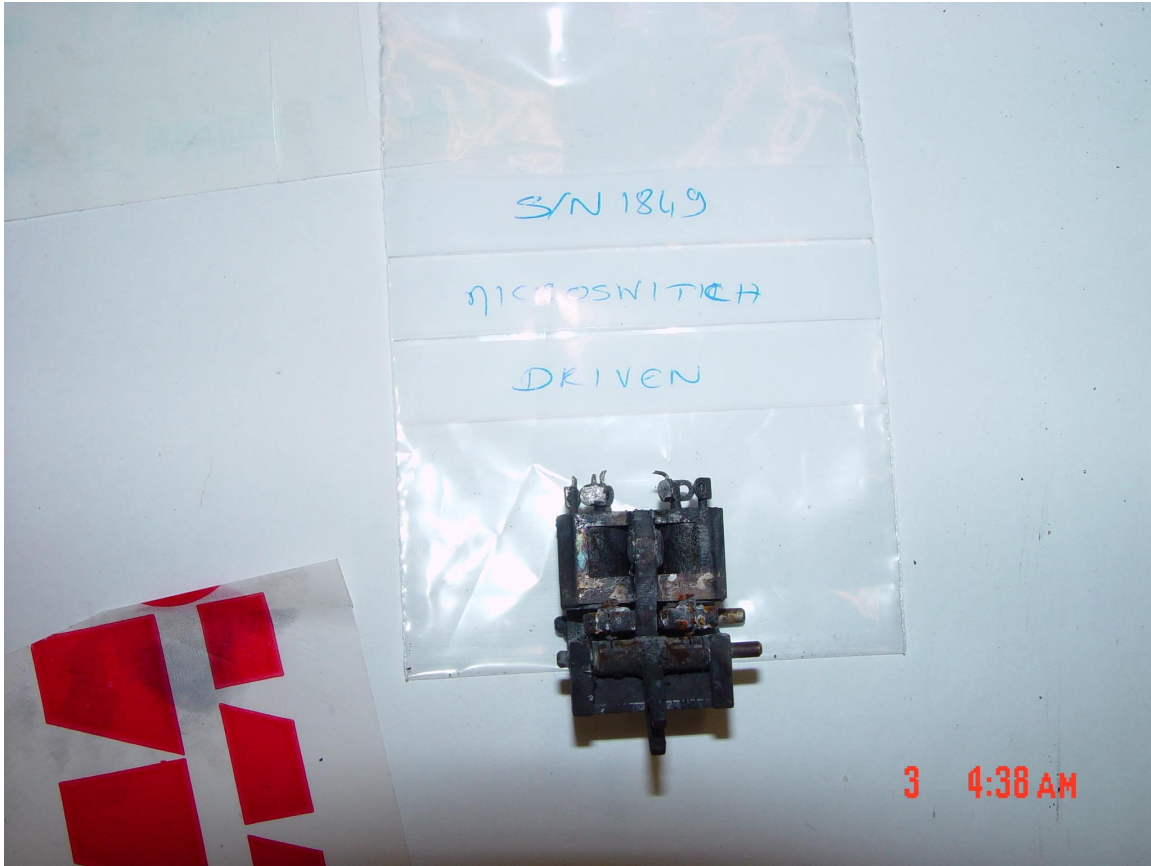
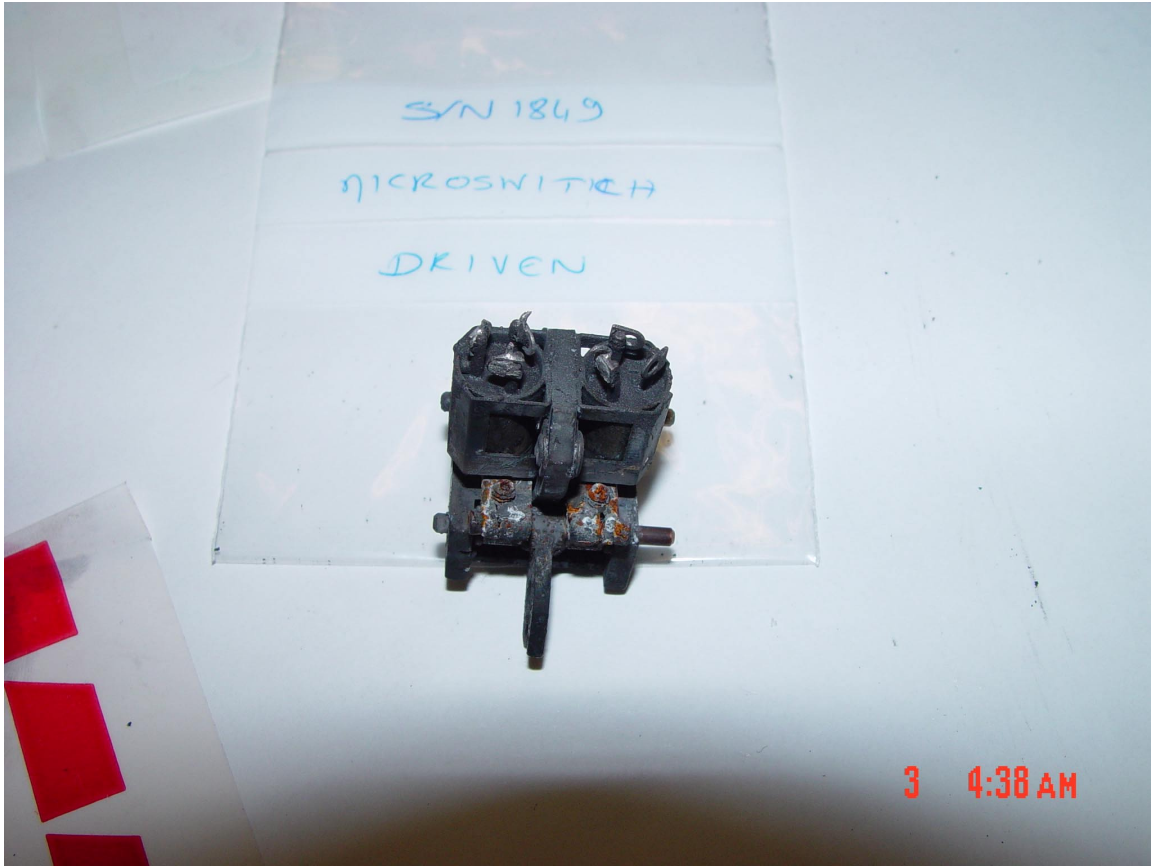
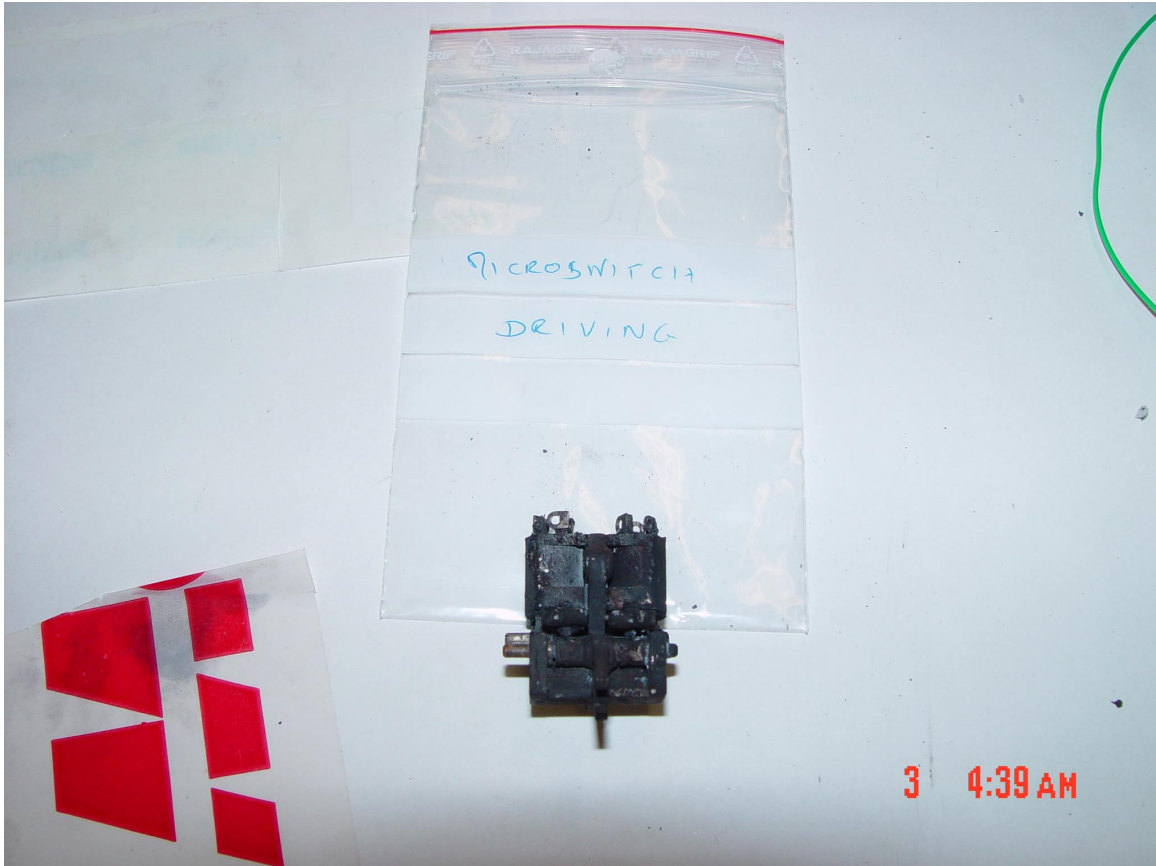
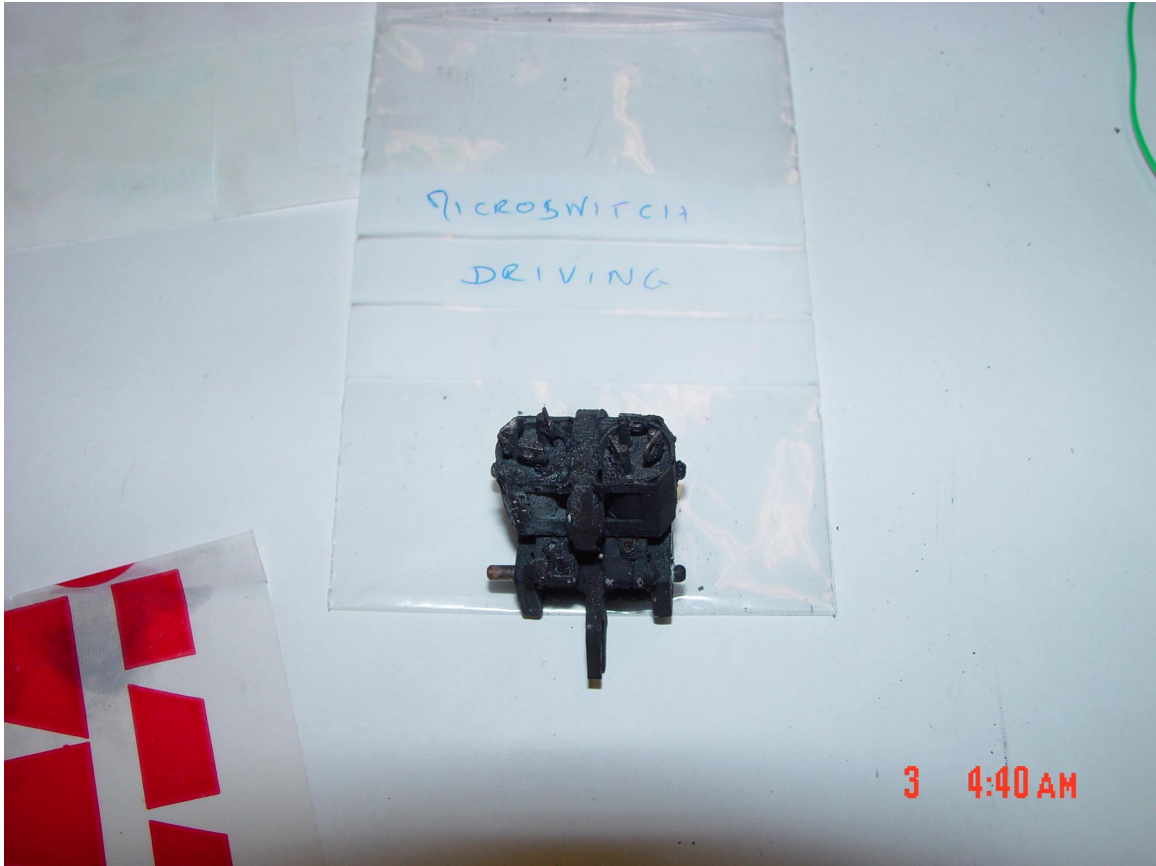
Wires were cut at the engagement switches and continuity was confirmed between 2 of the 3 pins as documented below in Figure 16. The switches are shown in top view. Appendix A, Figures 12 to 15 are the Driven and Driving switches.

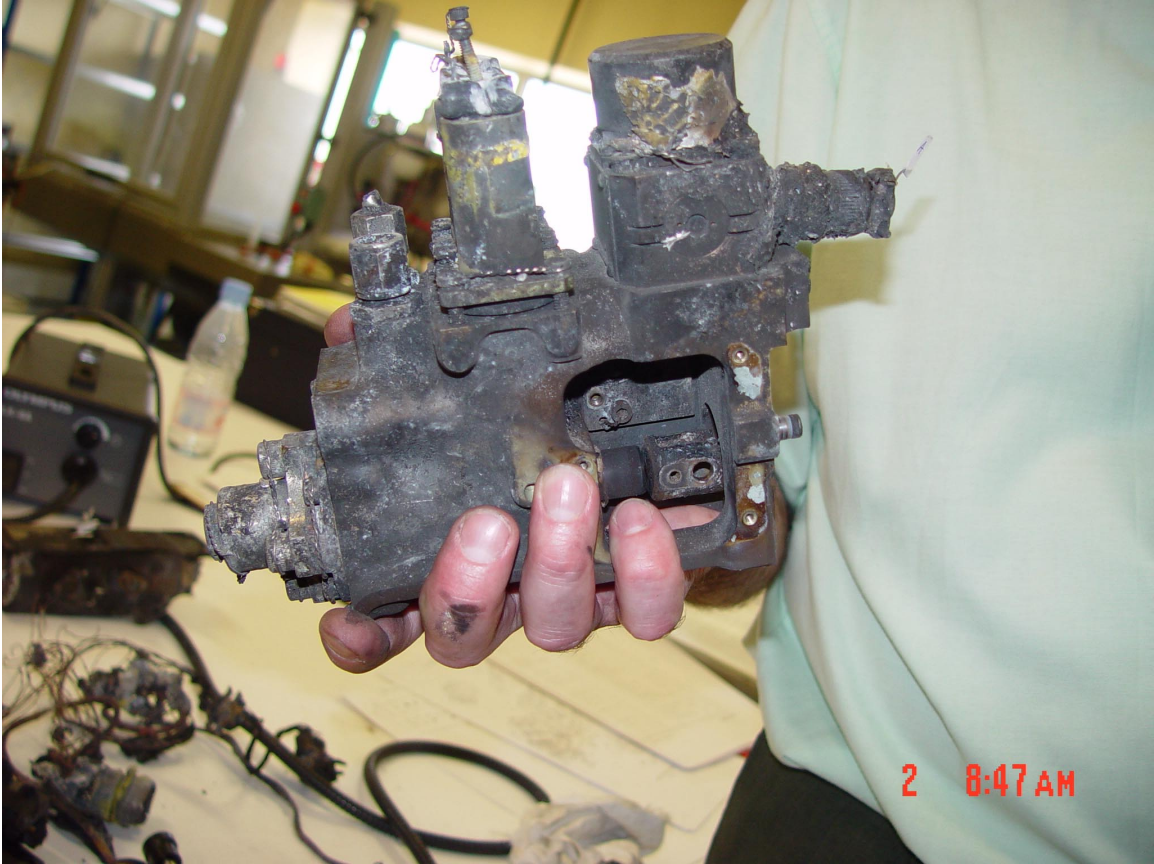
Figure 16. Driving Side Hydraulic Block.

The hydraulic units were removed (IPL 5-001 and 5-002), Driving Appendix A, Figure 16 and Driven Appendix A, Figure 17.

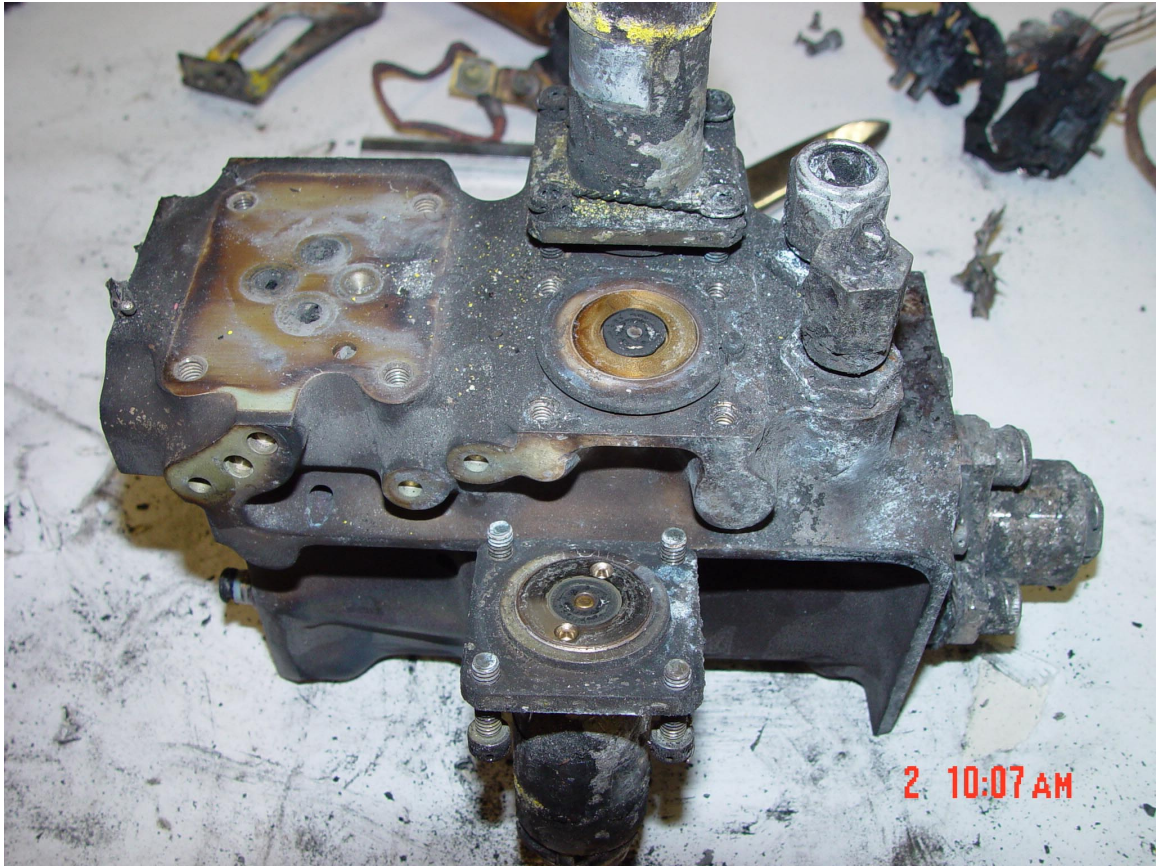
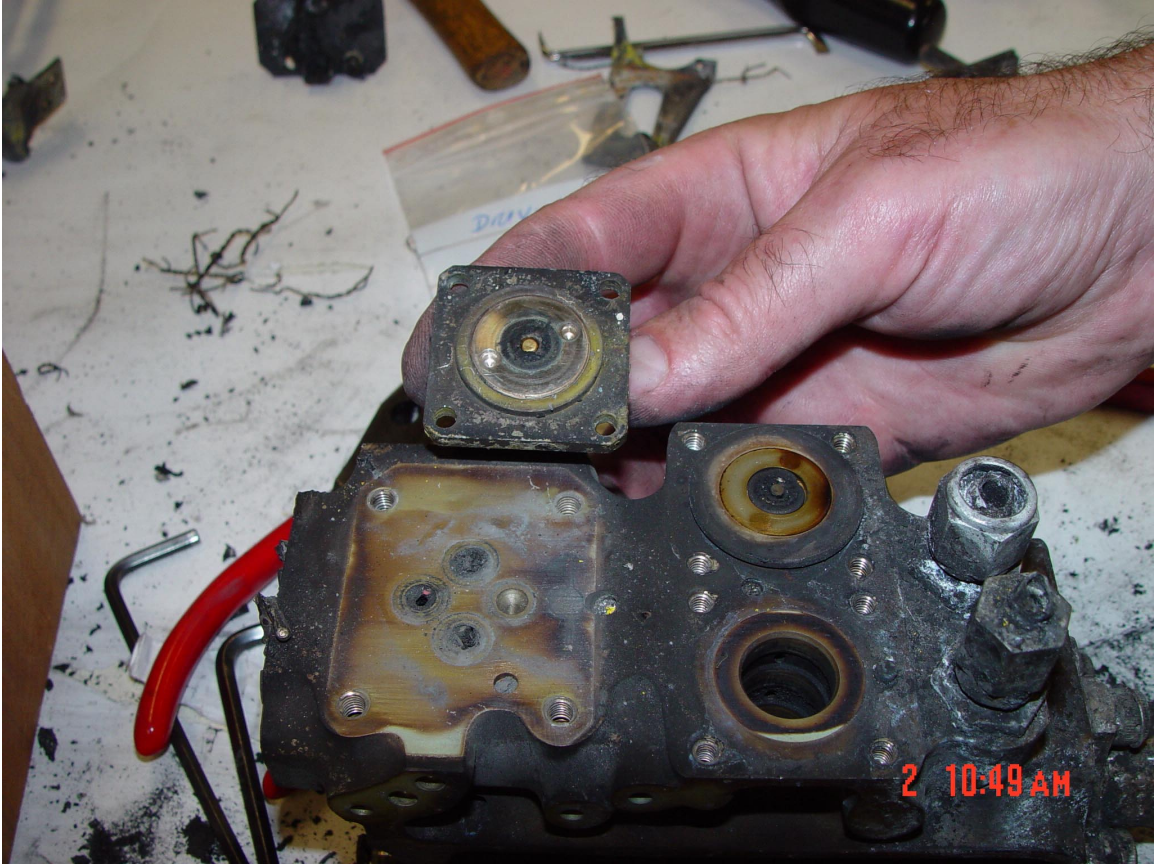
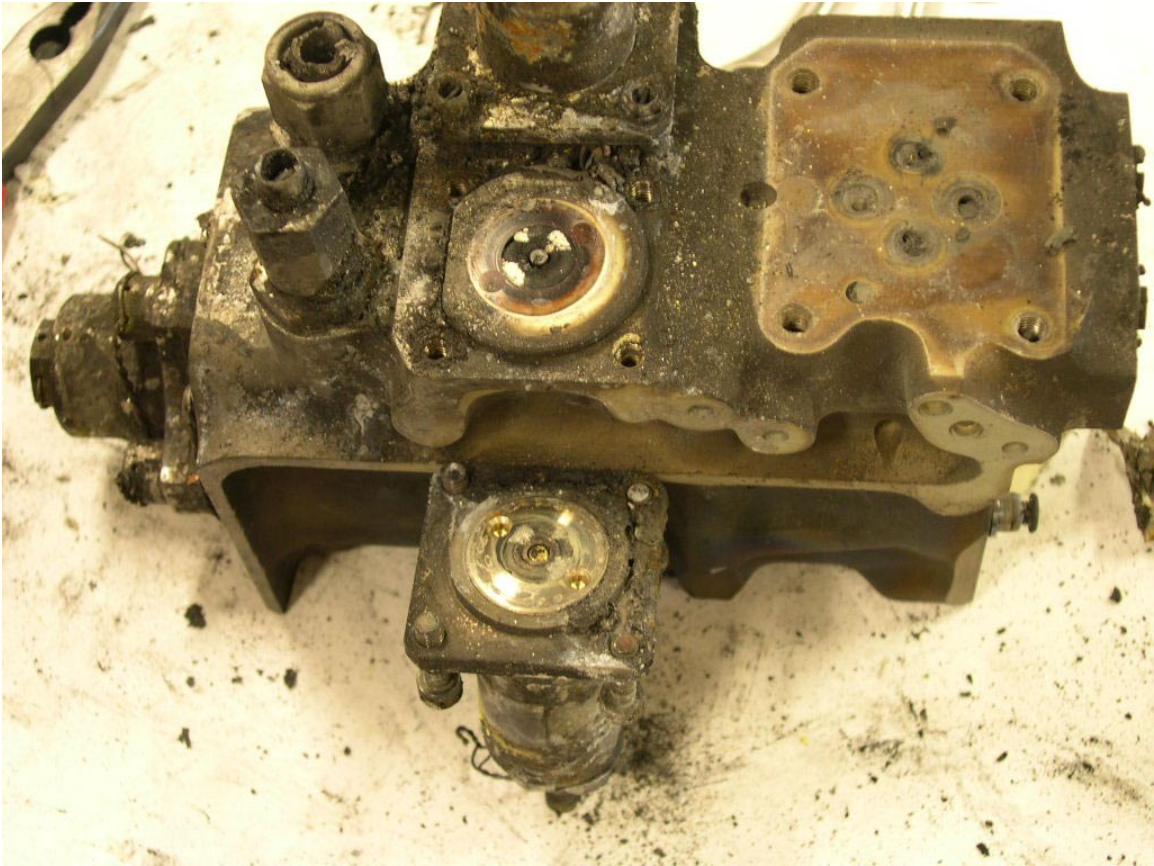
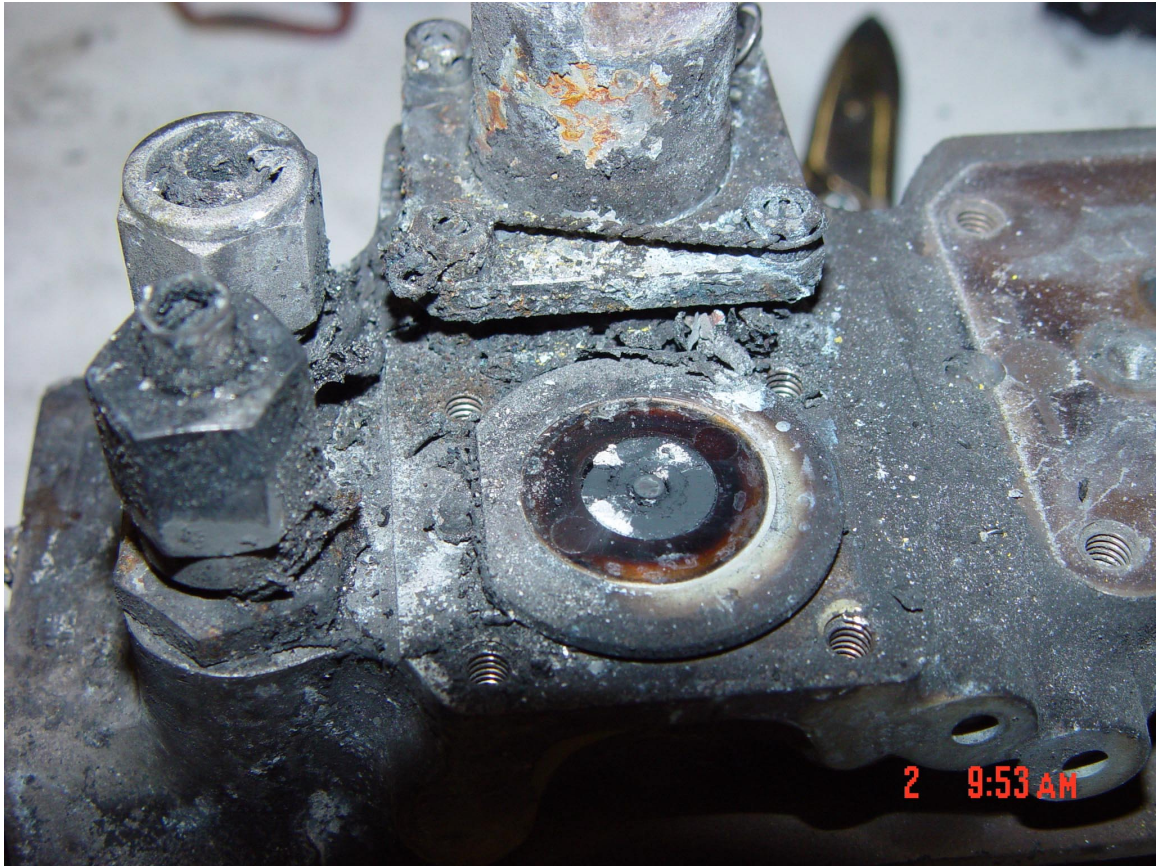
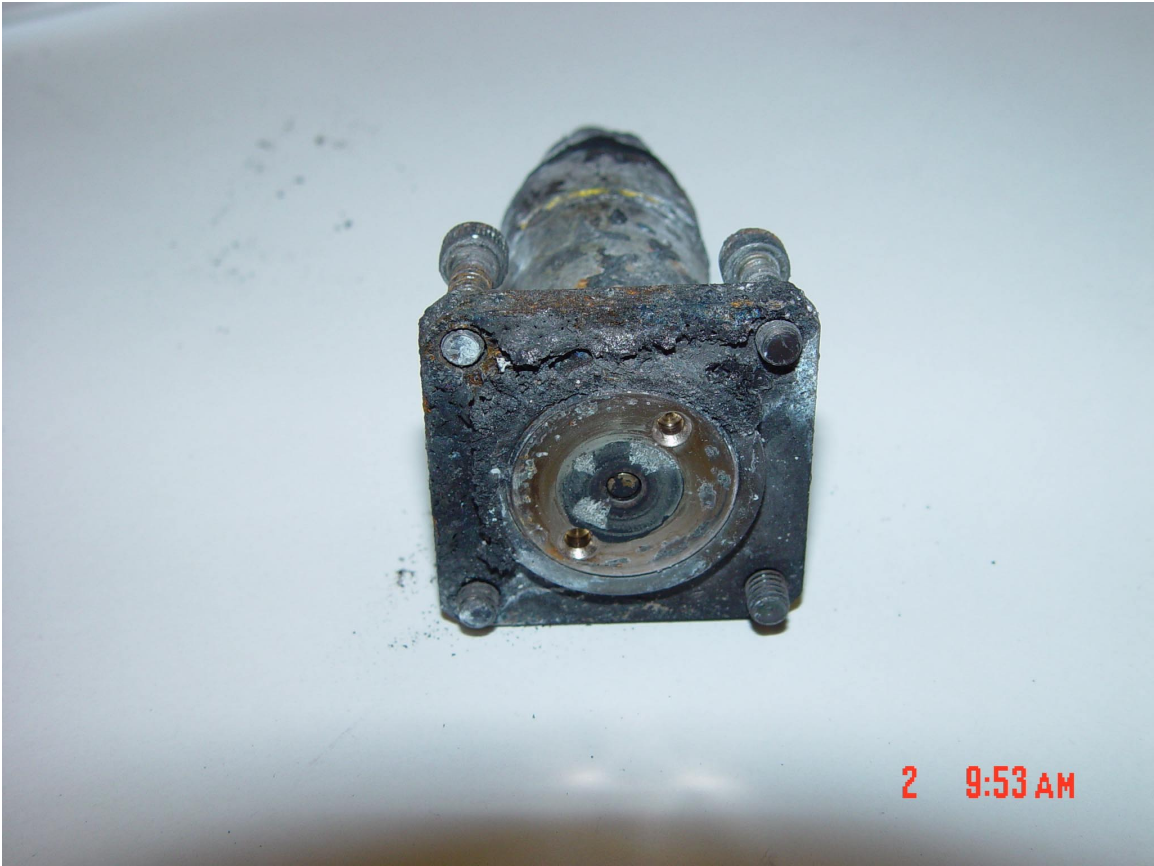
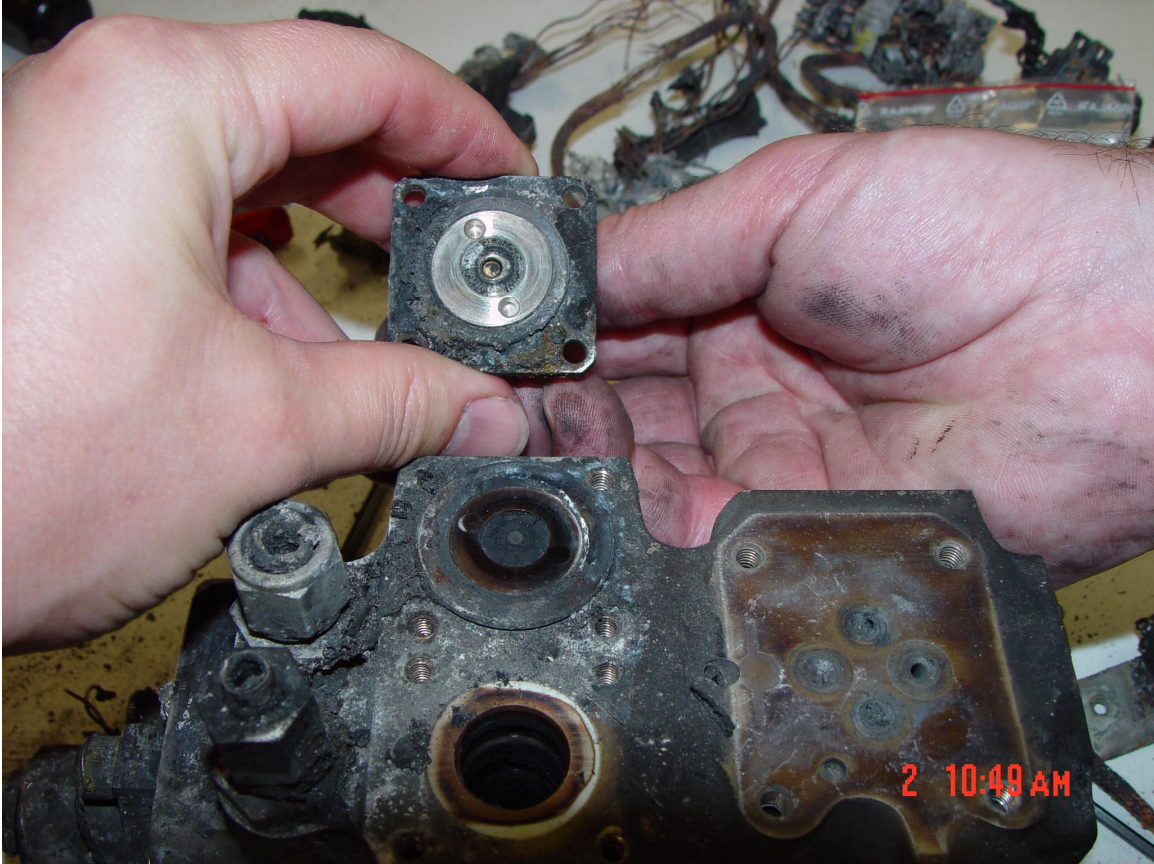
The solenoids were removed (IPL 1-240D), Appendix A, Figures 20 to 25. Upon disassembly, Appendix A, Figures 26 to 32, substantial heat damage was observed on all 4 solenoids as evidenced by the packings that had turned into powder. No foreign debris was found in the solenoids, especially in the bobbin and piston area. The powder was collected into containers.

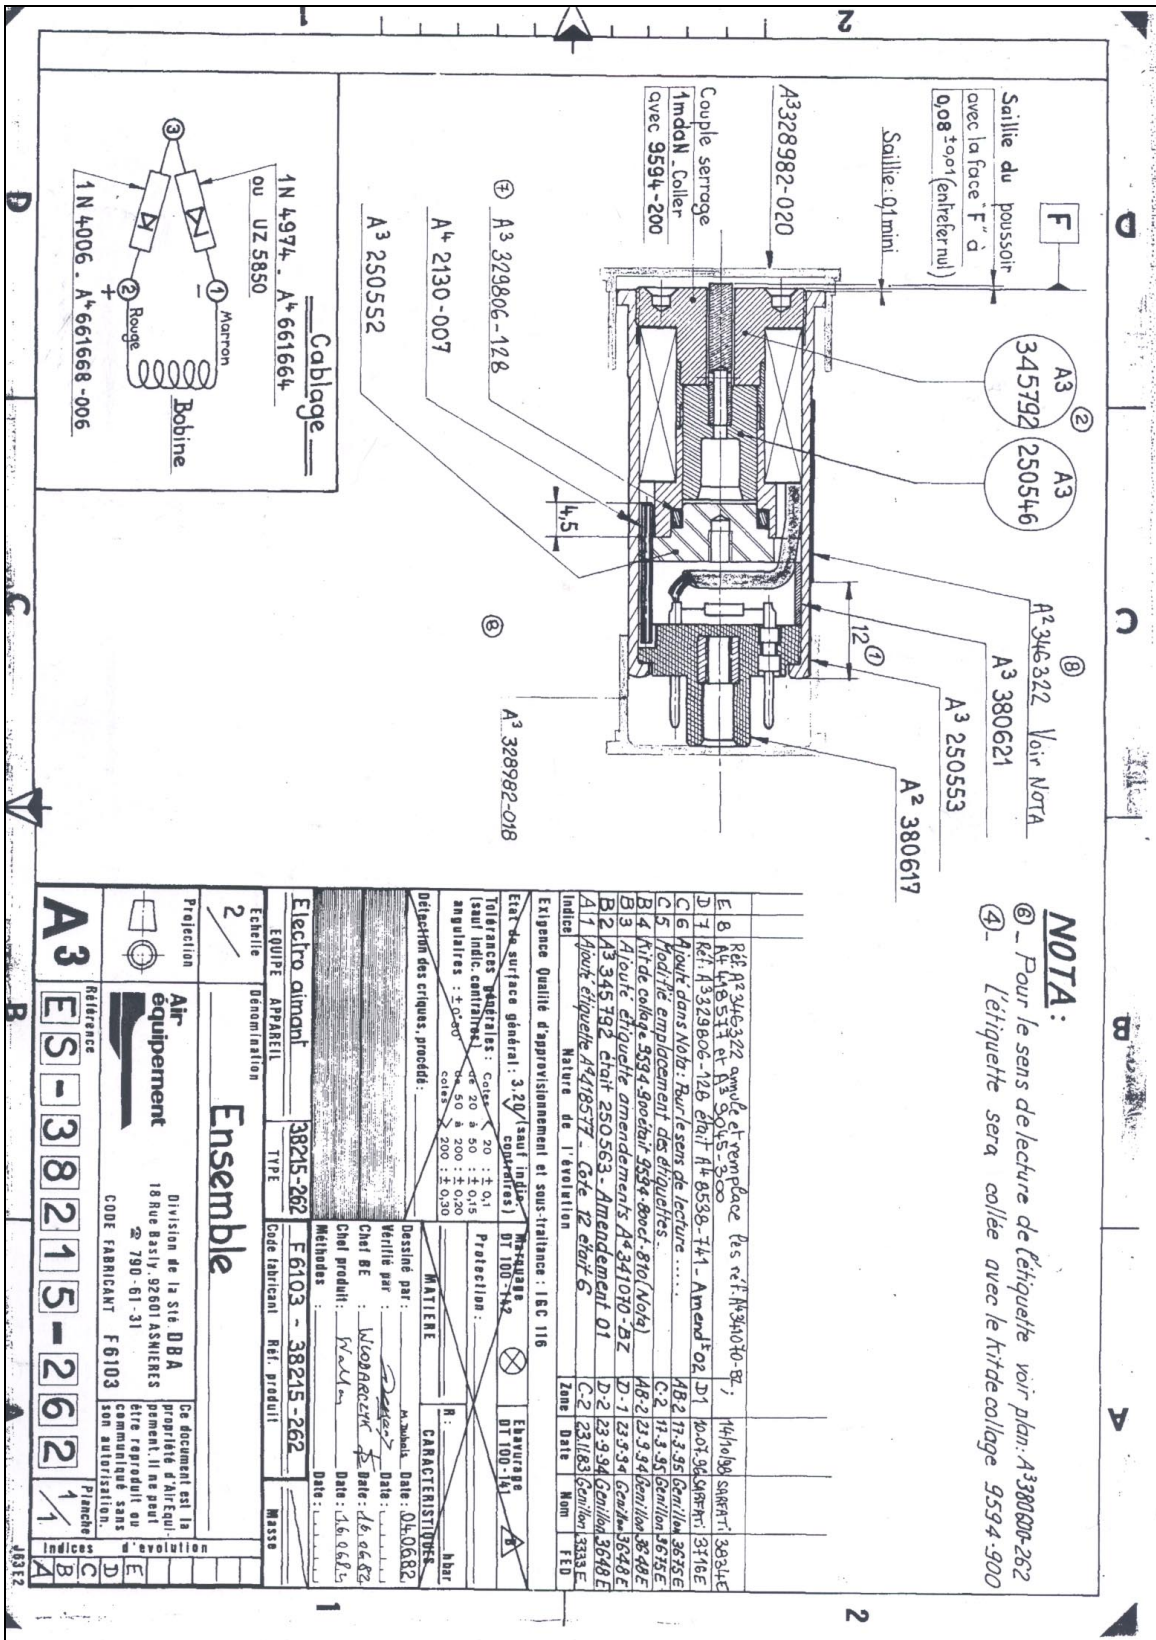
Figure 3. APSM Solenoid Drawing

Note: For Dimension C and Dimension (A-B-C-D) the specified value is not achieved because C is subsequently machined per drawing 38215-262 (Appendix C, Figure 3) so that the pushrod protrusion is 0.08 +/- 0.01 mm.
