**NATIONAL TRANSPORTATION SAFETY BOARD
OFFICE OF AVIATION SAFETY
WASHINGTON, D.C. 20594**

**ADDENDUM NUMBER 6 TO THE SYSTEMS GROUP CHAIRMAN'S
FACTUAL REPORT OF INVESTIGATION – YAW DAMPER EXAMINATION**

DCA02MA001

Operator: American Airlines
Aircraft: A300-600R
Location: Belle Harbor, New York
Date: November 12, 2001
Time: 09:16 EDT

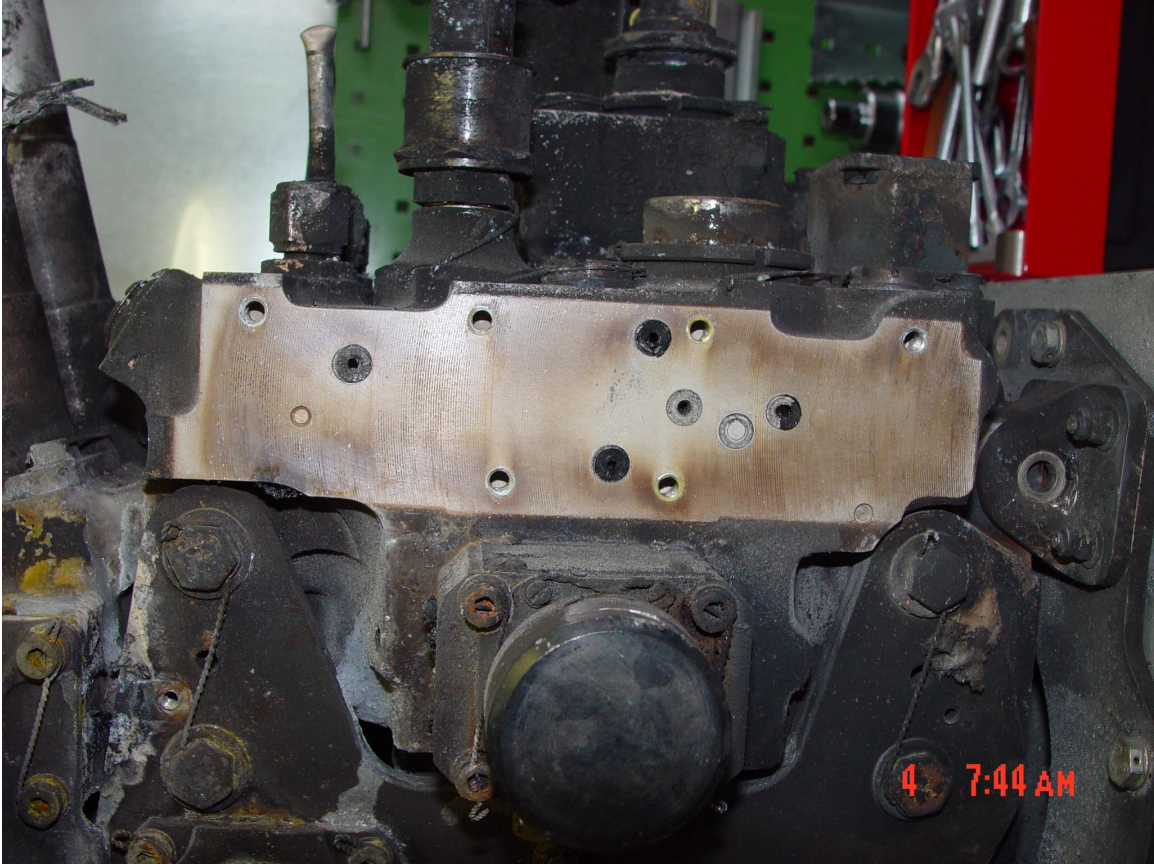
The Driving side electric distributor block was removed (IPL 1-80A), Appendix B, Figure 1 and Figure 2.

Figure 2. Driving Side of Actuator with Distribution Block Removed

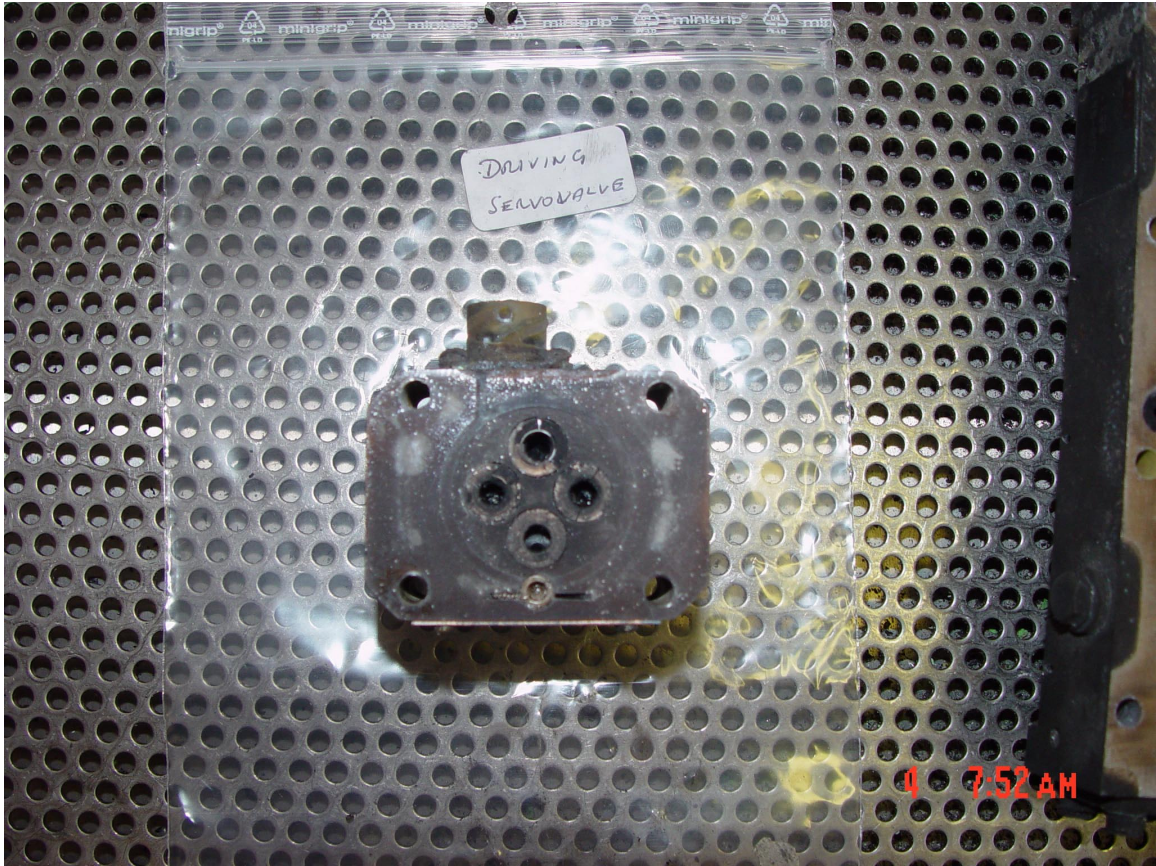
The Driving side servovalve was removed (IPL 1-20A), Appendix B, Figure 3.

Figure 3. Driving Side Servovalve.

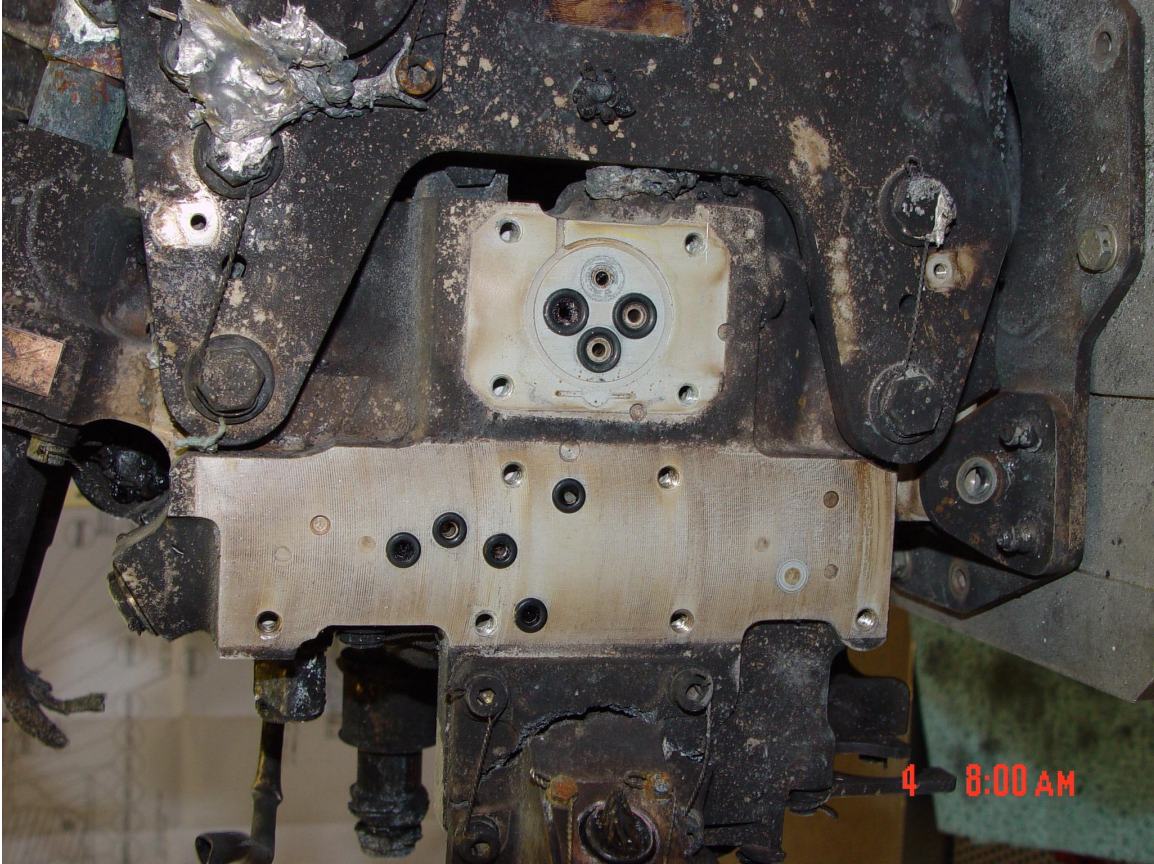
The Driven side distribution block was removed (IPL 1-80A), Appendix B, Figure 4 and Figure 5.

Figure 5. Driven Side of Actuator with Servovalve and Hydraulic Block Removed.

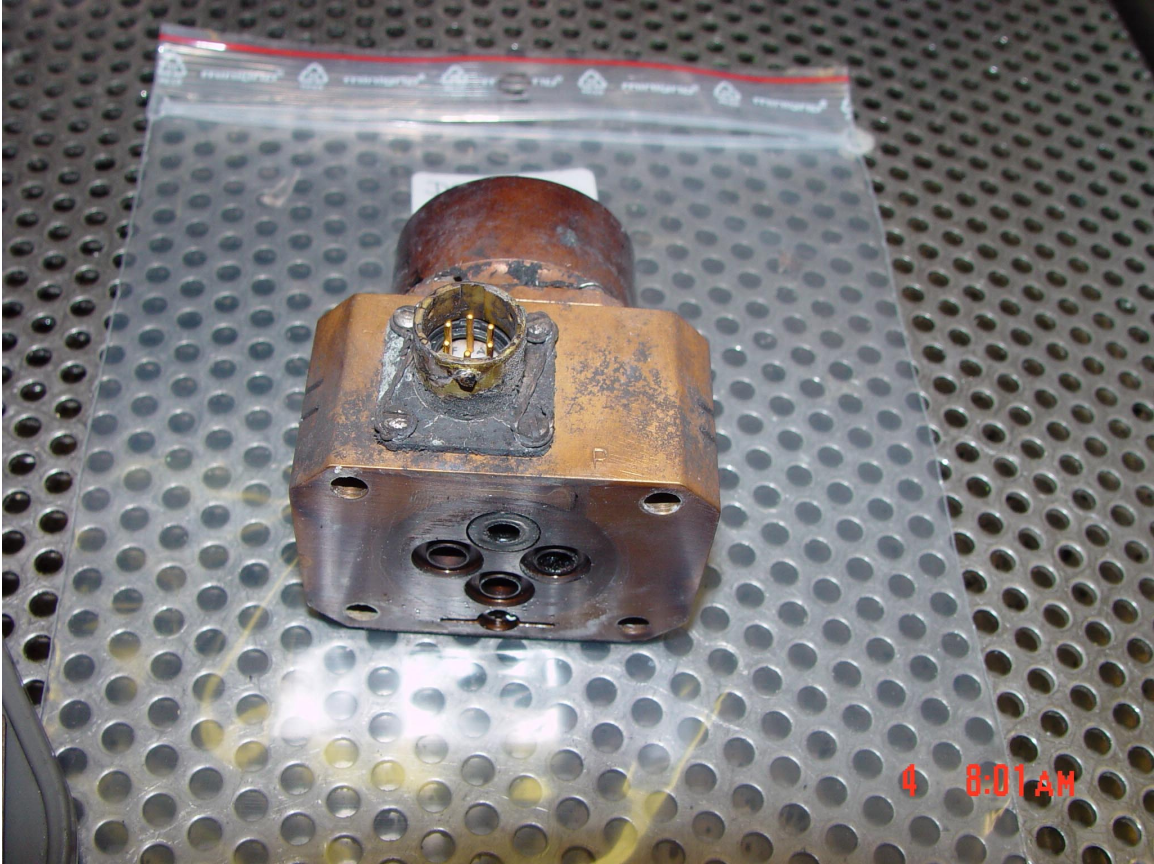
The Driven side servovalve was removed (IPL 1-20A), Appendix B, Figure 6.

Figure 6. Driven Side Servovalve.

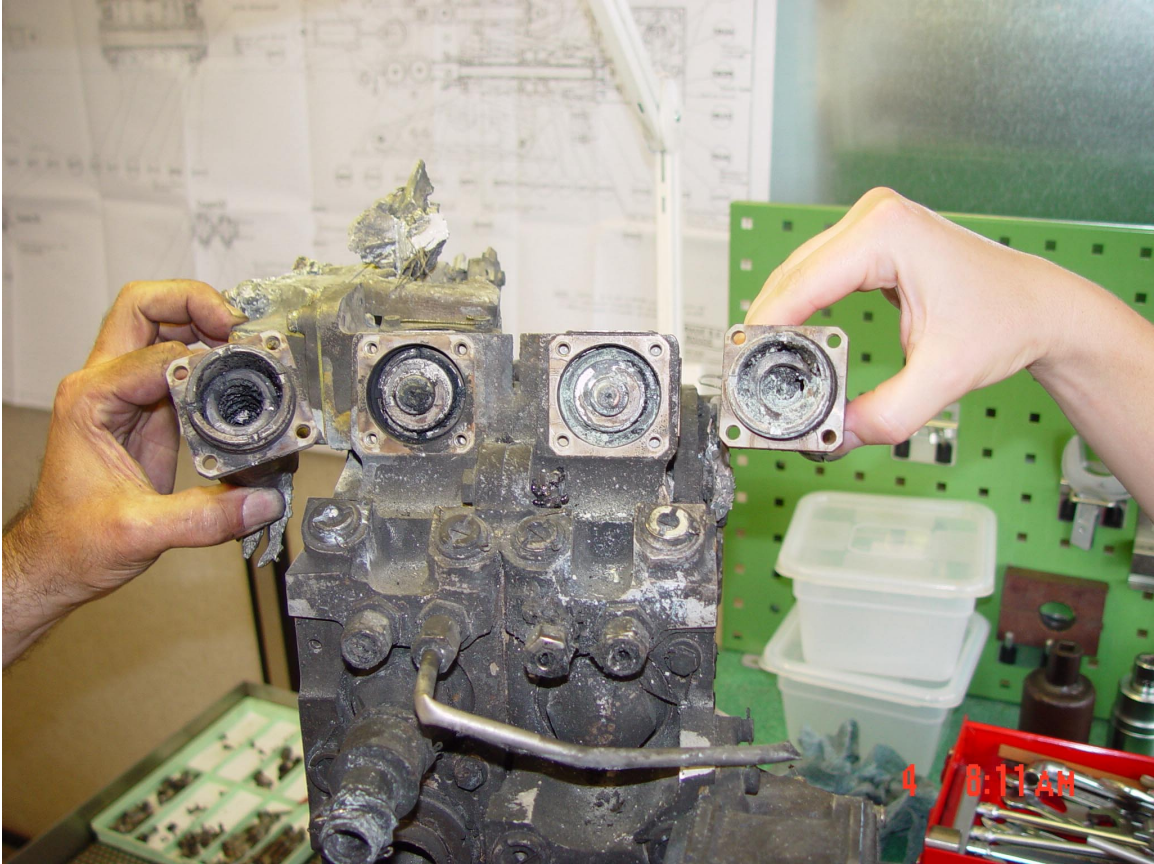
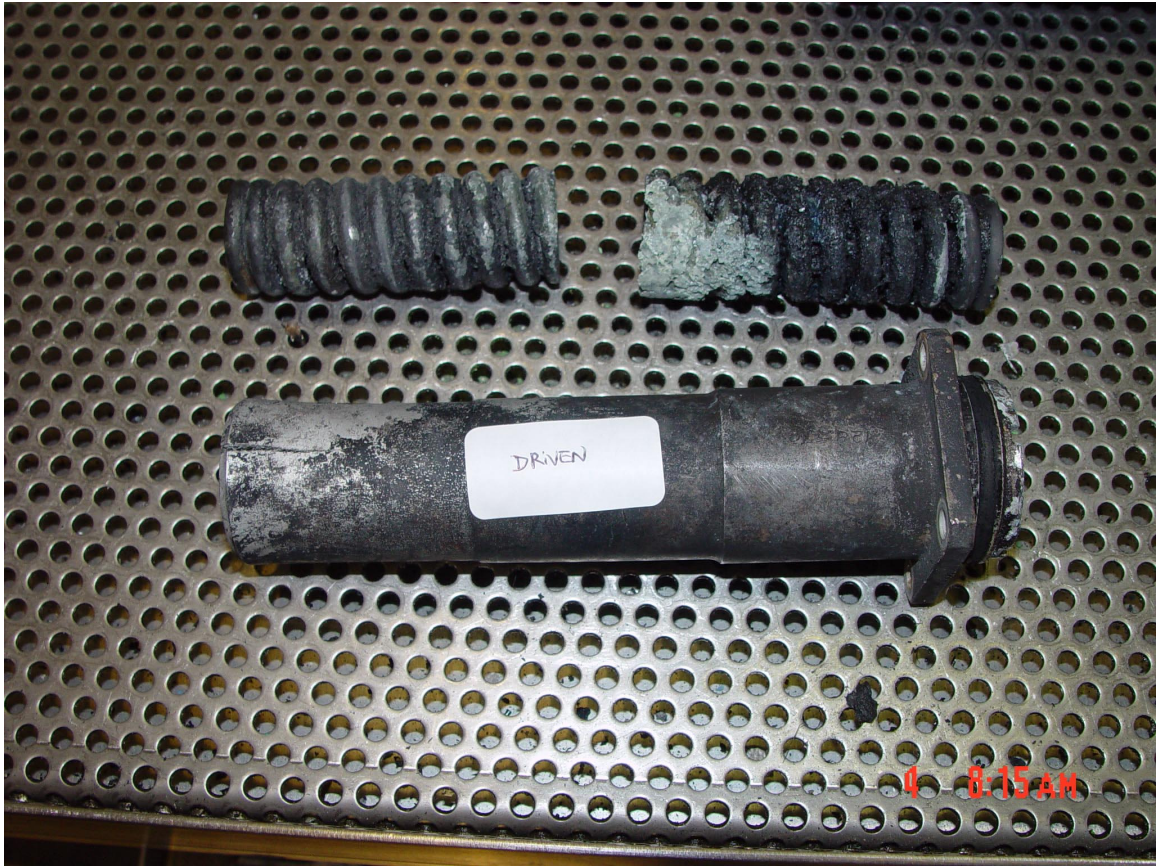
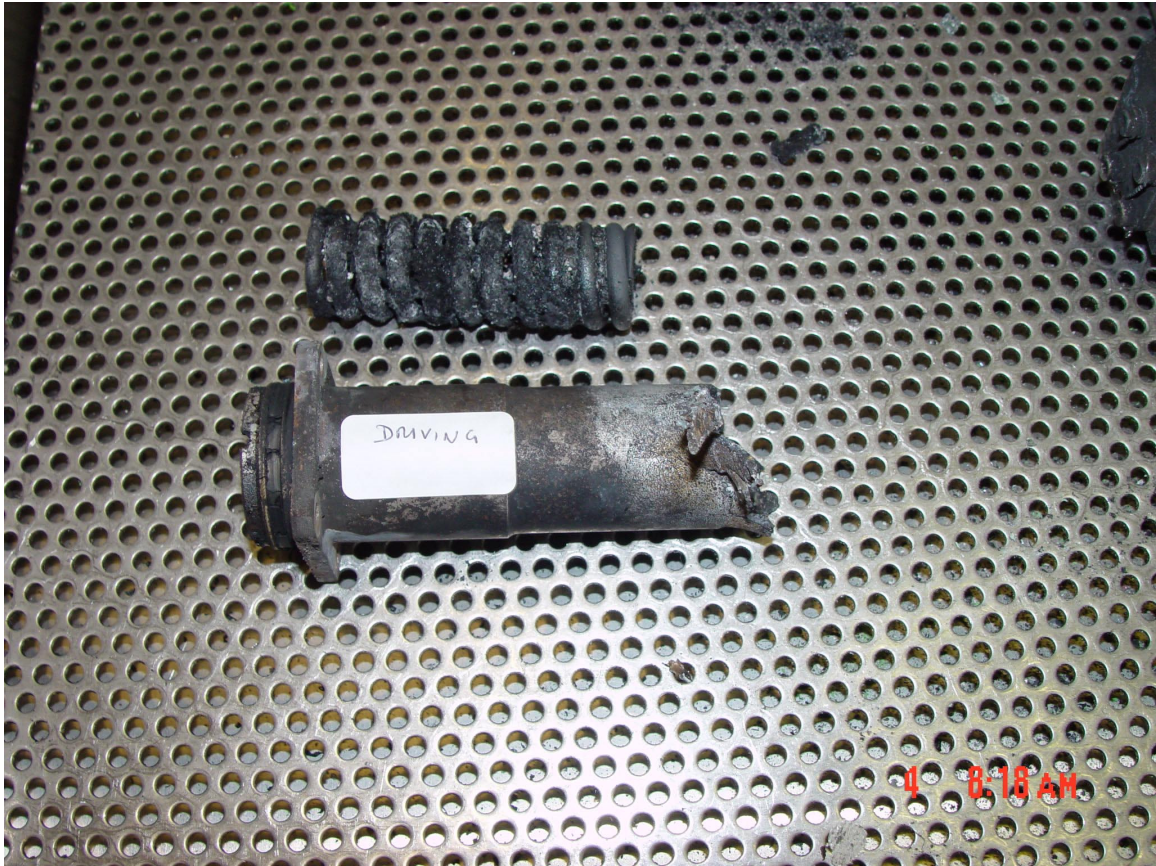
The spring housings (IPL 5-020) were damaged. The Driven channel had two springs, the Driving side had only one spring (IPL 5-060).

The Driving and Driven side locking cylinders were removed (IPL 5-20), Appendix B, Figures 7 to 9.

Figure 7. Driving (left) and Driven (right) Locking Cylinders Removed.

Figure 8. Driven Cylinder with Springs Removed.

Figure 9. Driving Cylinder with Spring Removed.

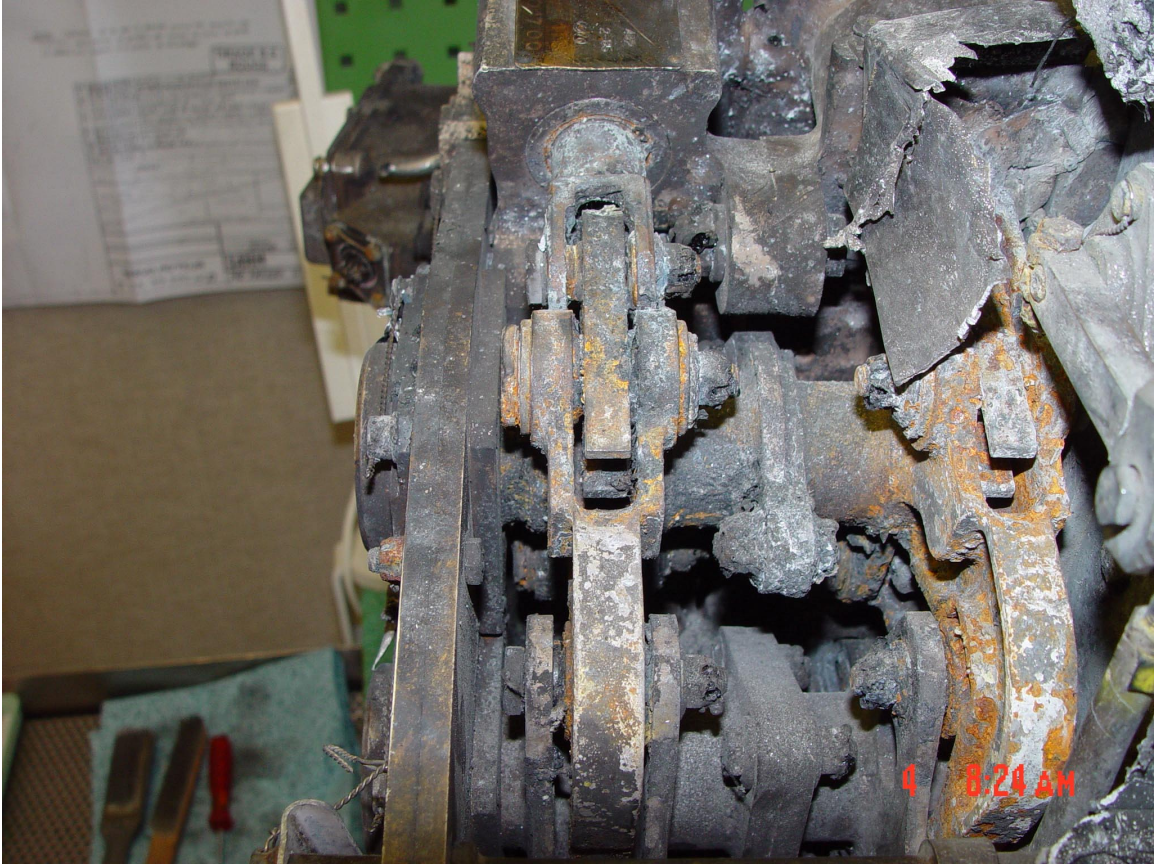
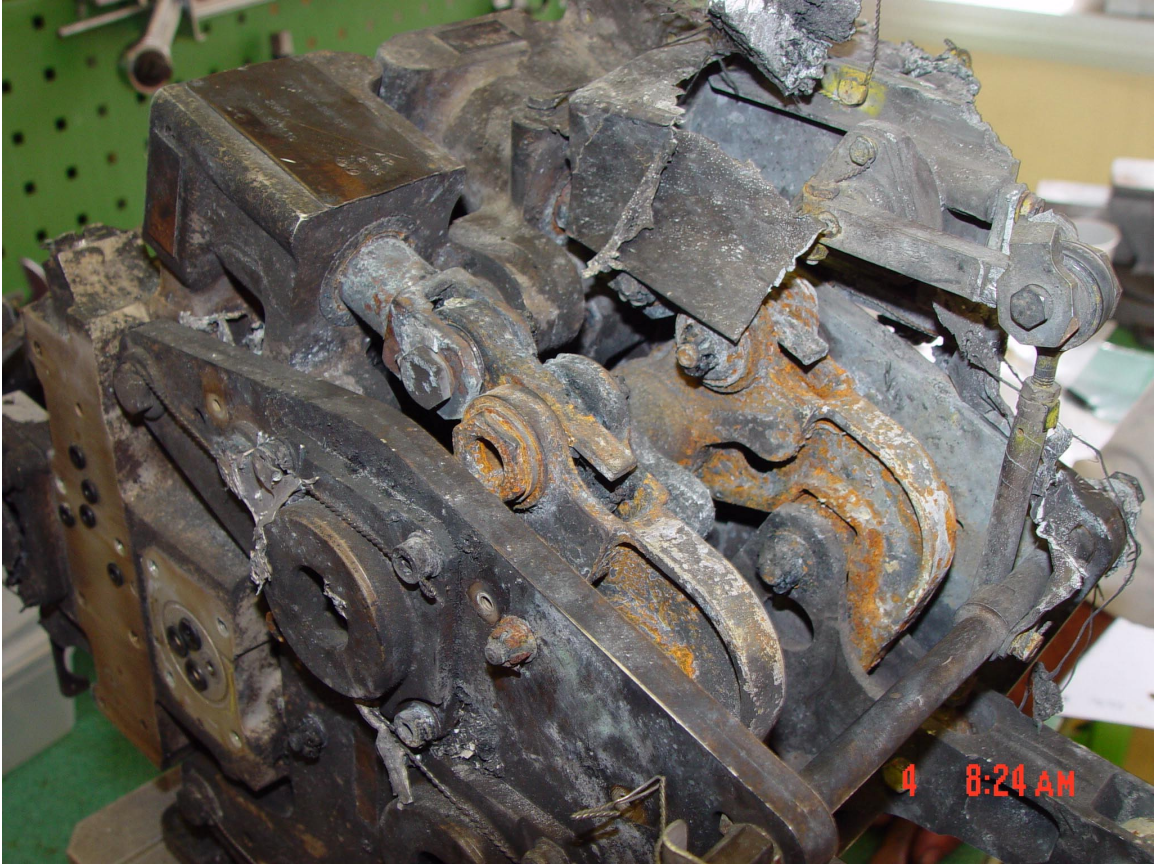
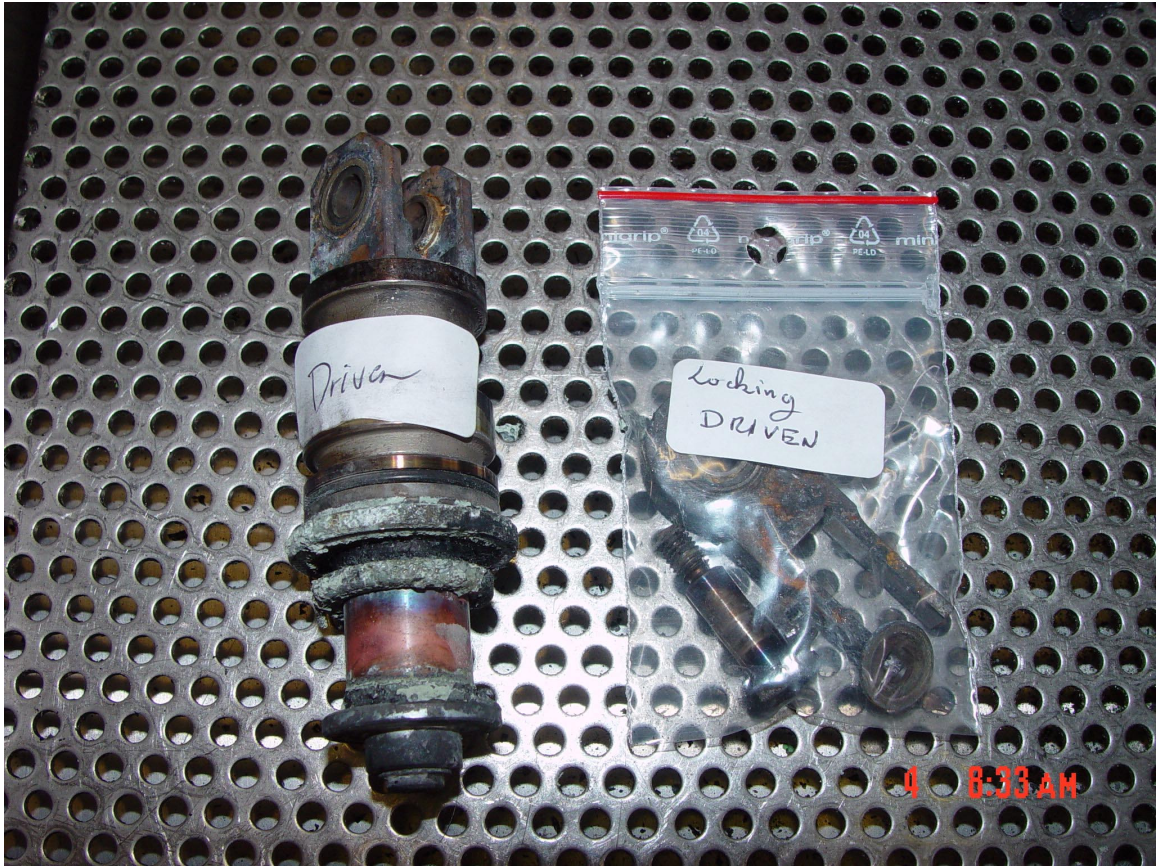
The Driven side lock linkage and piston were removed (IPL 5-150,5-190), Appendix B, Figures 10 to 12.

Figure 10. Driven side Locking cam linkage (left)

Figure 11. Driven Side Locking Cam Linkage.

Figure 12. Driven Side Locking Linkage Removed.

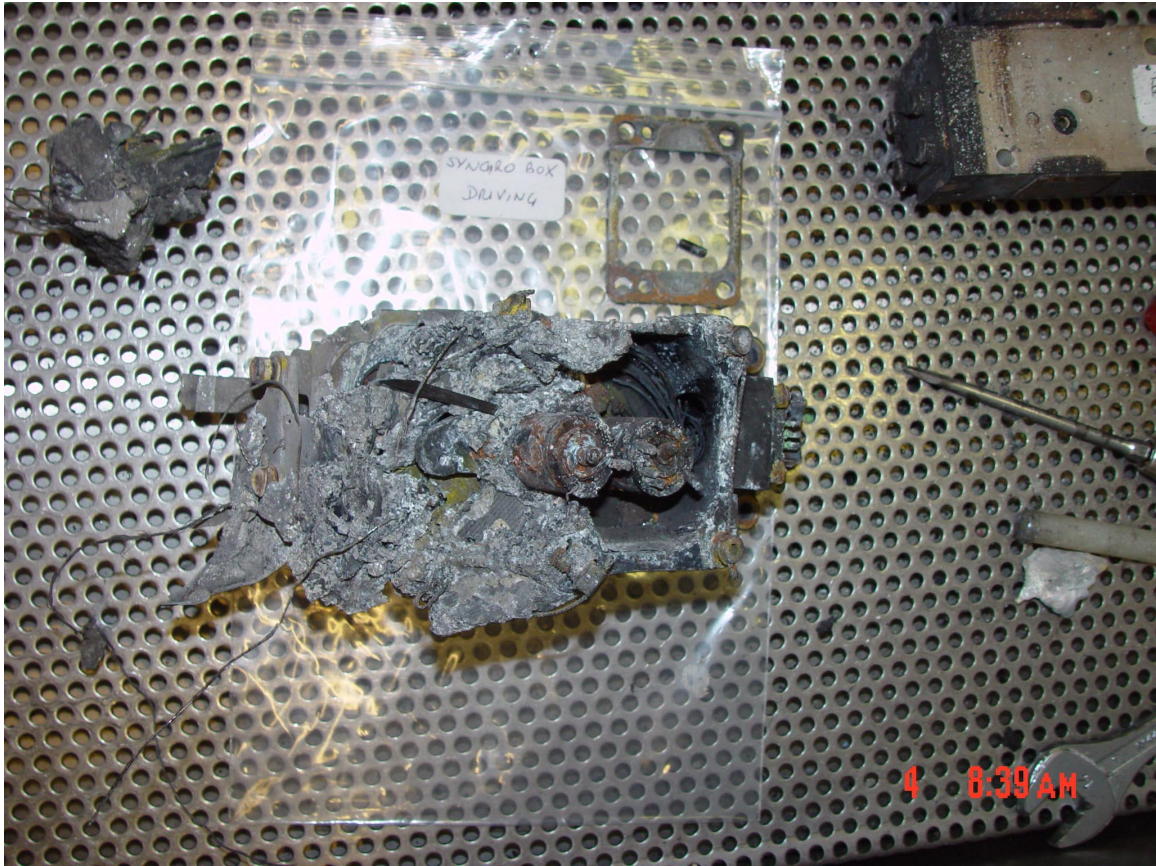
The Driving side synchro box input rod was fractured. This occurred while the unit was removed from molten metal parts which re-solidified on the component during the post accident fire. The synchro box linkage, which connected to the output arm was bent.

The Driving side synchro box was removed (IPL 1-140), Appendix B, Figure 13.

Figure 13. Driving Side Synchro Box Removed.

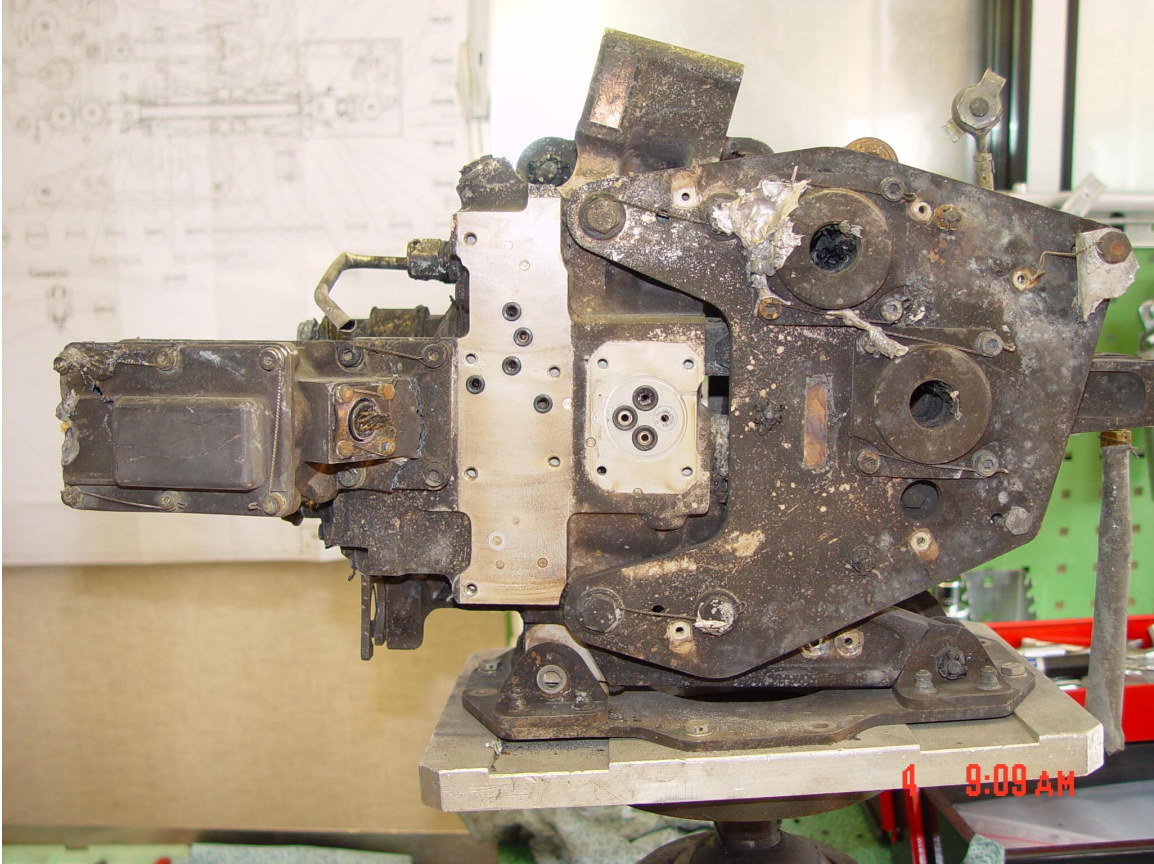
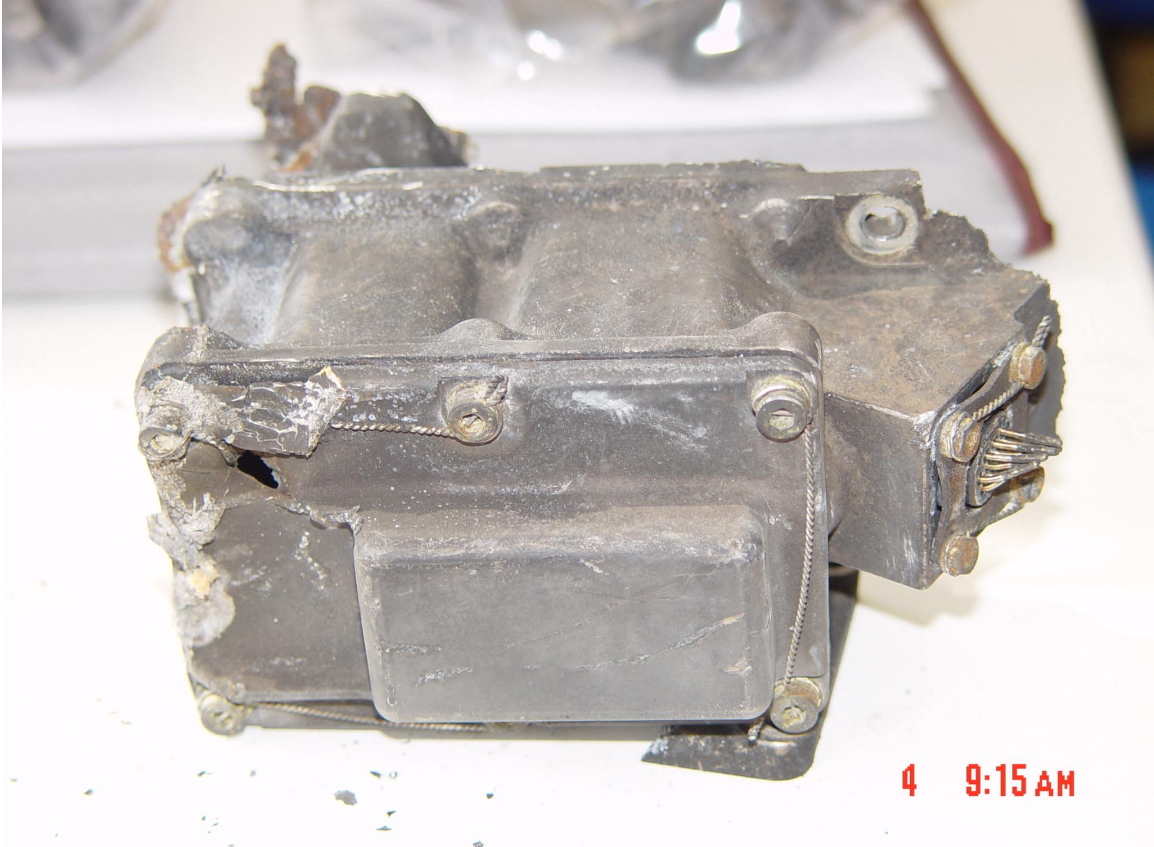
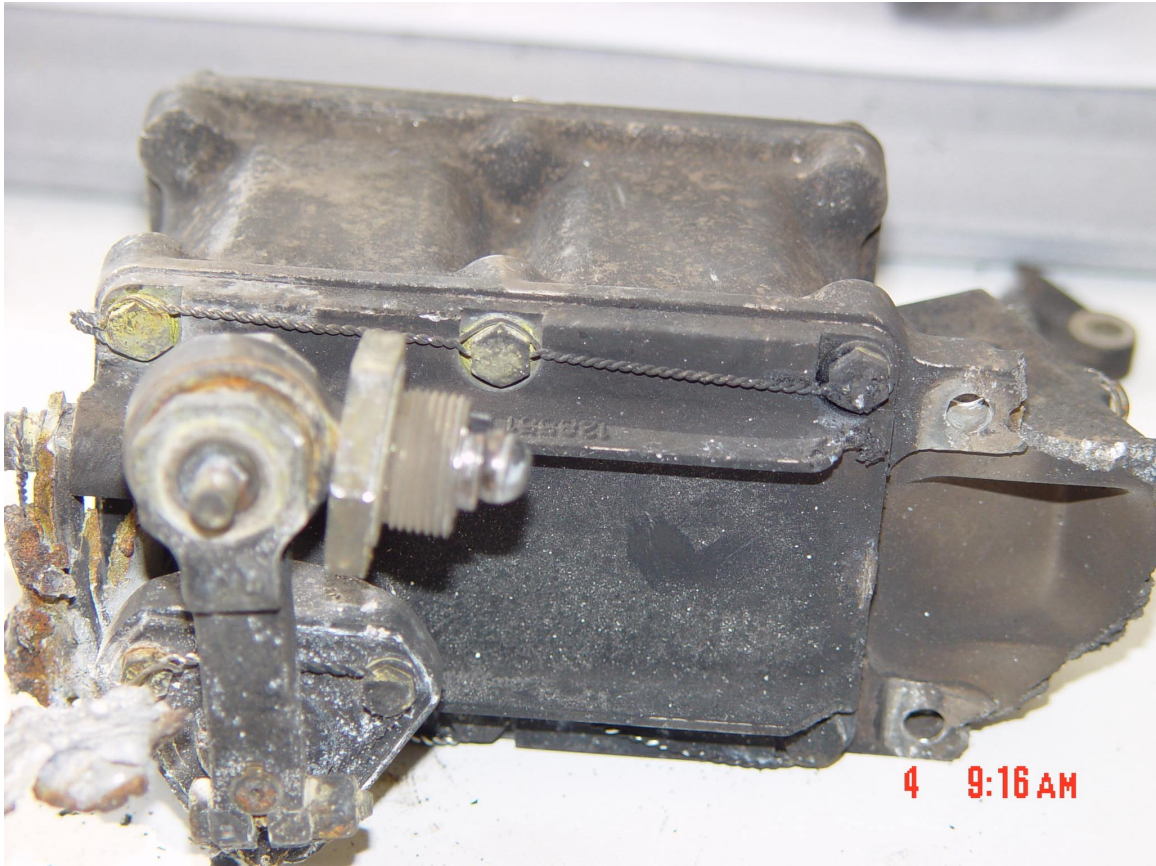
The Driven side synchro box attachment to the actuator was broken.

The Driven side synchro box was removed (IPL 1-140), Appendix B, Figures 17 to 19.

Figure 17. Driven side Synchro Box Installed (left).

Figure 18. Driven Side Synchro Box Removed.

Figure 19. Driven Side Synchro Box.

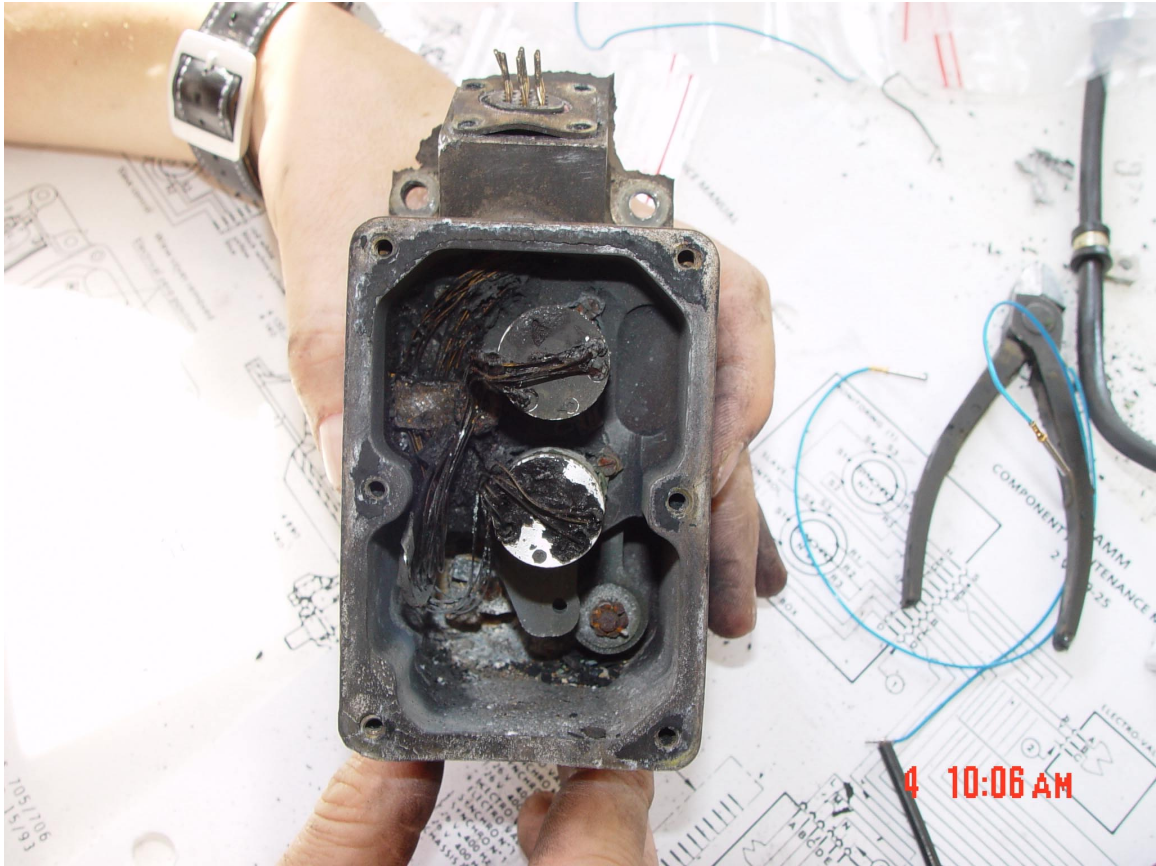
The cover of the Driven side synchro box was removed, Appendix B, Figure 20.

Figure 20. Driven Side Synchro Box with Cover Removed.

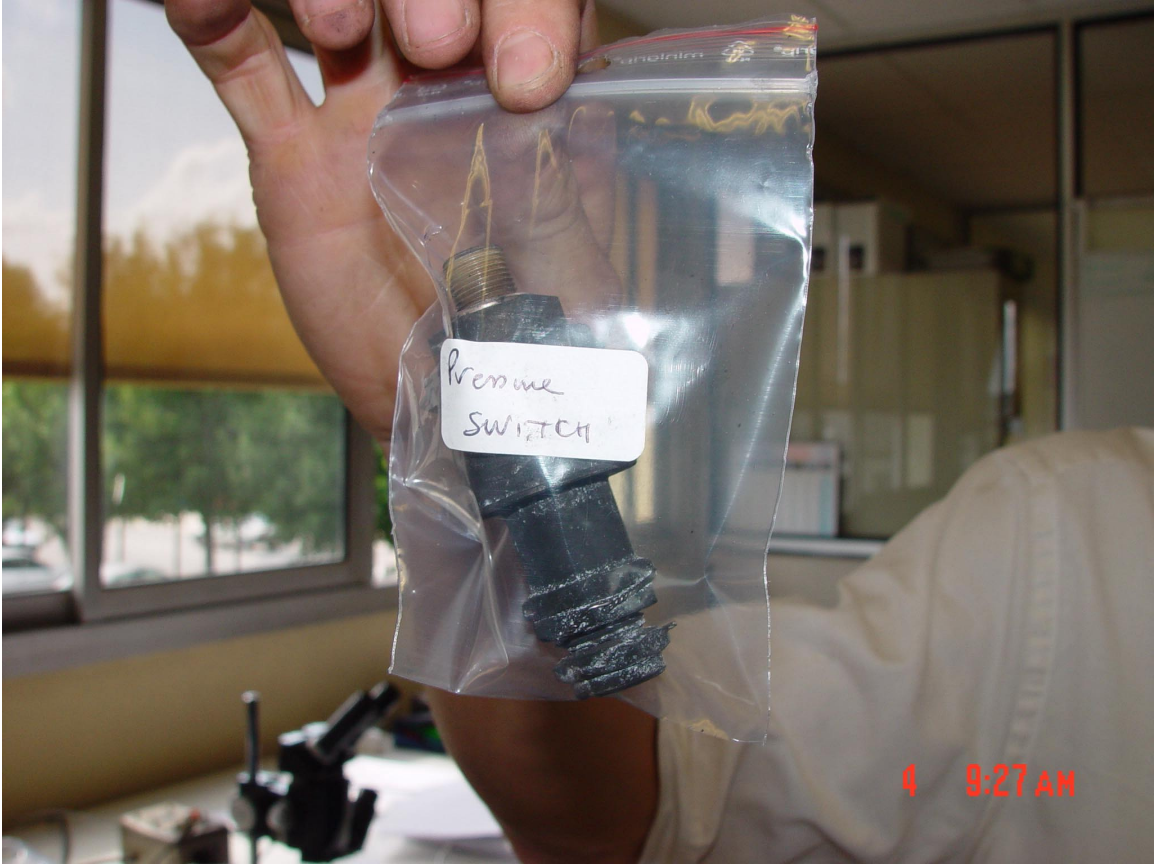
The engage pressure switch was removed (IPL 1-250), Appendix B, Figure 21.

Figure 21. Engage Pressure Switch Removed.

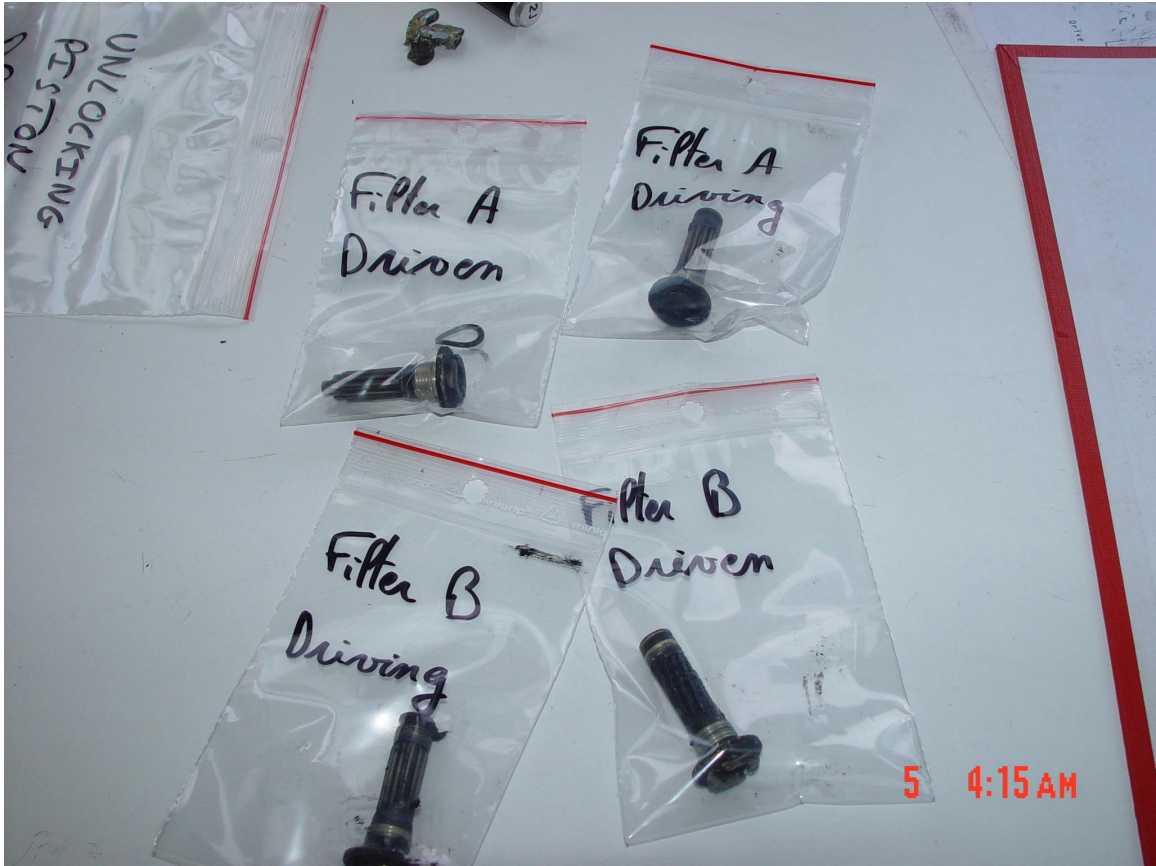
All filters were removed, Appendix B, Figure 22.

Figure 22. Removed Filters.
