**NATIONAL TRANSPORTATION SAFETY BOARD
OFFICE OF AVIATION SAFETY
WASHINGTON, D.C. 20594**

**ADDENDUM NUMBER 1 TO THE SYSTEMS GROUP CHAIRMAN'S
FACTUAL REPORT OF INVESTIGATION CONCERNING THE ARTIFICIAL
FEEL AND TRIM SYSTEM**

DCA02MA001

Operator: American Airlines
Aircraft: A300-600R
Location: Belle Harbor, New York
Date: November 12, 2001
Time: 09:16 EDT

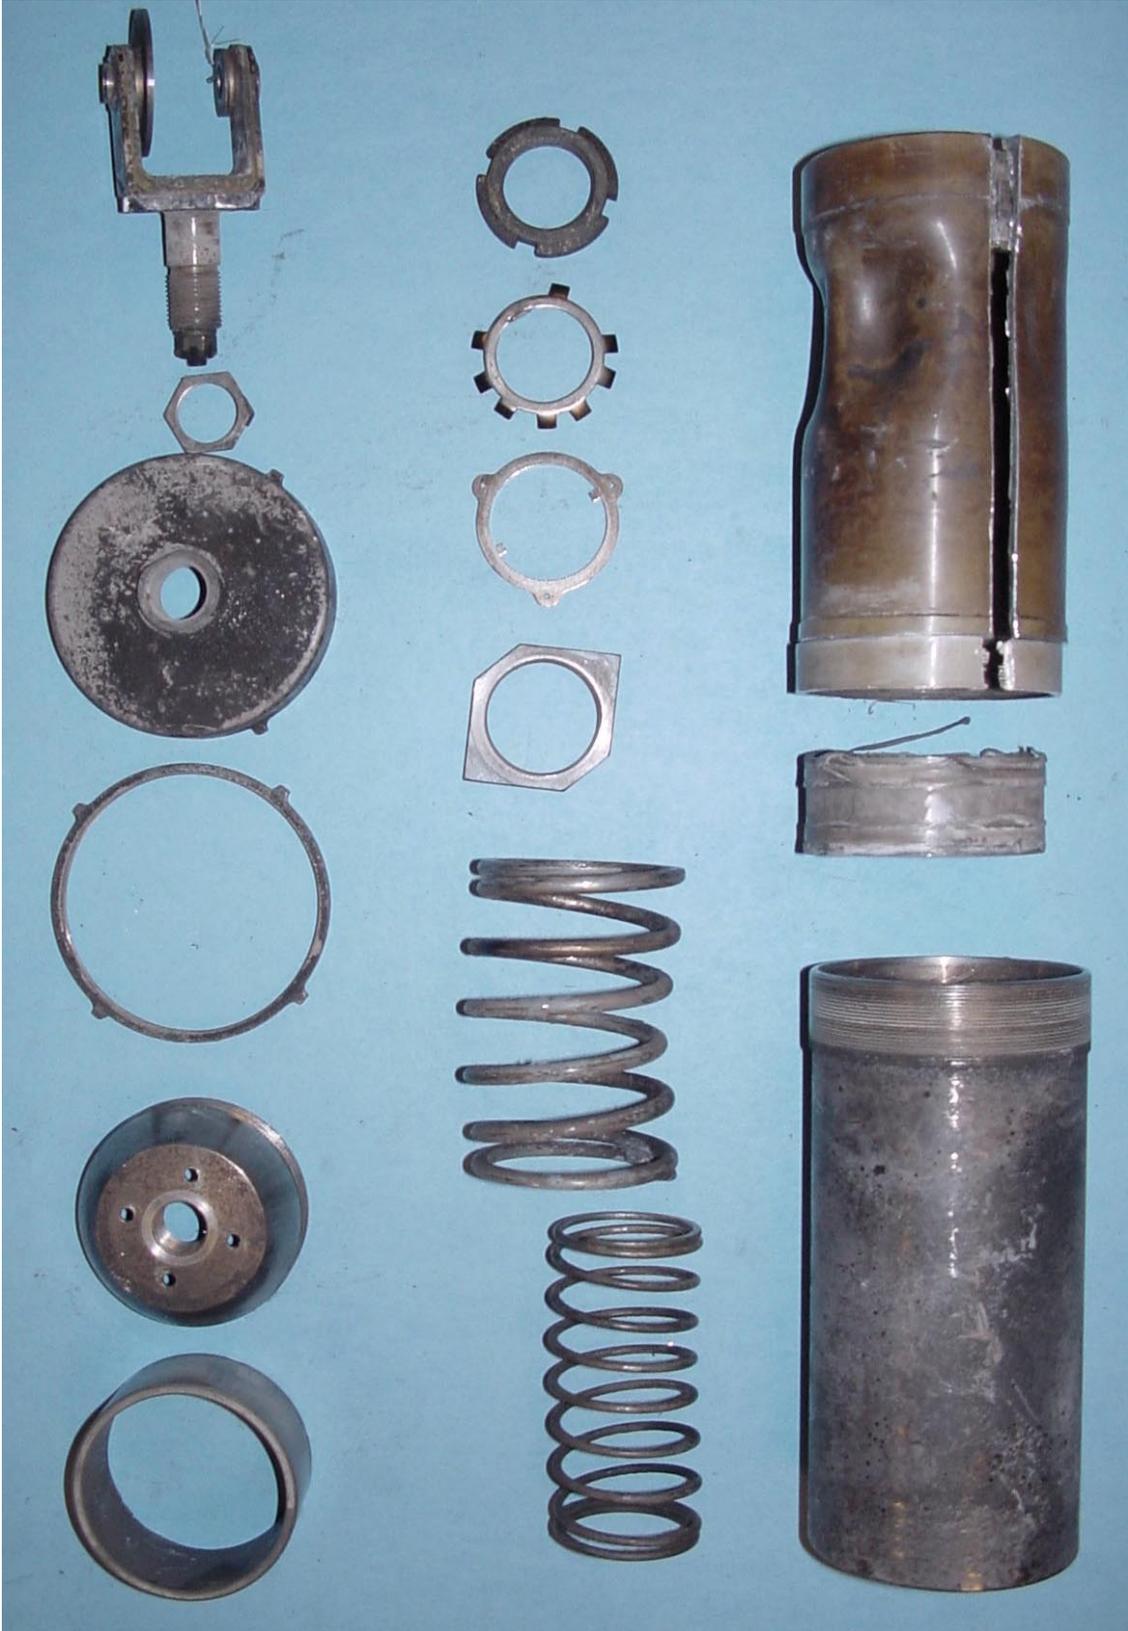
Figure 8. AFTU Spring Rod Assembly.

The item 100 inner end fitting could not be separated from the item 210 inner sleeve. A band saw was used to separate the item 100 part from item 210. This did not damage any other parts.

The inner sleeve, made of an aluminum alloy, was collapsed in on the item 190 outer spring. The sleeve was formed to the contour of the spring in some places (Figure 10). This restricted the compression of the outer spring and impeded any motion of the item 160 lower spring guide. The upper spring guide slip rings, made of Teflon, were partially melted. The inner spring was free to be removed from the assembly, but to remove the outer spring it was necessary to cut the inner sleeve.

The uncompressed inner spring was measured to be 90.15 mm. The uncompressed outer spring was measured to be 83.2 mm

The spring rate of each spring was determined by a calibrated load cell. The inner spring was compressed 50 mm under a load of 67 N - spring rate => 1.34 N/mm. The spring rate per the drawing is 1.15 N/mm. The outer spring was compressed 10 mm under a load of 85.4 N - spring rate => 8.54 N/mm. The specification per drawing is 8.22 N/mm.

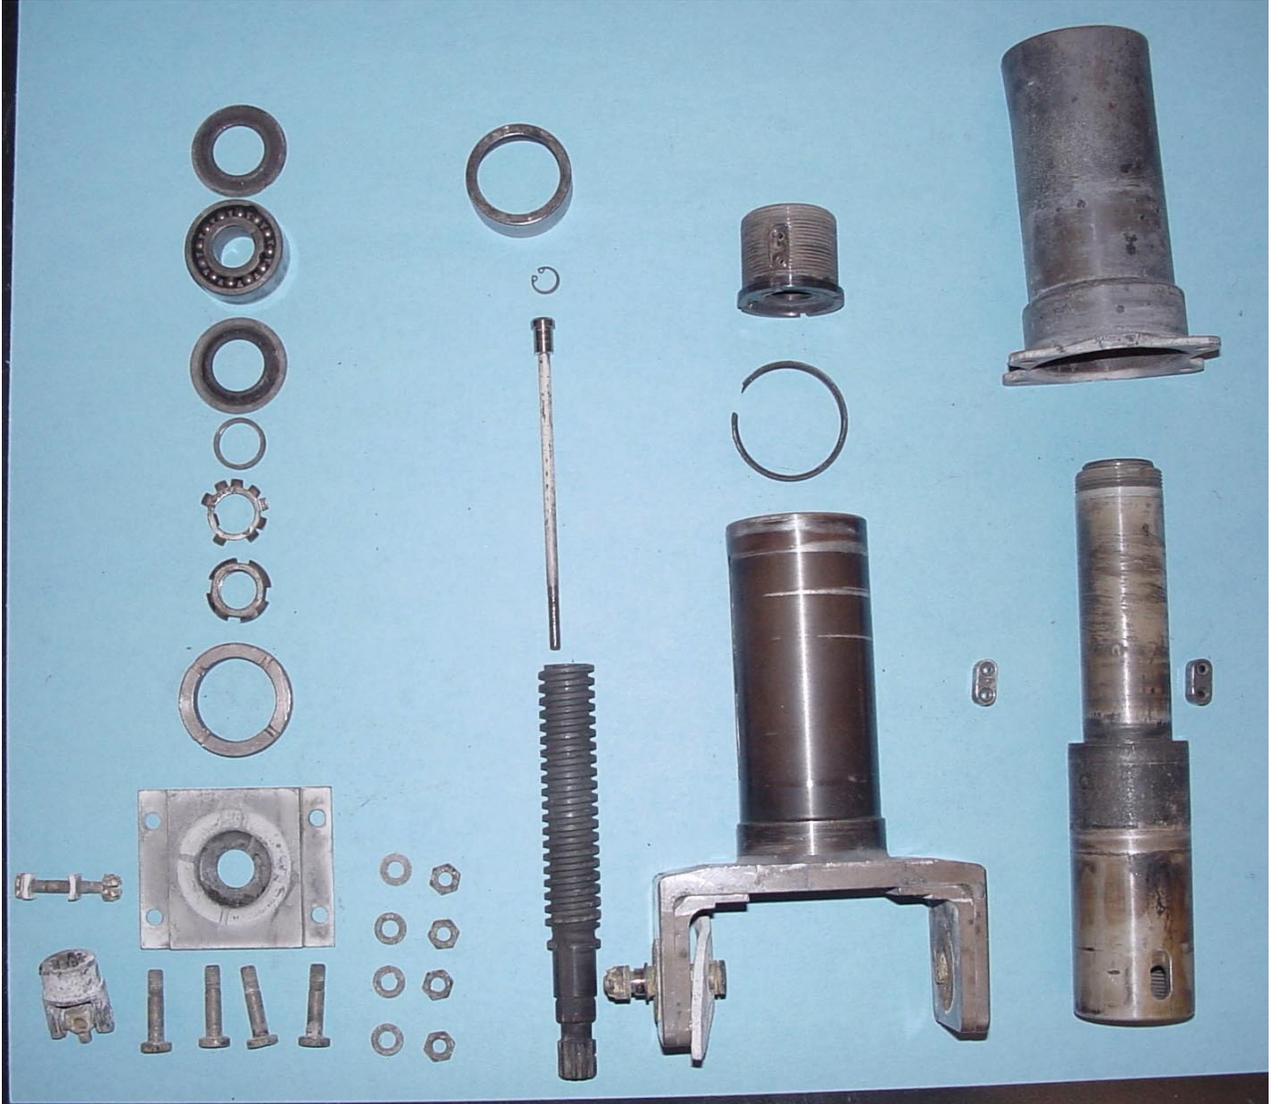
Figure 9. AFTU Screwjack Assembly

The item 56, silicone seal ring was brittle and segmented.

Considerable force was required to rotate and remove the item 10 outer casing from the item 100 fork end fitting. After removal the outer casing appeared to be slightly

ovalized. Two cracks were observed on the fork end fitting. The cracks are illustrated in Figure 11. The cracks appear to have deposits in them.

The item 70 screws could not be turned, so they were drilled out. The item 190, bearing did not rotate freely and the inner diameter was seized to the item 88 screwjack. This prohibited the removal of item 82 and the screwjack assembly from the item 100 fork end fitting. The screwjack was therefore removed from the item 86 nut by rotation, allowing the removal of item 82 from item 100.
