NATIONAL TRANSPORTATION SAFETY BOARD
Office of Aviation Safety
Washington, DC

**ADDENDUM TO SYSTEMS GROUP CHAIRMAN'S
FACTUAL REPORT OF INVESTIGATION**

A. **ACCIDENT:** NTSB Case No. DCA00MA023

AIRCRAFT: McDonnell Douglas MD-83; N963AS

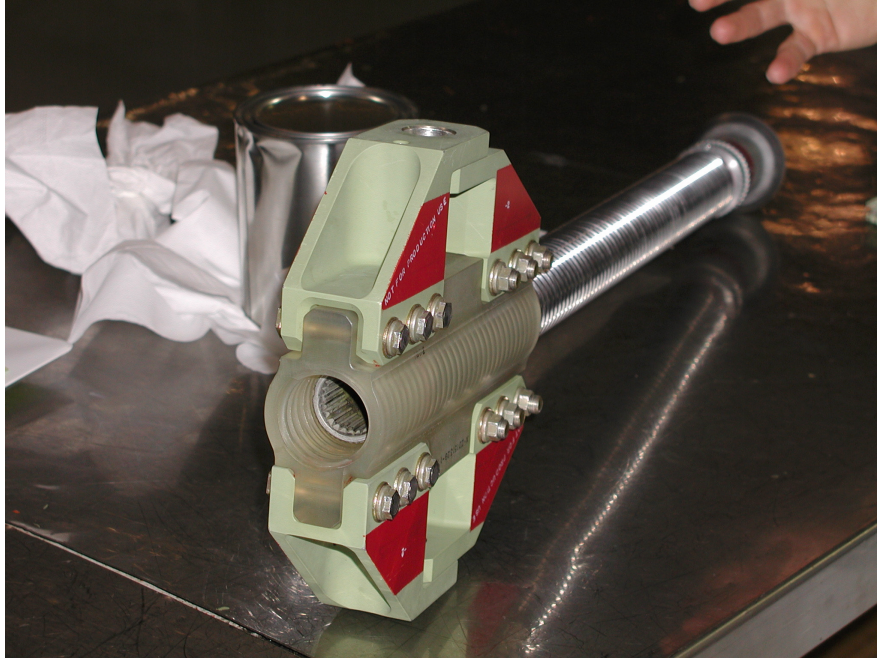
1. Translucent acme nut used in lubrication demonstration at Integrated Aerospace.

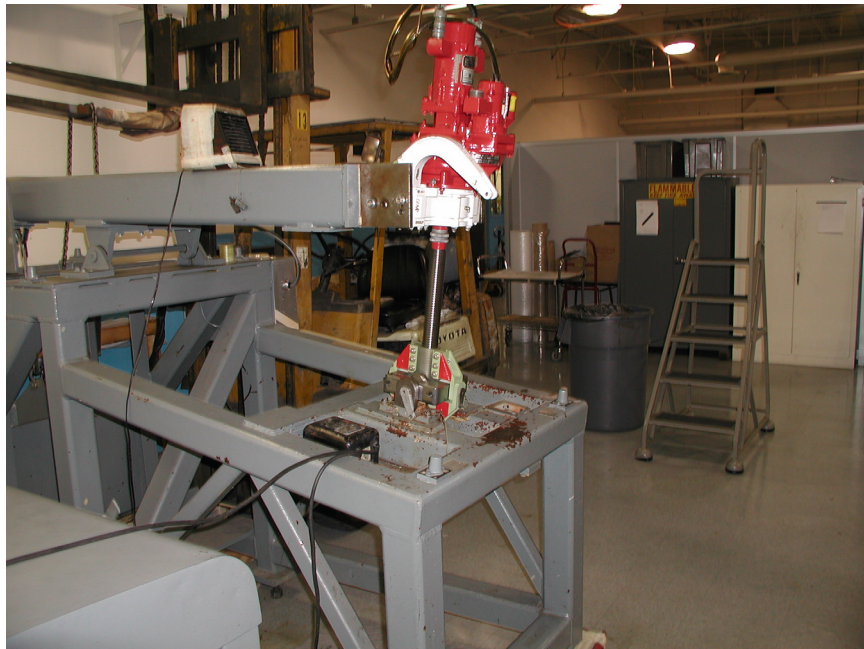
2. Acceptance Test Plan fixture used for acme nut demonstrations at Integrated Aerospace

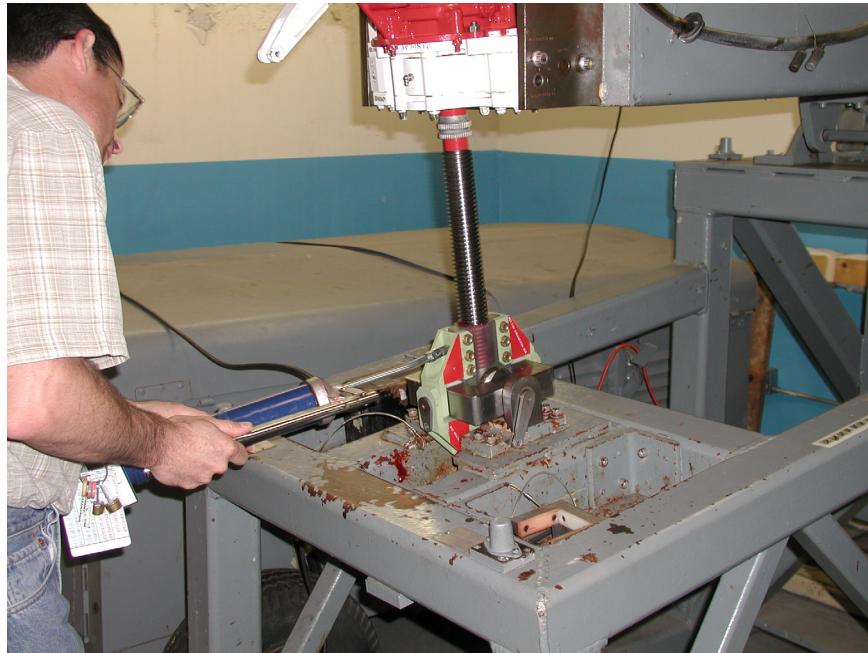
3. Application of Mobil 28 grease to translucent acme nut grease fitting only.

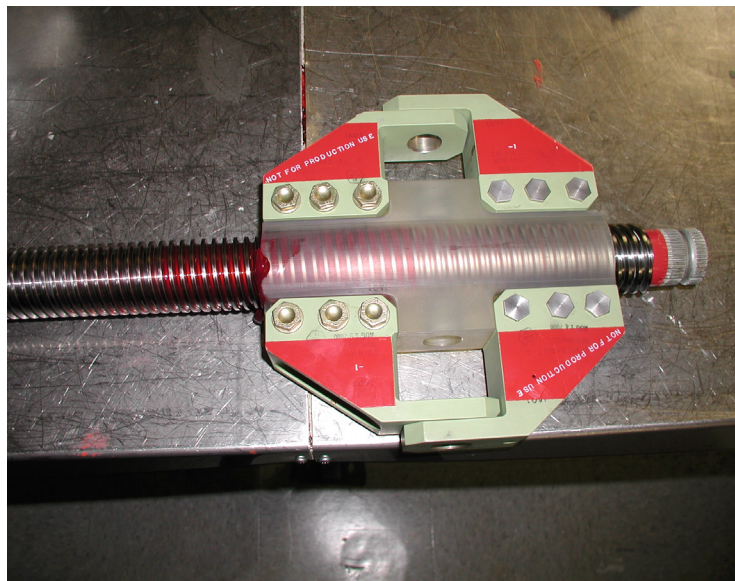
6. View of acme screw and nut after several cycles following grease application to fitting only.

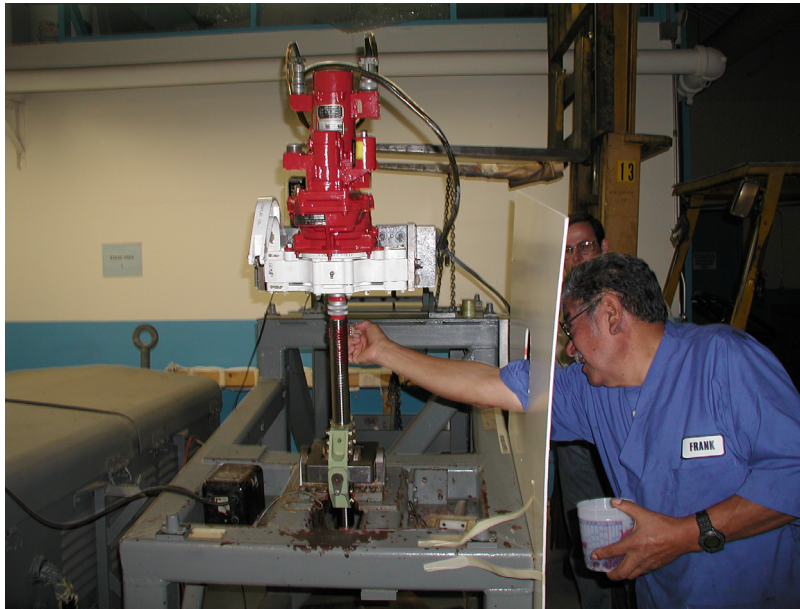
7. Demonstration of grease application onto acme screw only. Grease is being applied with a brush through a mockup of exterior aircraft skin and access panel (Panel is about 10 inches closer to the acme screw on an actual MD-83 aircraft)

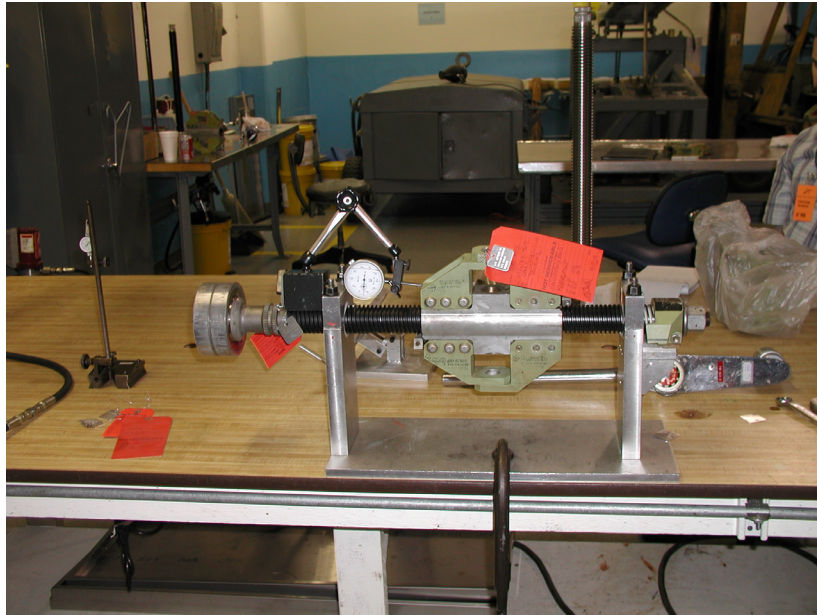
11. Bench test set-up used to perform end-play checks for varying tightness values on the torque tube nut.

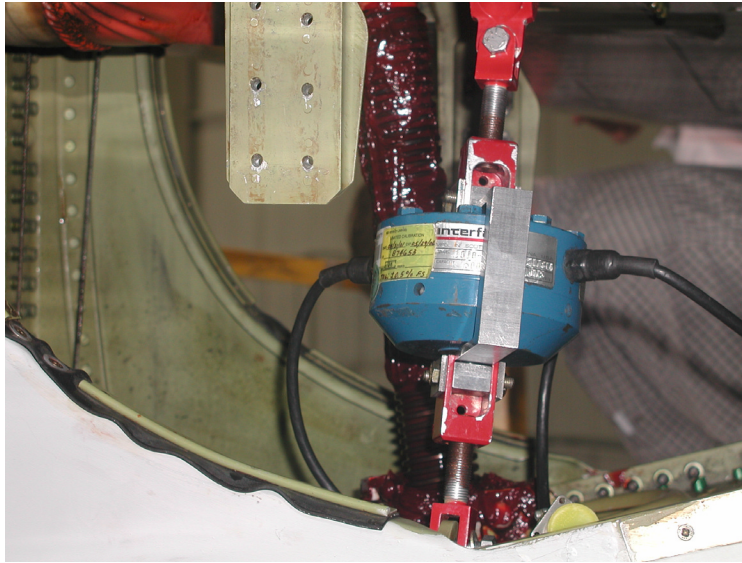
13. Boeing-fabricated restraining fixture tool used during on-wing force tests. Note the blue load cell device imbedded into the tool.

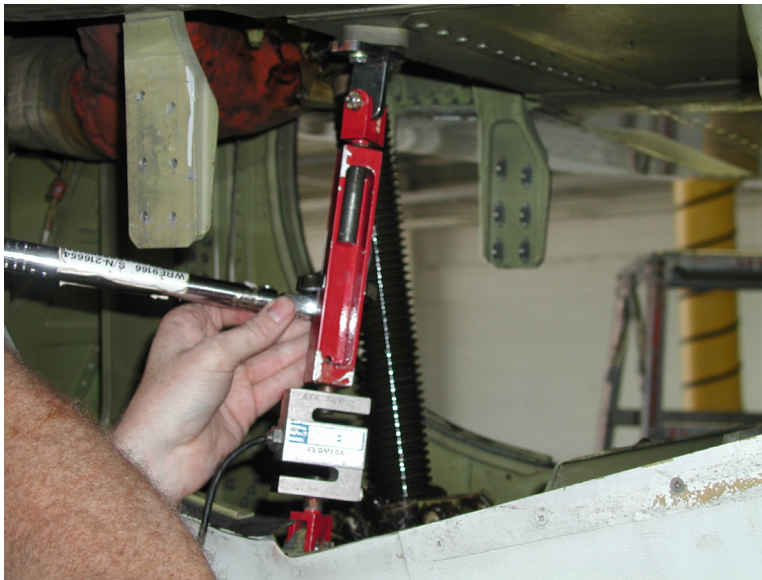
14. Alaska-fabricated strain gauge device imbedded into a Boeing restraining fixture used during on-wing force output tests.

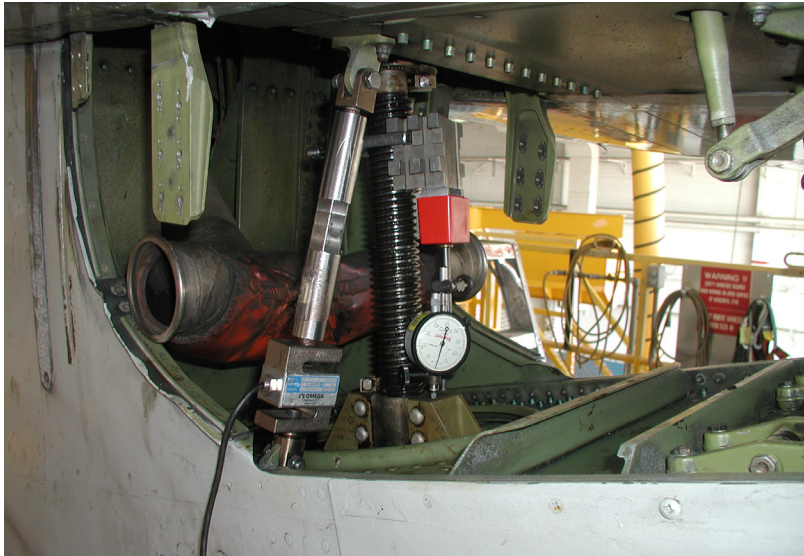
15. Alaska-fabricated strain gauge device imbedded into an Alaska Airlines restraining fixture used during on-wing force output tests.

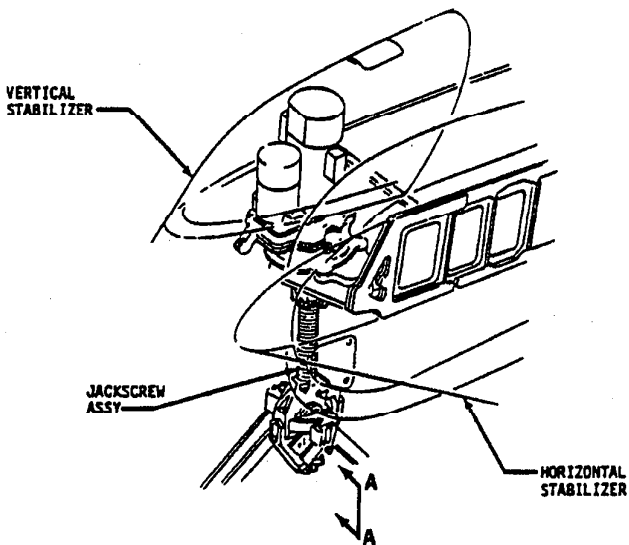
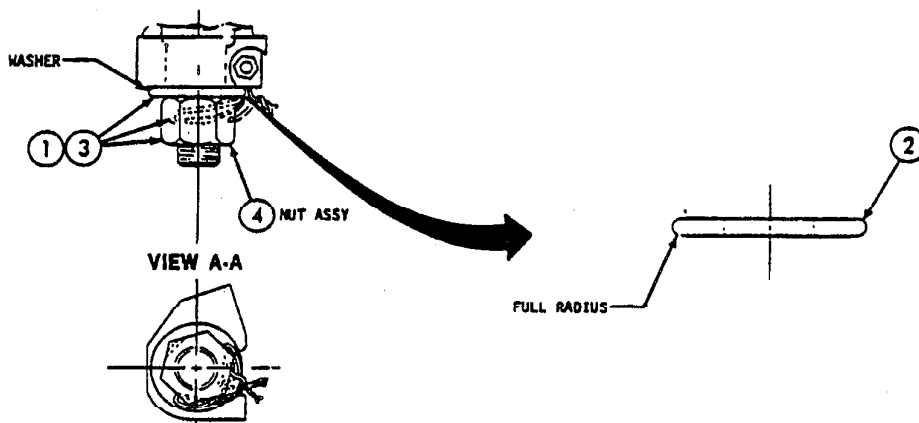
JACKSCREW WASHER - MODIFICATION

Three operators have reported finding the nut assembly on the bottom of the horizontal stabilizer jackscrew assembly loose. This condition results in excessive wear in the splined area at the upper end of the assembly. Increasing the torque requirement for the nut assembly, and installing double lockwire will alleviate this condition.

- ① REMOVE AND RETAIN NUT ASSEMBLY AND 2919060-1 WASHER FROM JACKSCREW ASSEMBLY.
- ② MODIFY 2919060-1 WASHER BY ADDING A FULL RADIUS SURFACE TO OUTBOARD EDGE. REIDENTIFY MODIFIED WASHER AS 2919060-501 BY INK STAMPING.
- ③ INSTALL MODIFIED AND REIDENTIFIED WASHER USING RETAINED NUT ASSEMBLY. TIGHTEN NUT ASSEMBLY TO A TORQUE OF 110 FOOT-POUNDS. BACK OFF NUT ASSEMBLY UNTIL 2919060-501 WASHER IS FREE TO ROTATE.
- ④ TIGHTEN NUT ASSEMBLY TO A TORQUE OF 50 TO 60 FOOT-POUNDS. DOUBLE SAFETY NUT ASSEMBLY WITH MS20995NC51 LOCKWIRE.
