ANALYTICAL ENGINEERING REPORT

AIRPLANE 17

SUBJECT: Analysis of Contaminants on BACC45FT Connectors

**Honeywell 757 Fuel Tank Compensator
(Failure Analysis)**

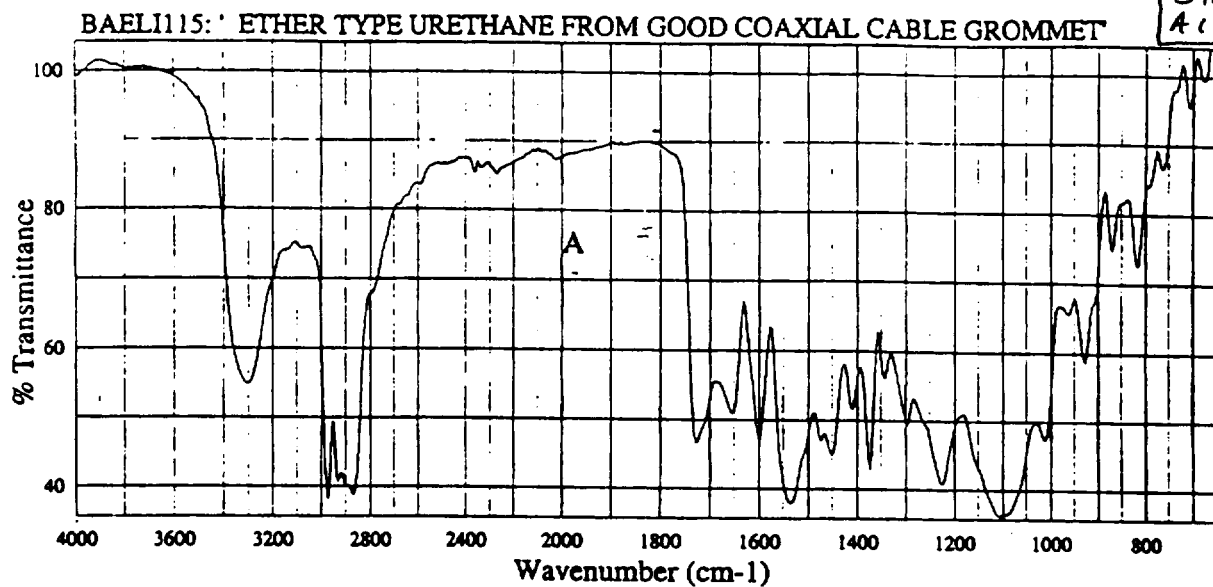
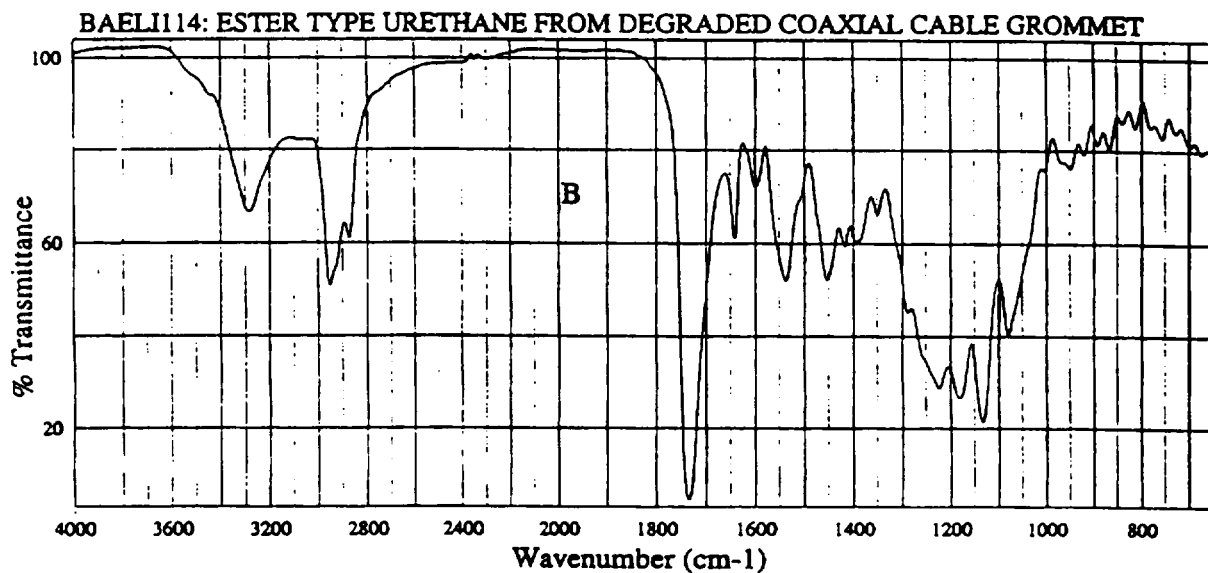
Figure 2. Infrared reference spectra of (A) a polyether urethane and (B) a polyester urethane.

Samplings of the foam pads were analyzed by infrared microspectroscopy, yielding the spectra in Figure 1. Figure 1A reveals that the yellow foam consists of a urethane polymer that was synthesized from a polyether pre-polymer. Urethane foams of this type are known to exhibit good chemical stability and resistance to hydrolysis under humid conditions. The spectra of the degraded black and orange pads (1B and 1C) are typical of urethane foams synthesized from polyester pre-polymer. Urethanes of this type have poor resistance to environment in that the ester linkage is subject to hydrolysis. The hydrolysis process is often termed "reversion" due to the fact that such products eventually return to a liquid state. The rate of hydrolysis is a function of the temperature and humidity to which the material is exposed. No liquid contaminants were indicated by the spectra. Reference spectra are included in Figure 2 for comparison. The polyether urethane foam is recommended for this application rather than the polyester urethane, but consideration should be given to the requirement of BACC10DS that calls for a silicone product.
