**NATIONAL TRANSPORTATION SAFETY BOARD
OFFICE OF AVIATION SAFETY
WASHINGTON, D.C. 20594**

**ADDENDUM NUMBER 2 TO THE SYSTEMS GROUP CHAIRMAN'S
FACTUAL REPORT OF INVESTIGATION – RUDDER SERVO CONTROLS
AND LINKAGE**

DCA02MA001

Operator: American Airlines
Aircraft: A300-600R
Location: Belle Harbor, New York
Date: November 12, 2001
Time: 09:16 EDT

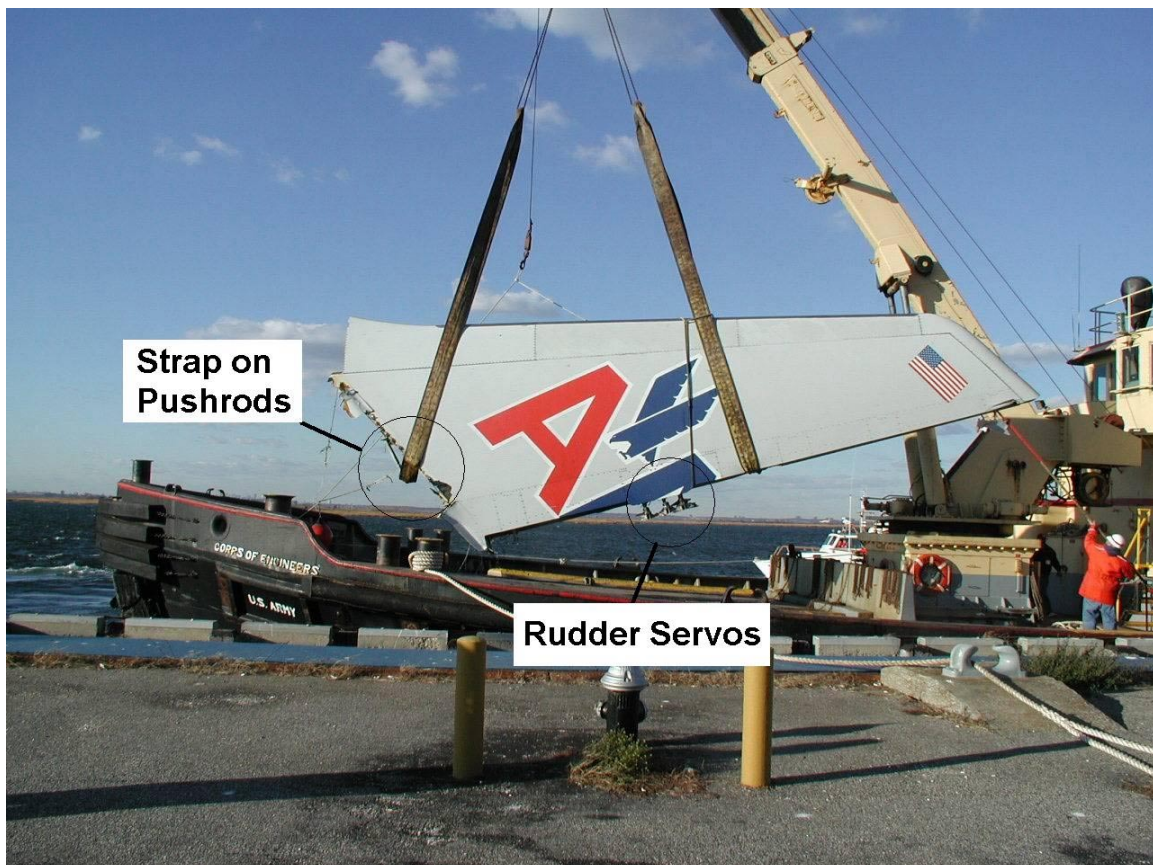
Figure 2.1A Recovery of Vertical Stabilizer from Jamaica Bay.

The control linkage was intact from the bellcranks at the rudder servo to the base of the vertical stabilizer (See Appendix A for photos). The control rods fractured at the location indicated in Figure 1, approximately six inches from the end of the rod. Figure 2.1A and 2.1B show the recovery of the vertical stabilizer from Jamaica Bay. The support straps were positioned in the same area where the control rods were fractured. The pushrod and bellcrank near rib 3 were damaged, as shown in Appendix A, Figure 10. The bearing from one of pushrods had been removed and bagged during shipping, so documentation of that bearing in situ was not possible. There did not appear to be any binding or measurable freeplay in the linkage.

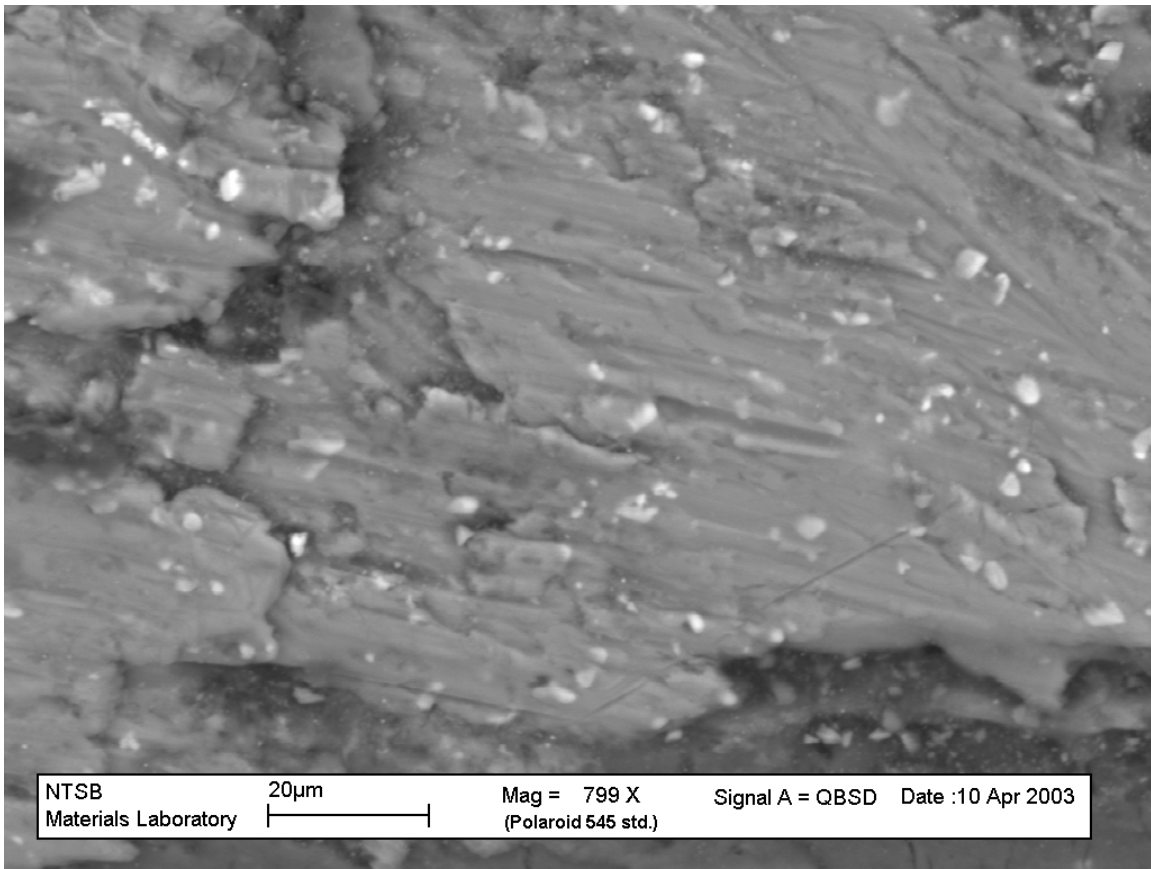
Figure 3.4C. Scanning Electron Microscope Image, Typical of the Areas Identified in Figure 3.4B.

The upper springrod was bent as shown in Figure 3.4A. A dent was observed in the springrod cap as well as damage to the corner of the middle rudder servo hydraulic block. After disassembly the springrod was submitted to the NTSB lab for further examination. The results were provided in the Materials Laboratory 15 - Factual Report 02-091, dated October 11, 2002.

The springrod cap, and rudder servo hydraulic block are manufactured from aluminum alloys (2024 and 2618 respectively). The American Society for Metals, Metals Handbook, Volume 9, page 366, indicates that alloy 2618 contains insoluble particles of FeNiAl_9 . Alloy 2024 is not known to have these constituents. The dent in the cap was inspected by scanning electron microscope (SEM) and energy dispersive spectroscopy (EDS). Figure 3.4B shows three areas of the dent which were sampled. Figure 3.4C is an enlargement of one of the areas. Many of the small bright spots in 3.4C were examined with EDS, and the results shown in Figure 3.3.4D were typical. Figure 3.4D showed the bright areas primarily contained Al, Fe, and Ni.
