NATIONAL TRANSPORTATION SAFETY BOARD
Office of Aviation Safety
Washington, D.C. 20594

SYSTEMS GROUP CHAIRMAN FACTUAL REPORT ADDENDUM
FOR DEPOSITS ON FUEL TANK ELECTRICAL COMPONENTS

A. ACCIDENT: DCA96MA070

Airplane : Boeing 747-131, N93119
Operated as Trans World Airlines (TWA) Flight 800

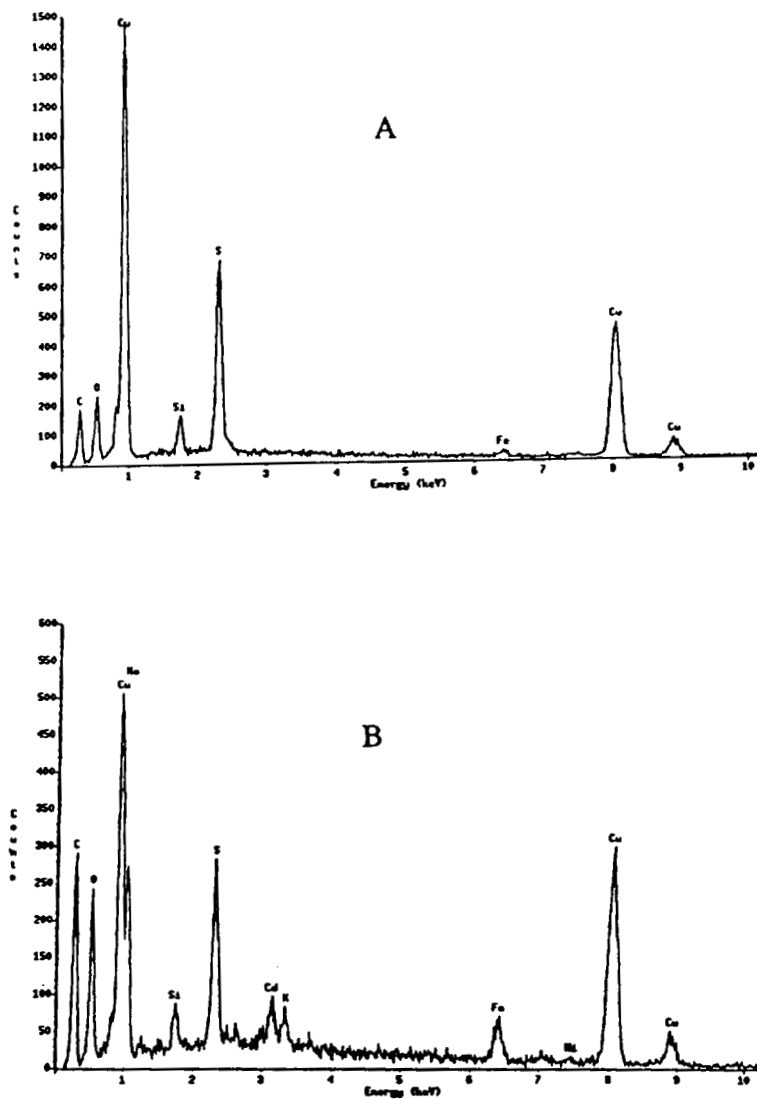
Figure 10. Electron microprobe elemental surveys of dark deposits sampled from the fuel quantity tank unit F44 Hi-Z terminal block (A) before and (B) after the month long sea water exposure.

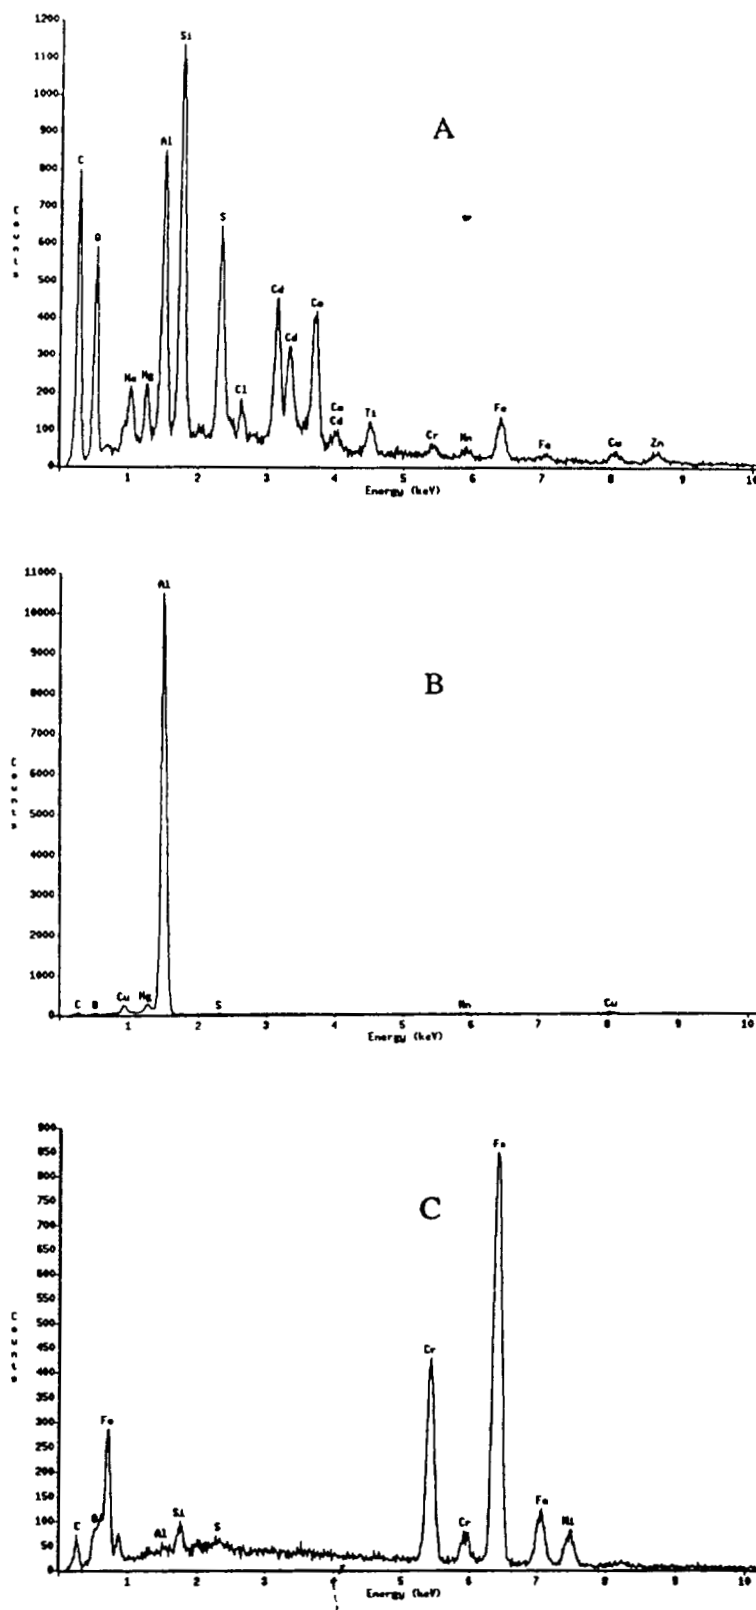
Figure 2. Electron microprobe elemental surveys of (A) the gray deposits indicated in Figure 1B, (B) an aluminum fragment and (C) a corrosion-resistant steel fragment from the surfaces shown in Figure 1.

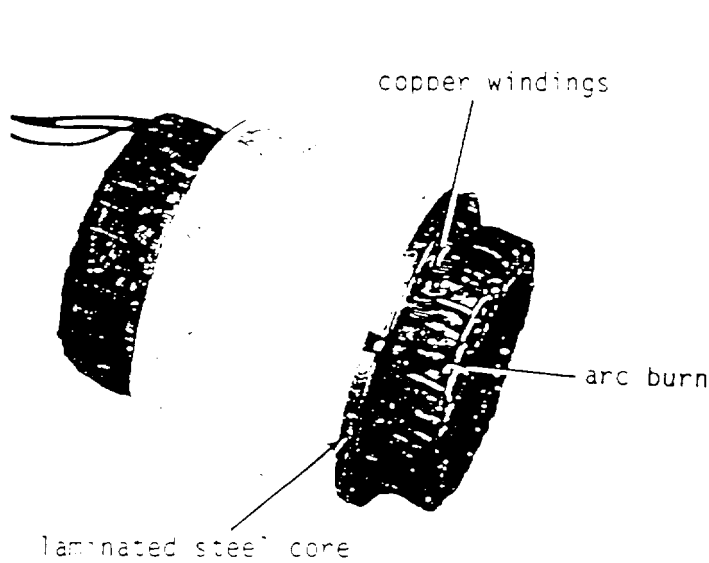
Fig. 2 Photograph of a stator component from a fuel boost pump (Mag. 0.75X).

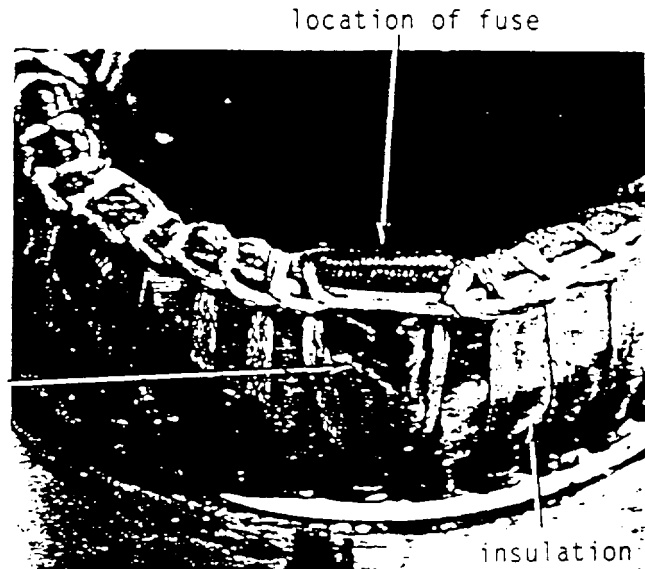
Fig. 3 Photograph showing the thermal fuse incorporated in the winding insulation wrap (Mag. 1.75X).

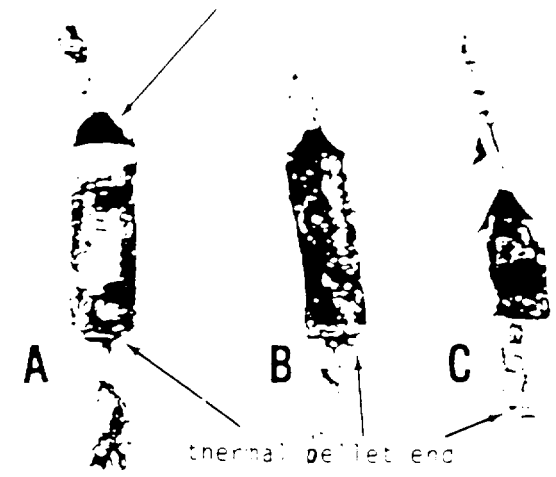
Fig. 10 Photograph of three arc burned fuses showing three different burn hole locations, A) thermal pellet end, B) at the whole length, and C) opposite the thermal pellet end (Mag. 2.5X).

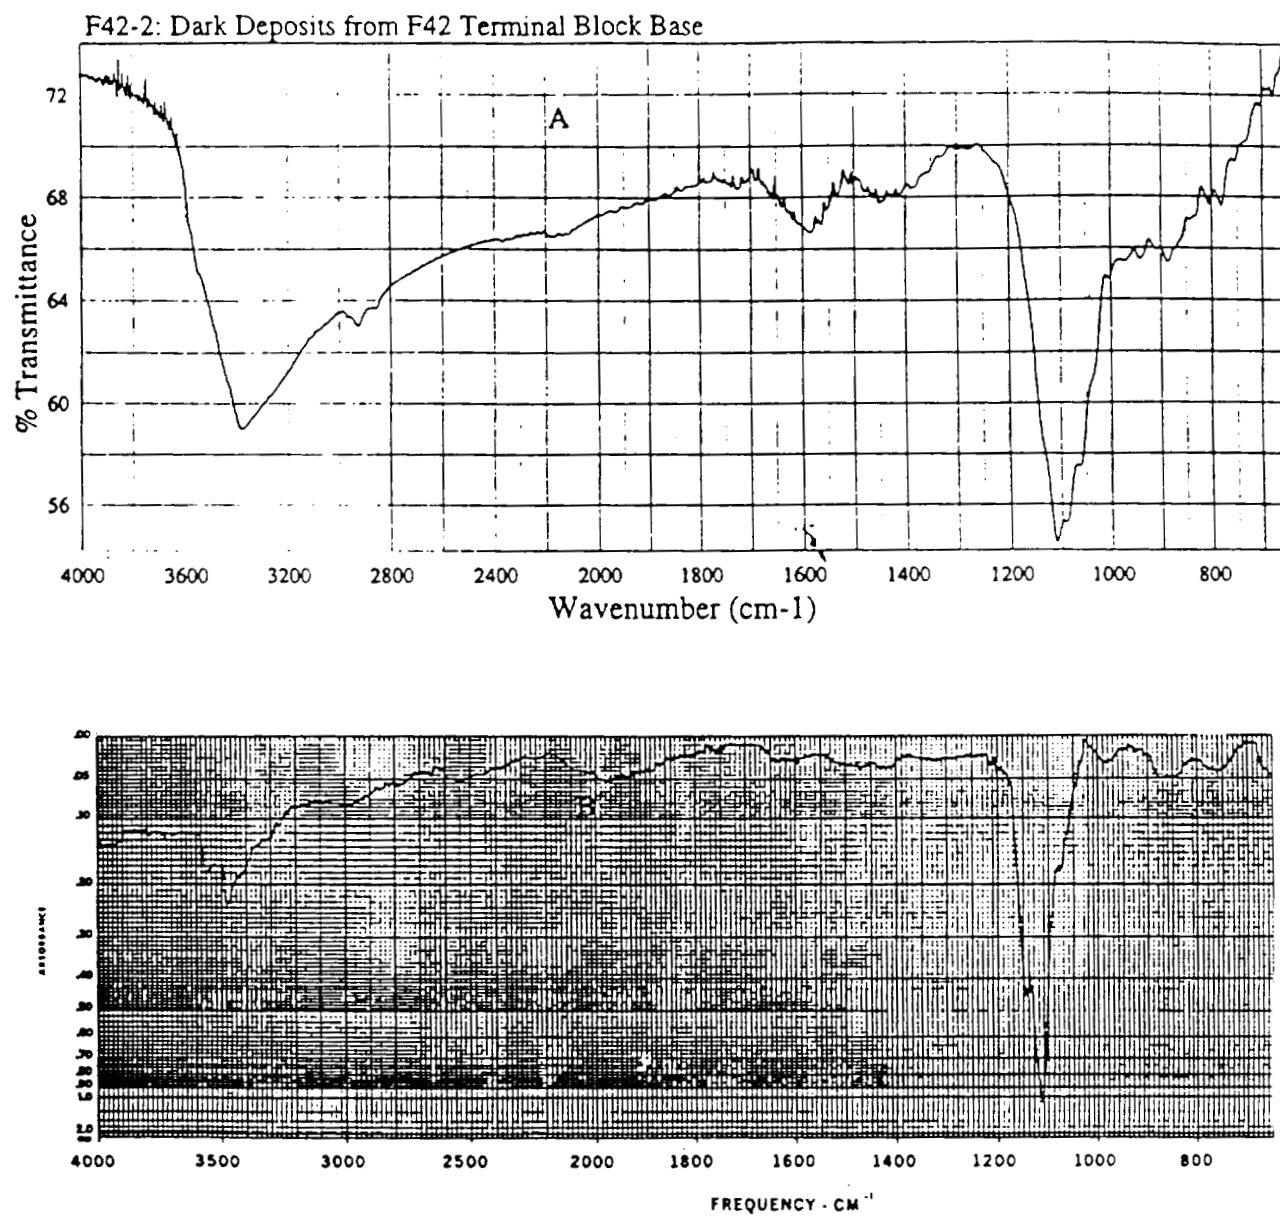
Analysis of the Dark Deposits. An infrared spectrum representative of the dark deposits from the terminal blocks is presented in Figure 15 along with a reference spectrum of copper sulfide (cuprous sulfide, Cu_2S). Condensed phase hydroxyl absorbs near 3400 wavenumbers, indicating the presence of some water of hydration or hydroxyl functional groups. The absorption near 1100 wavenumbers in both spectra in Figure 15 could be due to a sulfate impurity, but silicates also absorb near 1100 wavenumbers. Representative electron microprobe elemental surveys of the dark deposits, presented in Figure 16, provide clear indication that the deposits consist of copper-sulfur compounds and most likely of copper sulfide.

Figure 15. (A) An infrared spectrum of dark deposits on a terminal block from fuel quantity tank unit F42. (B) An infrared reference spectrum of cuprous sulfide, Cu_2S (© 1967, Sadler Research Laboratories).

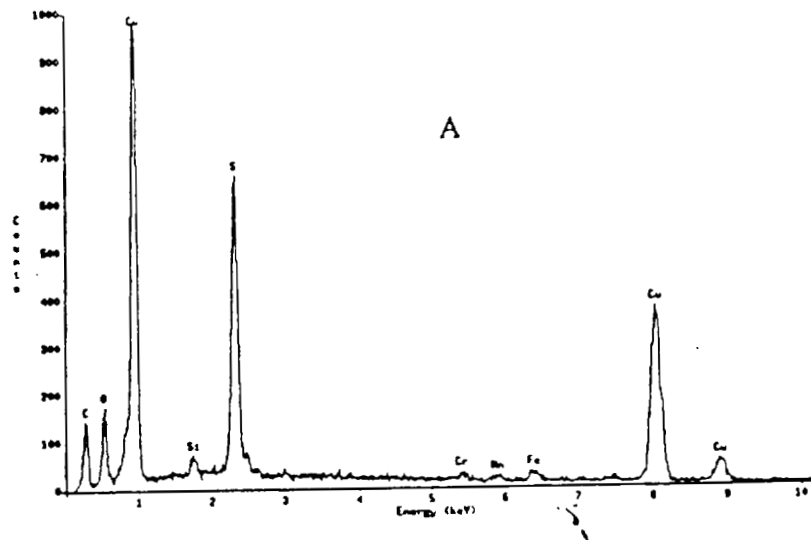
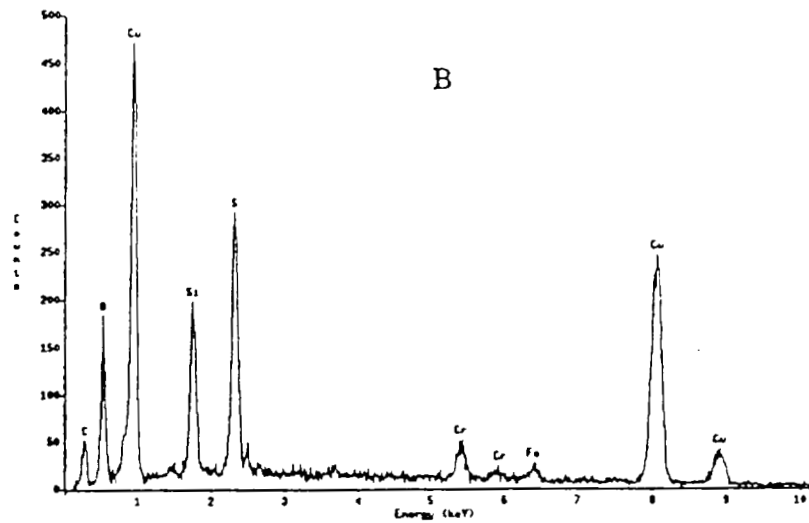
Varying concentrations of silicon and low concentrations of chromium, manganese and iron were also detected (16B). Essentially only silicon was detectable in the filaments observed on the terminal blocks (Figure 17A), shown in Figure 6, perhaps accounting for the silicon signal in the deposits. The blocks themselves were identified as a 300-series corrosion-resistant steel alloy which appeared to be plated with copper, at least in some locations. Metallurgical analysis is recommended to confirm composition if it is in question. Black deposits lifted from a hold-down nut on the F44 Hi-Z terminal block were identified as silver sulfide (Figure 17B).

Figure 16. Electron microprobe elemental surveys of (A) dark deposits from the Hi-Z terminal block of F41 and (B) dark deposits from the Hi-Z terminal block of F42.

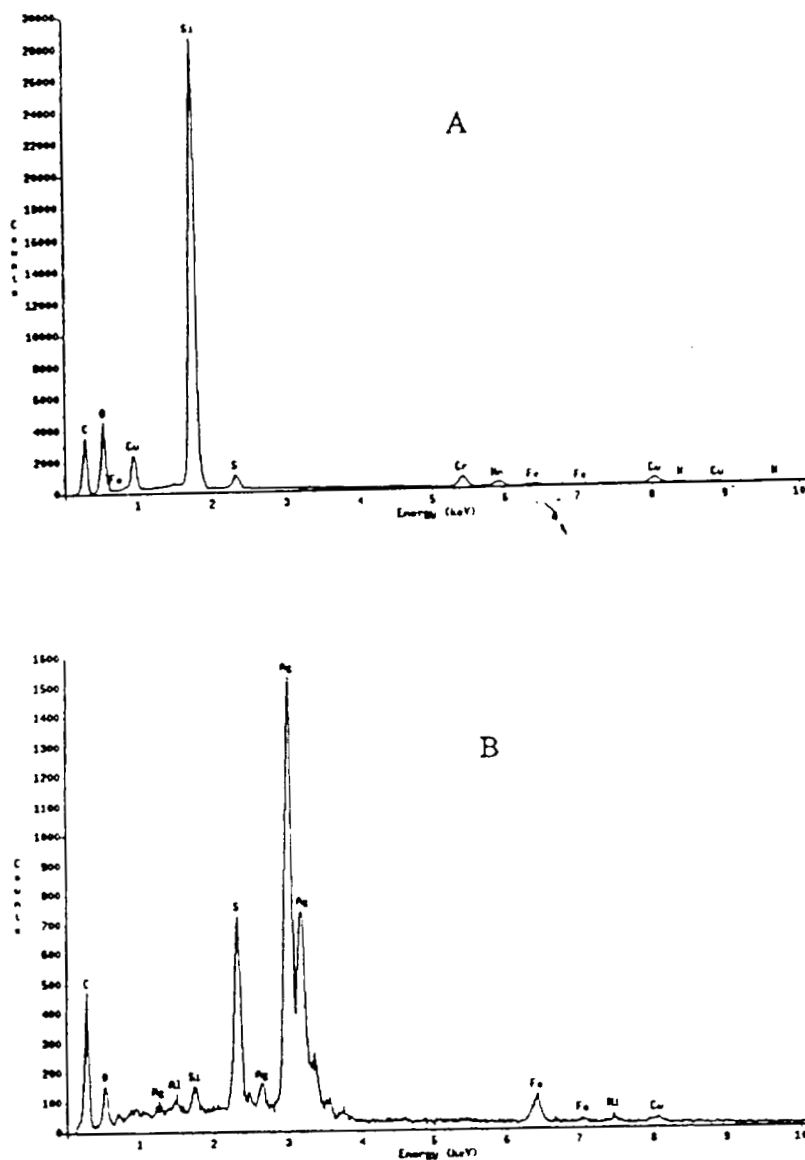
Figure 17. Electron microprobe elemental surveys of (A) filaments from the Lo-Z terminal block of F40 and (B) dark deposits from the Hi-Z terminal block hold-down nut of F44.

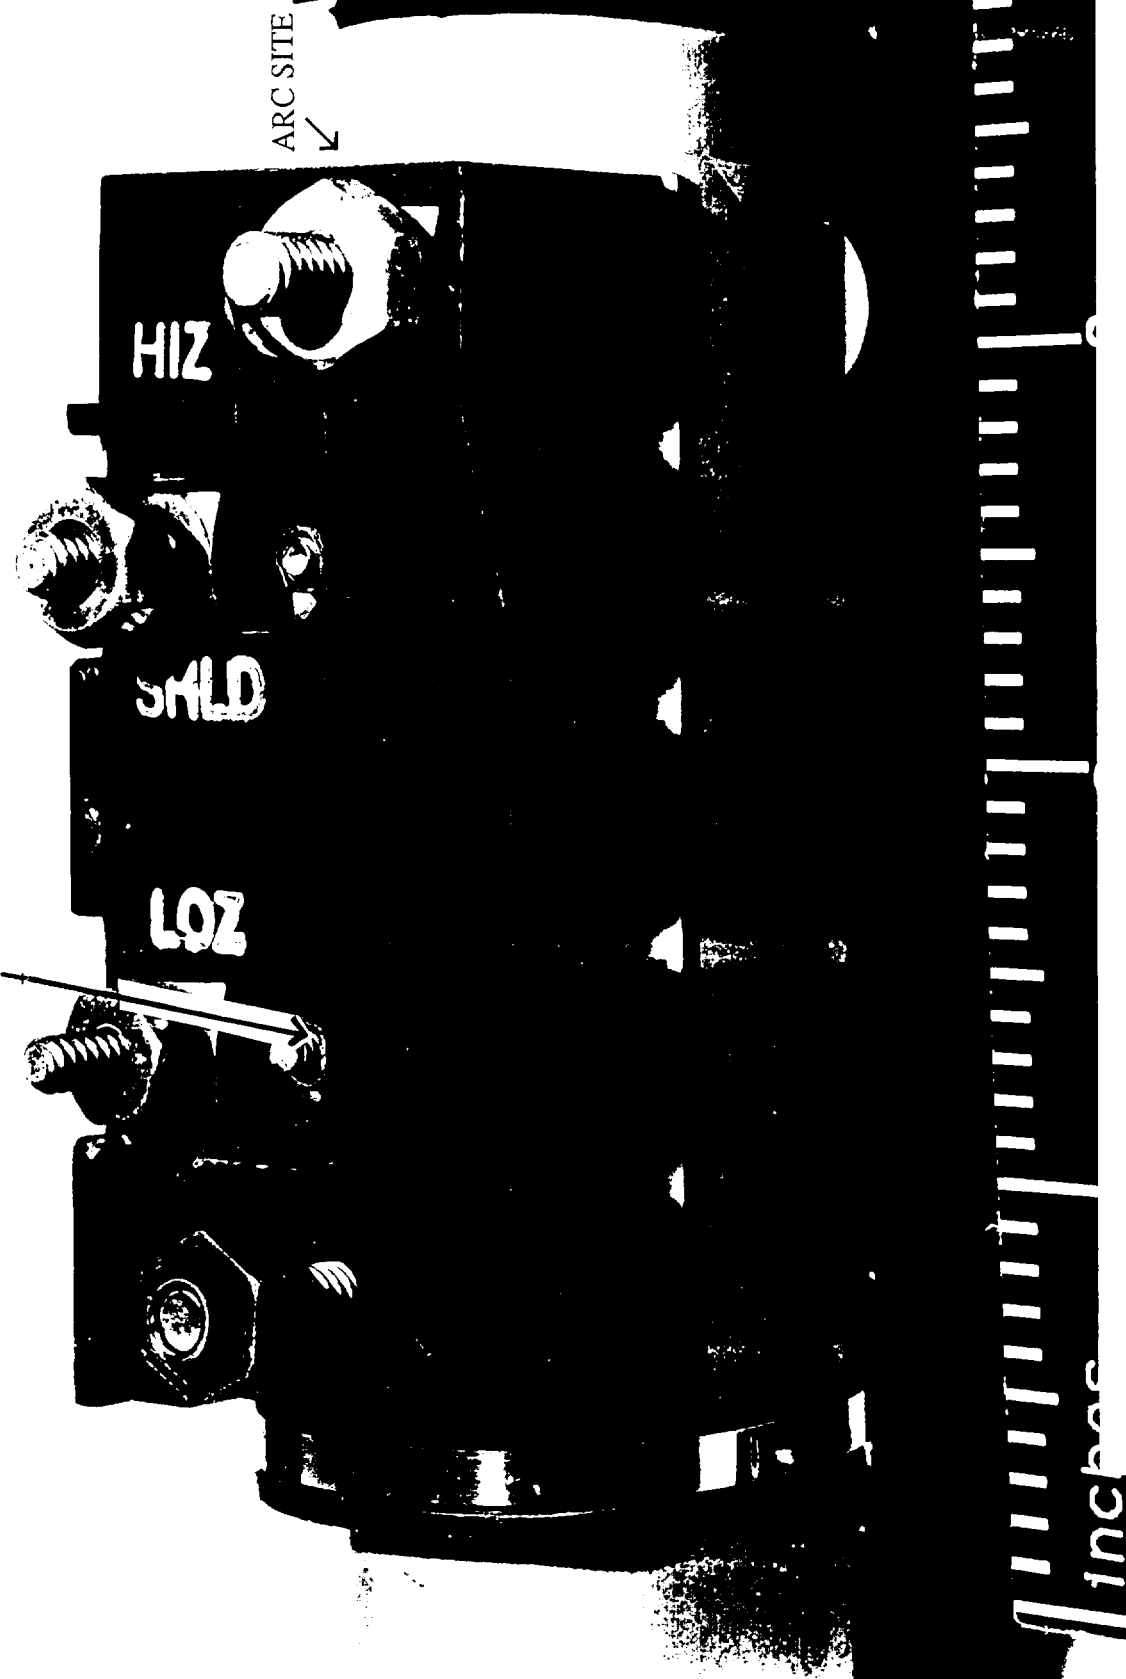
Figure 2. The terminal assembly of fuel quantity tank unit F40 (2.25X). The edge along which arcing occurred is indicated.

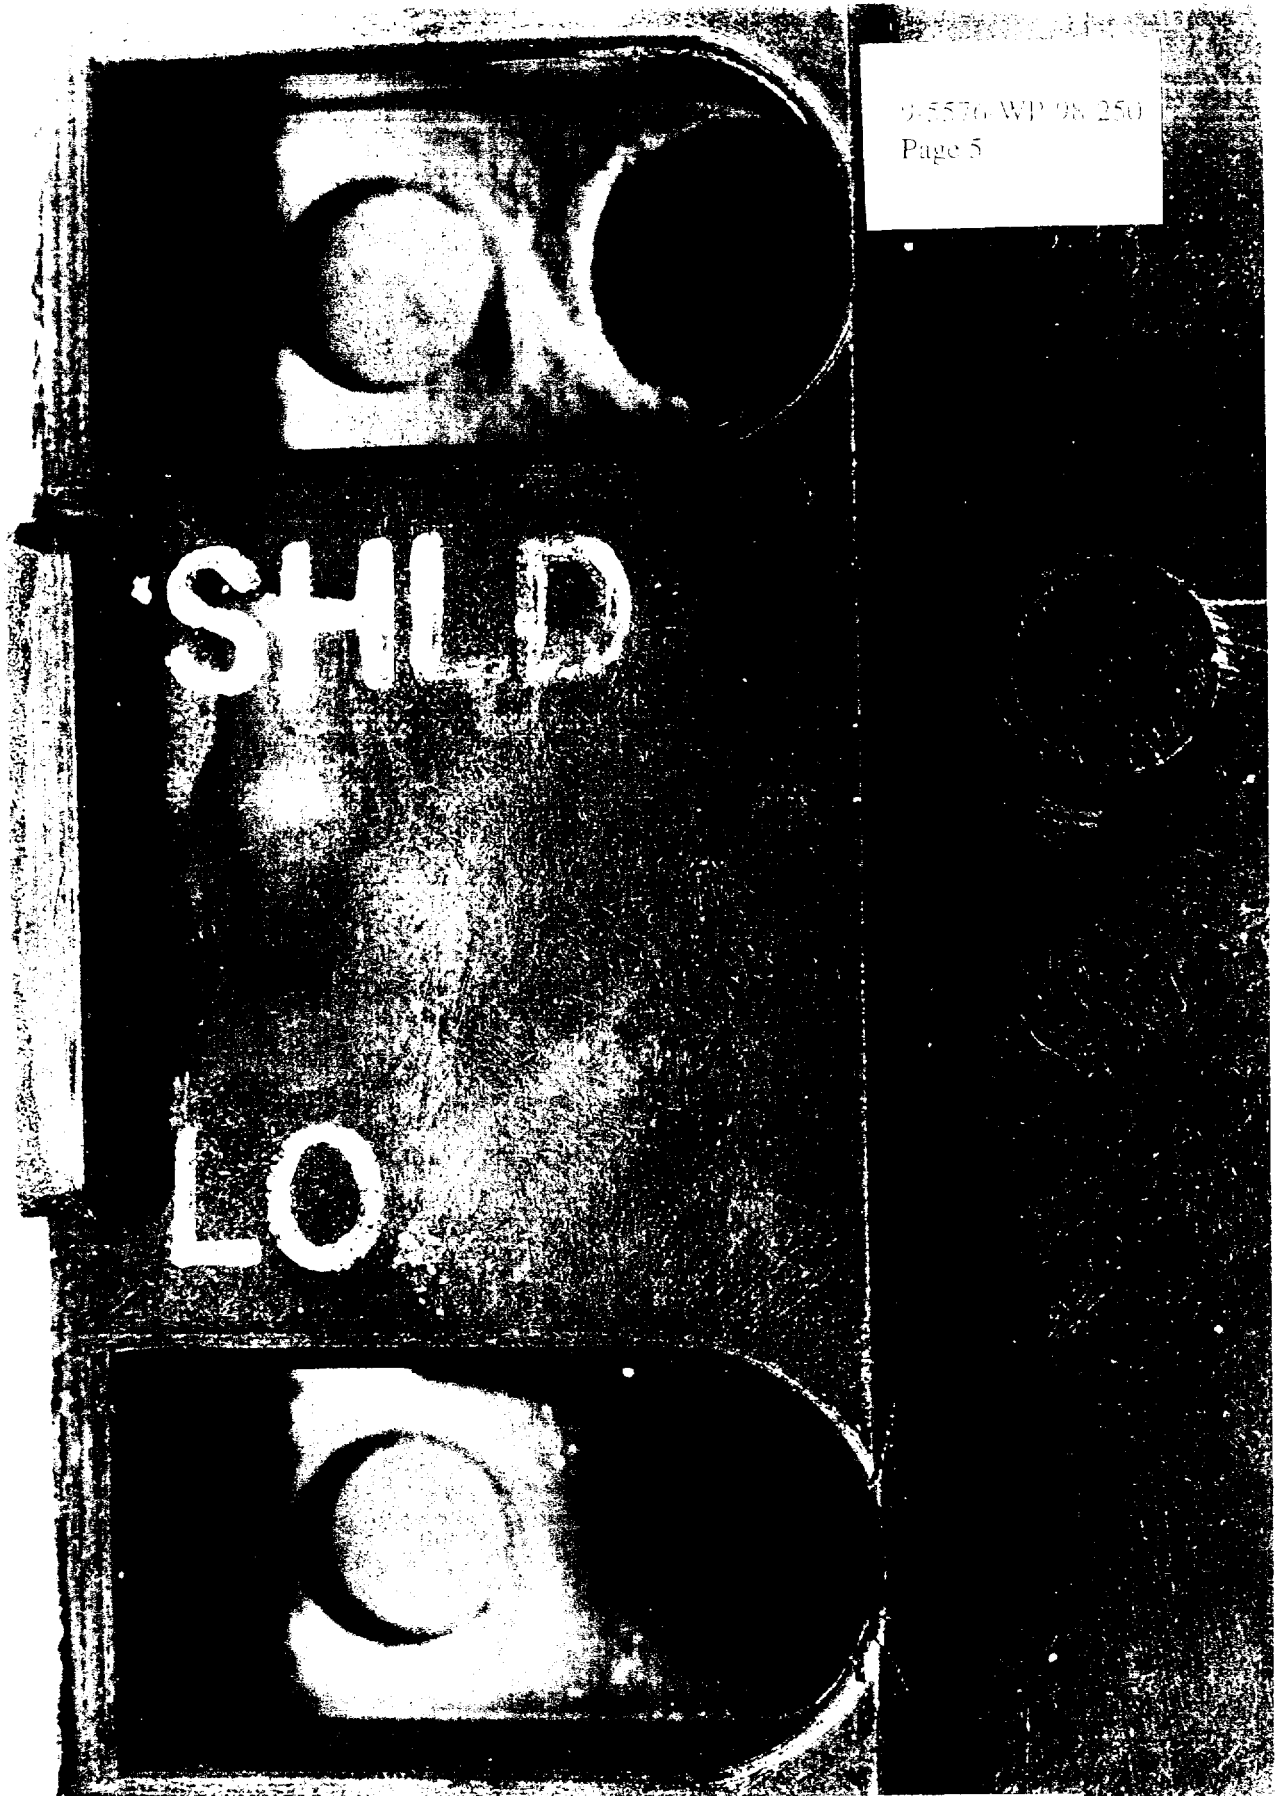
Figure 2. Deposits on surface of FH terminal block between LoZ and shield (approximately 6.6X).

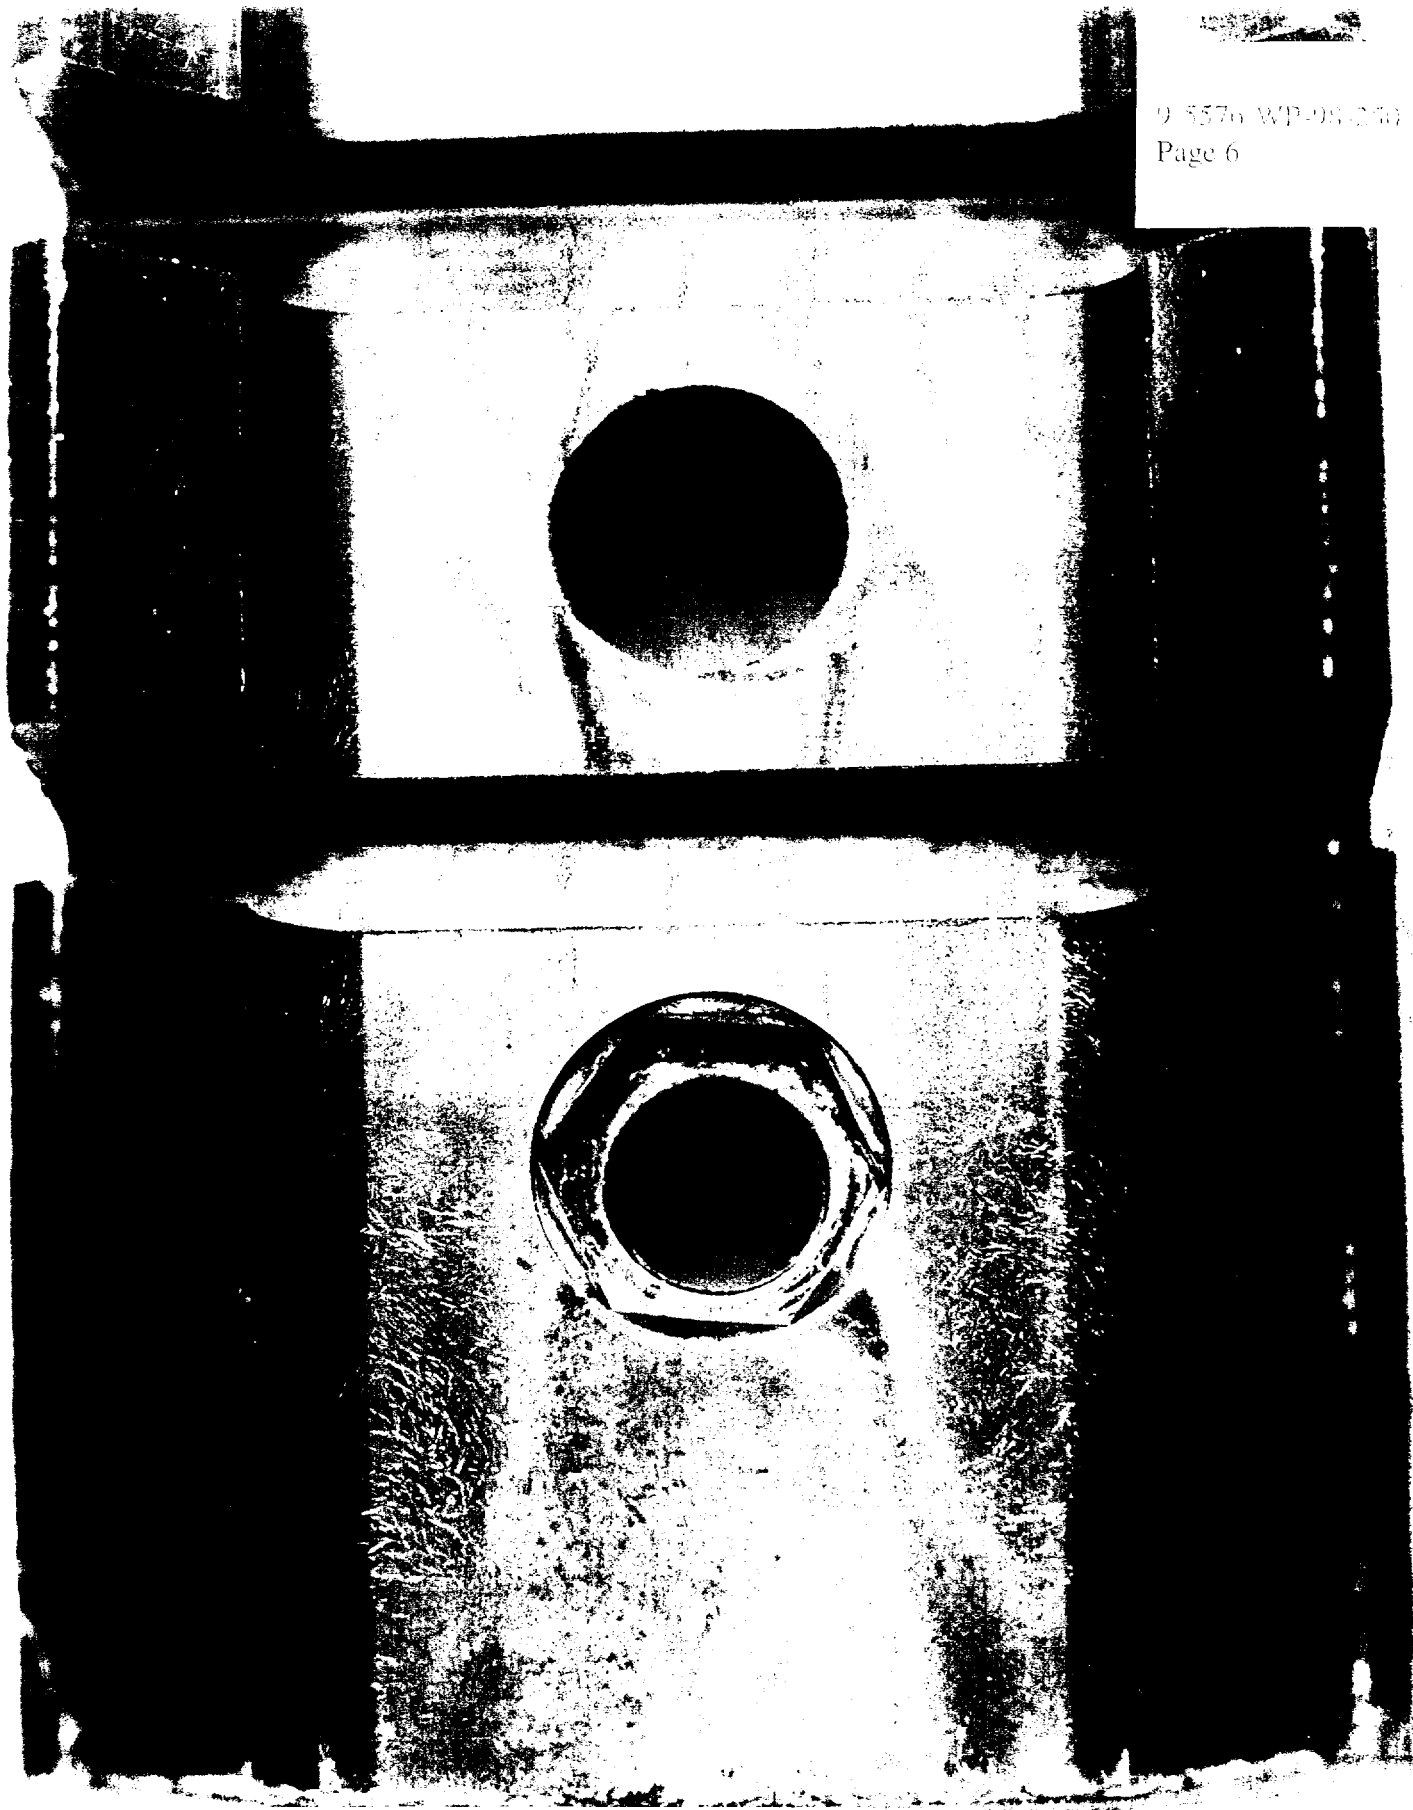
Figure 3. Deposits on underside of F11 terminal block (approximately 6.6X).

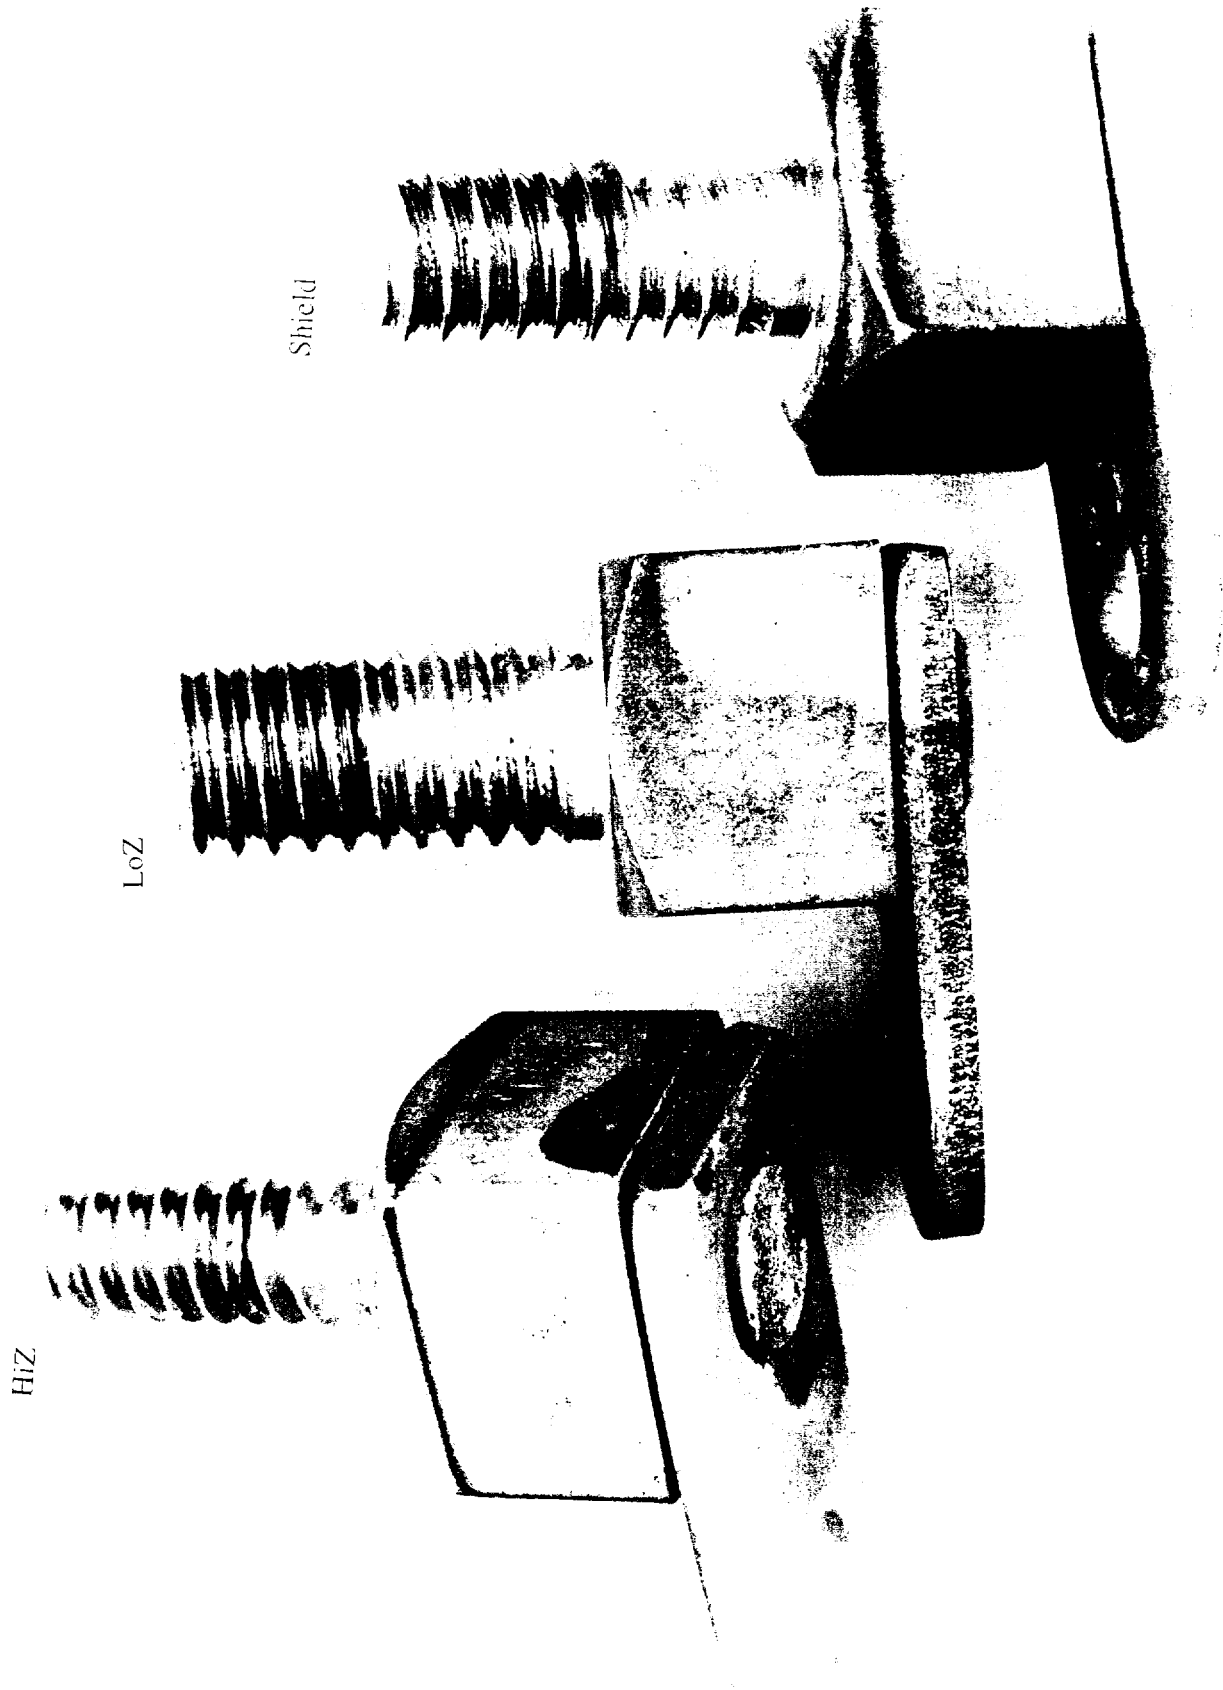
Figure 4. Dark deposits on F11 terminal studs (approximately 6.4X).

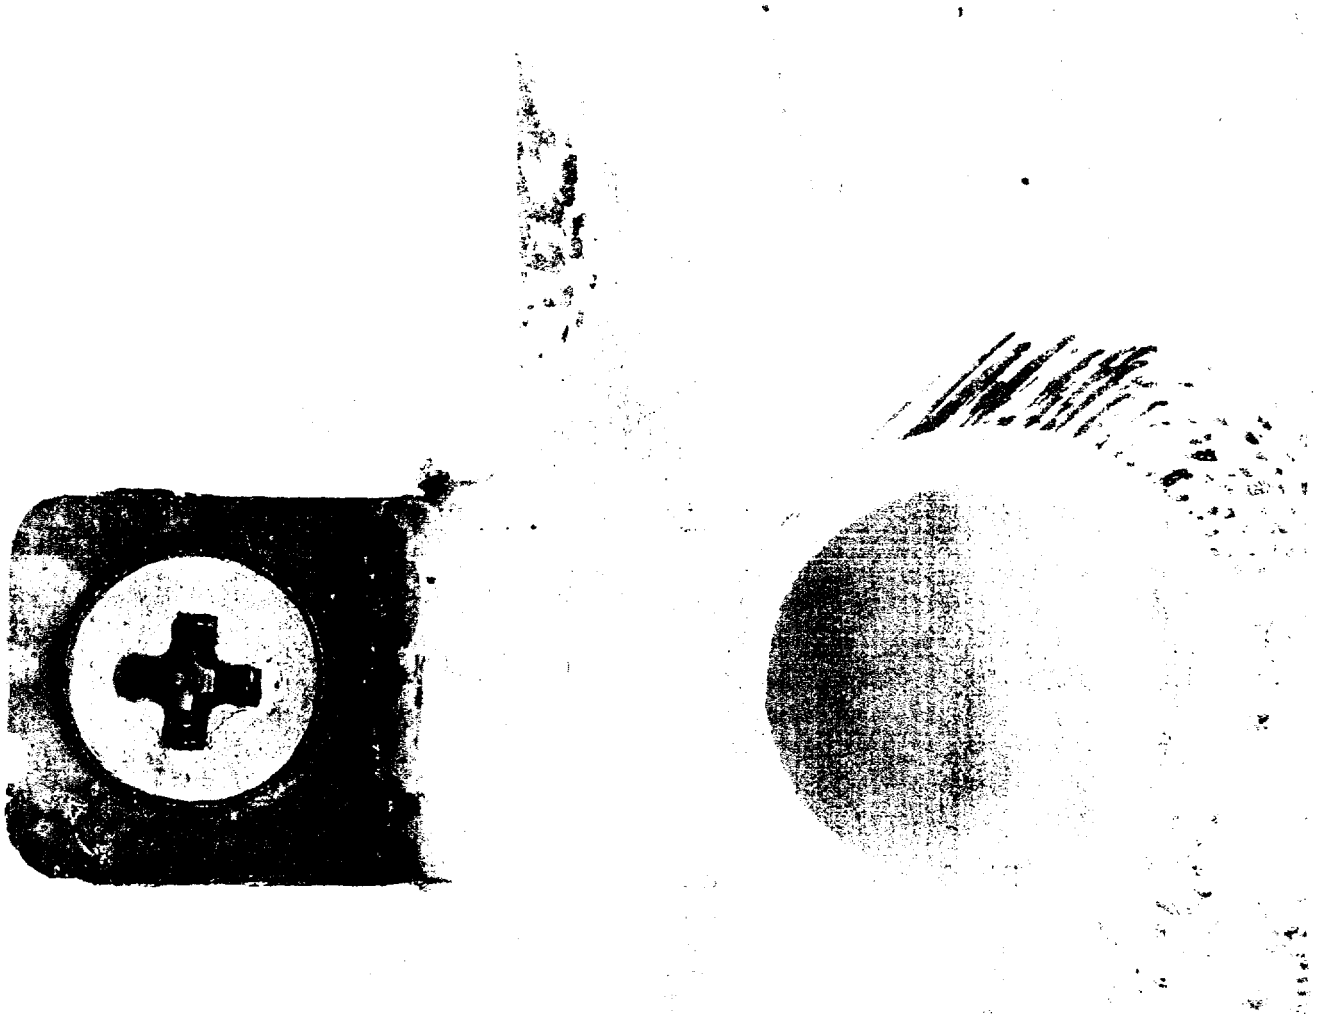
Figure 6. F11 laminated copper shield, bottom side (approximately 6.9X).

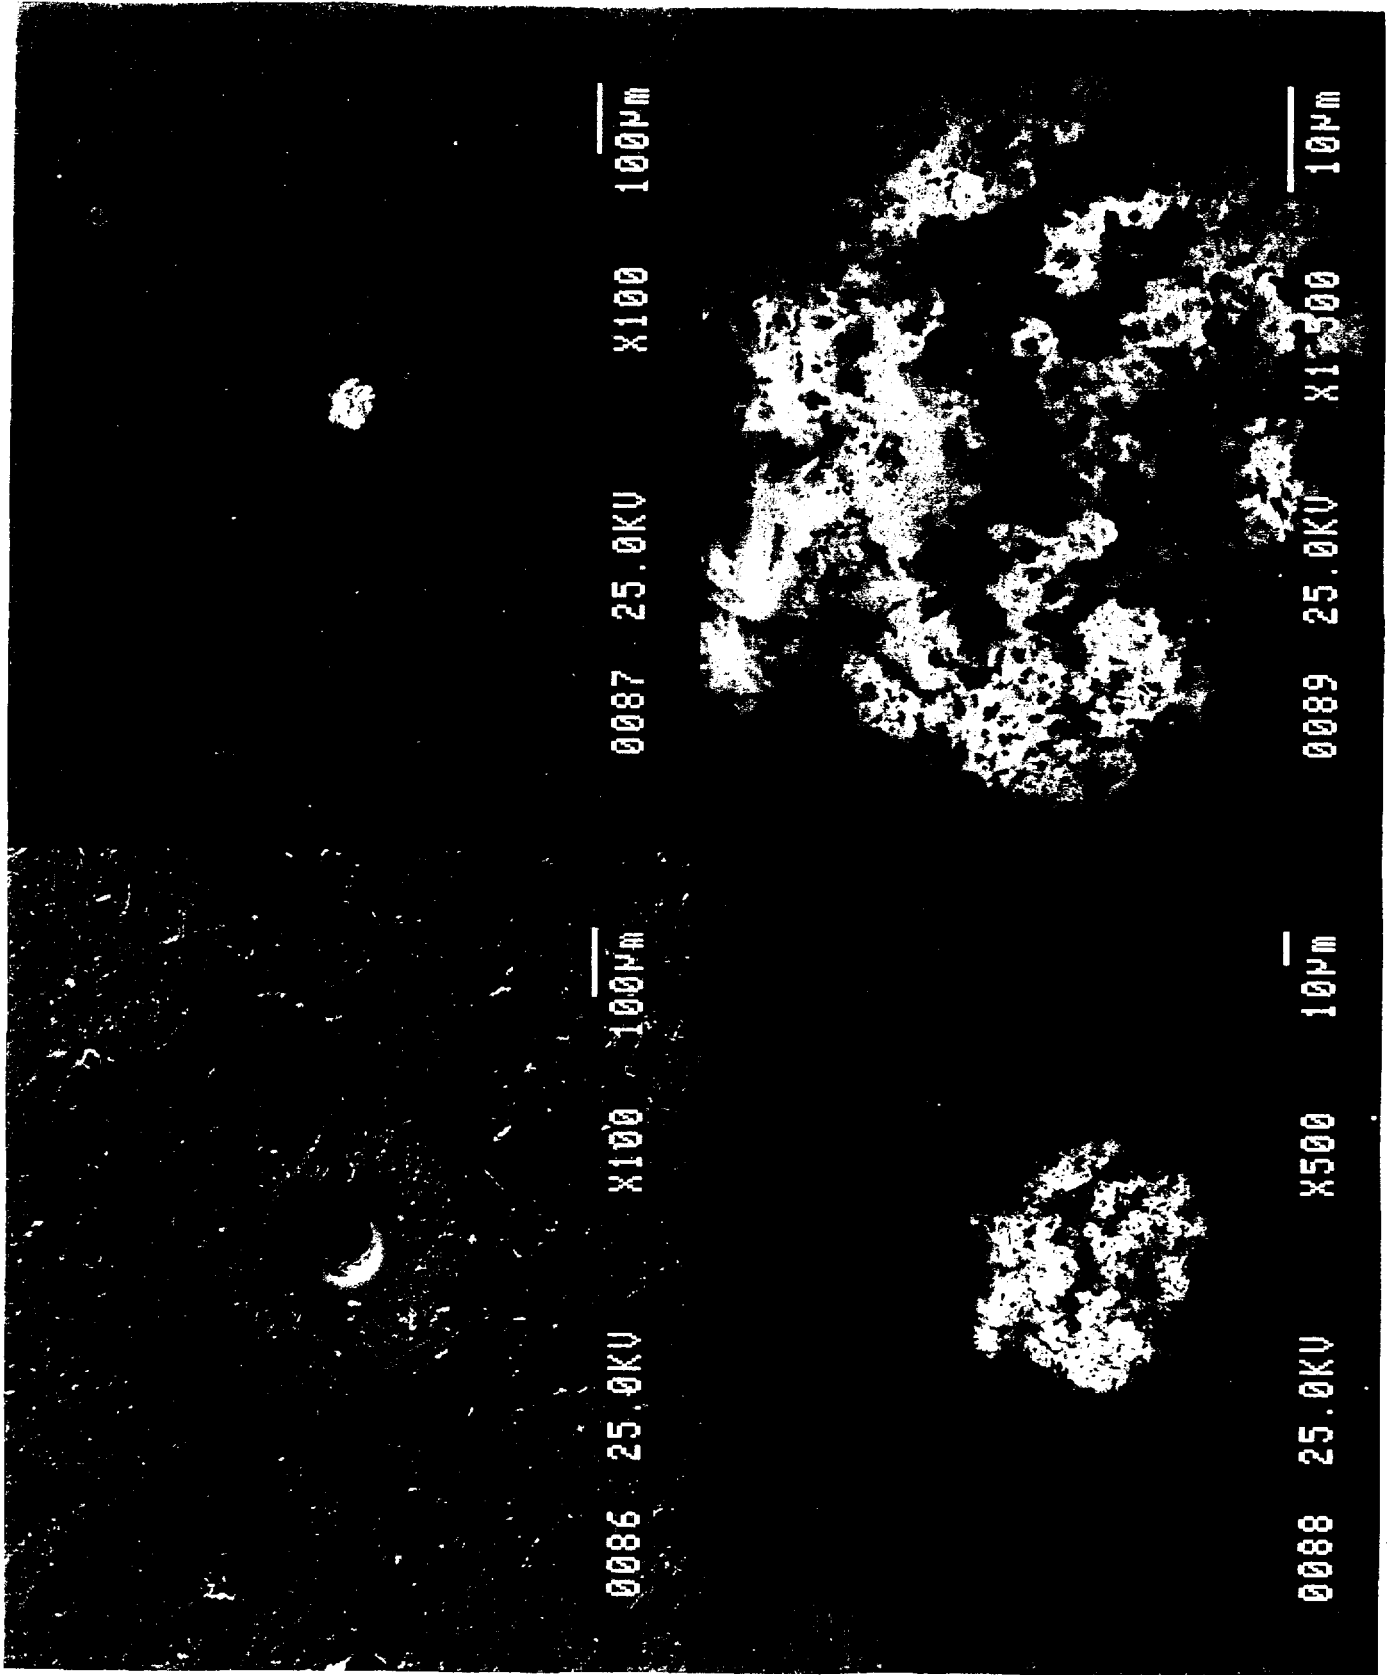
Figure 8. Electron micrographs of hole in F11 laminated copper shield.

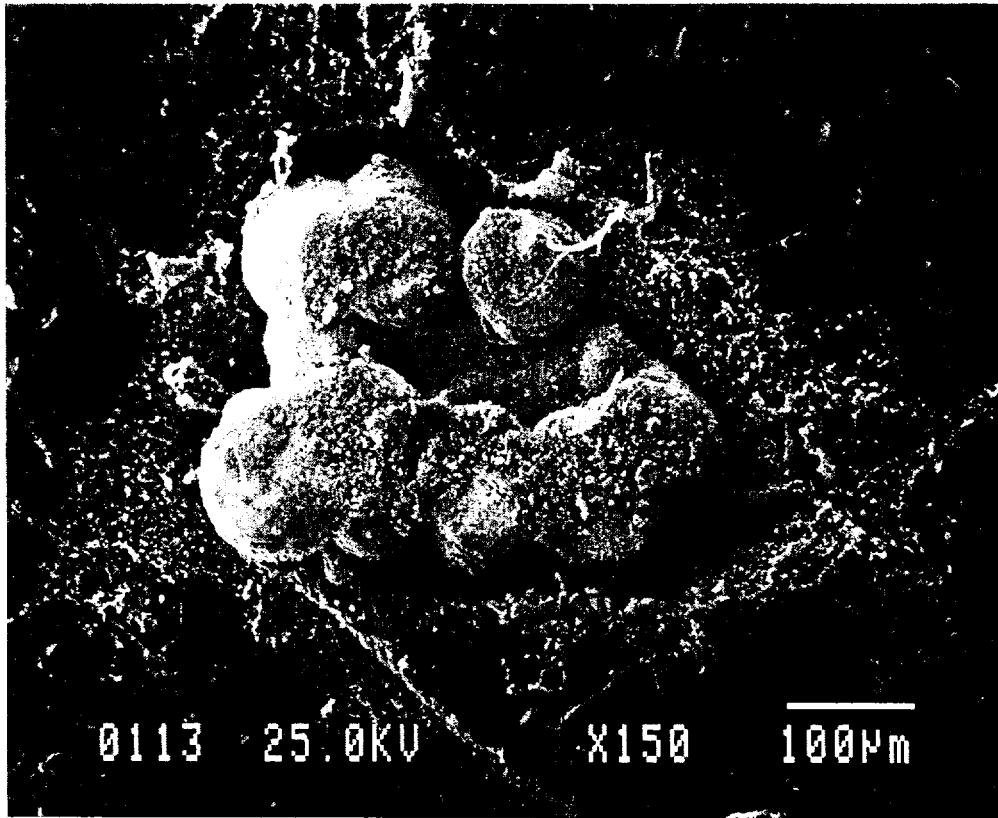
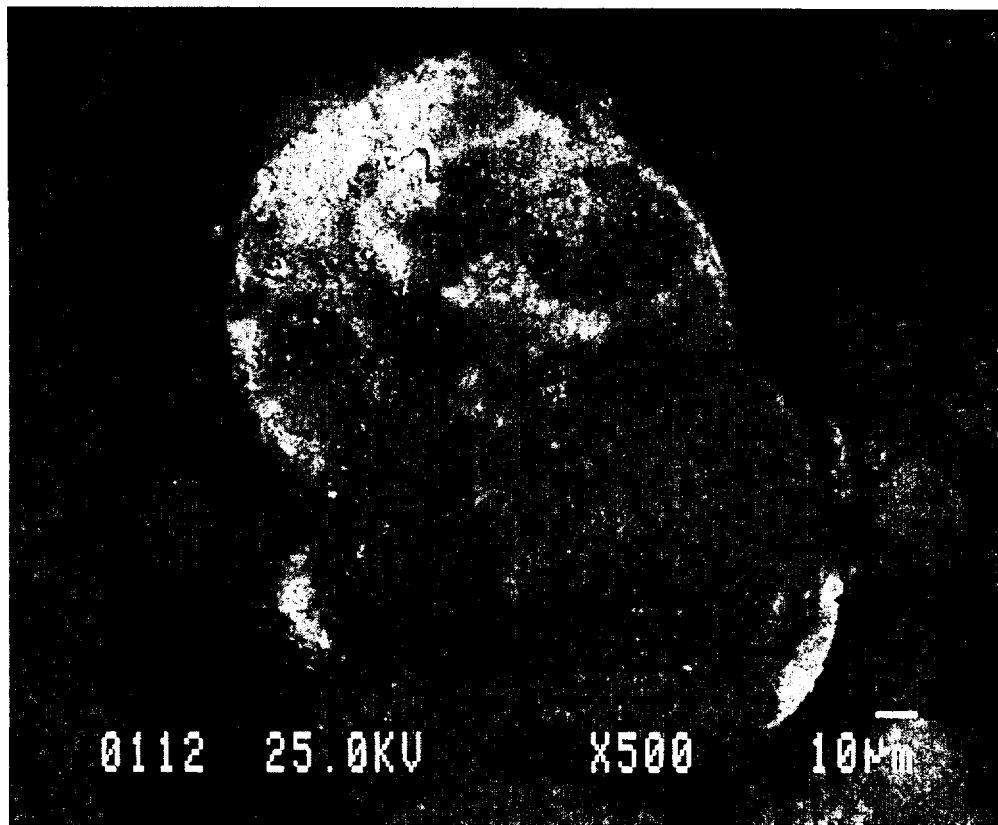
Figure 11. Electron micrographs of solder spatter on F48 laminated copper shield.
